## **Massachusetts FACE • Occupational Fatality Report**

### **Carpenter Fell from the Roof of a Single Family Home Under Construction - Massachusetts**

**Investigation: # 10-MA-036-01**

**Release Date: March 23, 2012**

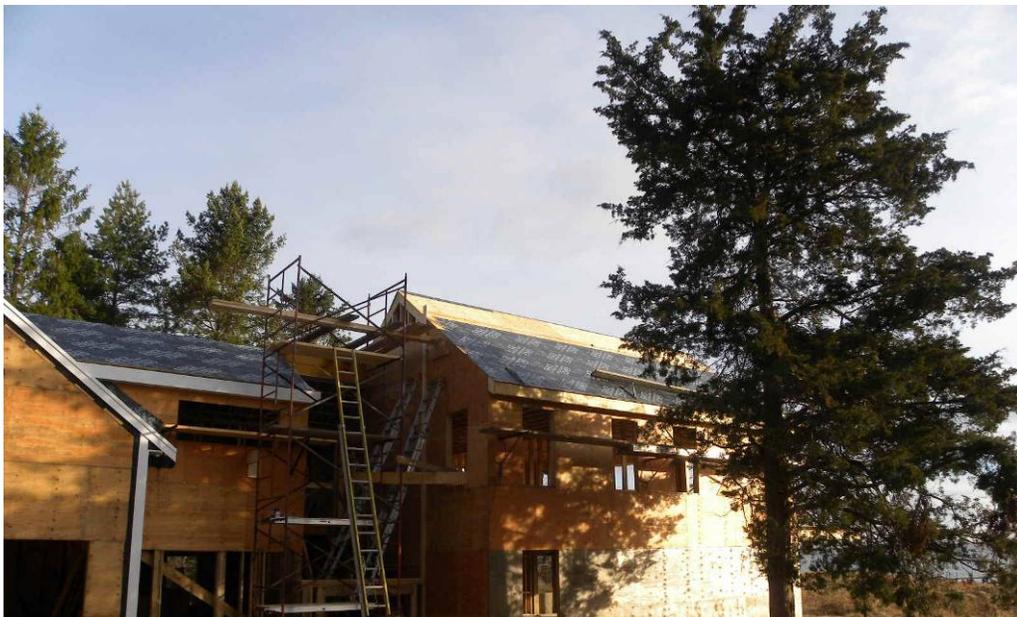
Most of the exterior framing had been completed on the structure, including framing of the main section of the house and a two story garage. The main section of the house is about two and one half stories high, with a 9-in-12 pitch roof and a roof edge height of approximately 19 feet (Figure 1). The one section of the structure that was not yet framed was the breezeway to be located in the front of the house between the house and the garage. The breezeway had not yet been framed because the design of the breezeway had not been completed at the time construction began.

**Figure 1 – Incident location**

Because this job was new construction of a house, a guardrail system may have been a good choice for fall protection. The guardrail system could have been installed early in the project and stayed in place for most of the construction process.

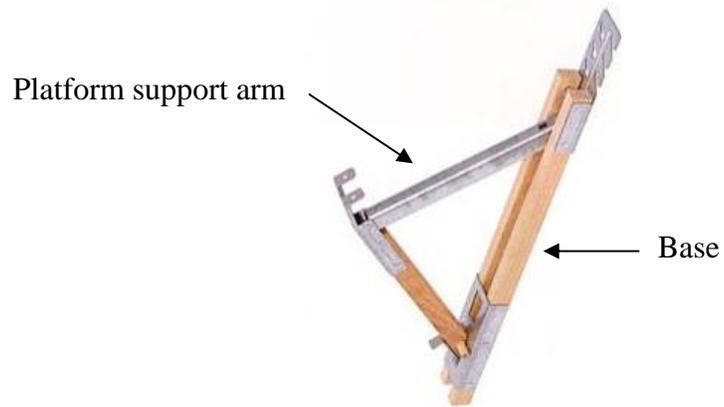
The roof bracket scaffold was made of four adjustable roof brackets that were installed approximately 12 feet apart and planked with 2x10 inch boards. The roof brackets are made of galvanized steel and wood (Figure 2). The two main pieces of the bracket are: 1) the base and 2) the platform support arm. The base section consists of a rectangular piece of wood with two notches at one end and a metal plate with nail holes attached to the other end of the wood piece. The metal plate, which is connected to the platform support arm by a hinge, is used to fasten the bracket's base to the roof (Figure 2).

The platform support arm is made up of two rectangular steel pieces connected by a hinge and a rectangular wood piece attached directly to one of the steel pieces (Figure 2). When the roof bracket is in use, the support arm's wood piece is inserted into one of two notches in the base's wood piece to create a 45 or 60 degree angle platform. Wood planking is positioned on the support arm creating the

**Figure 2 – Similar roof bracket to the one that was being used**

**Discussion:** There are a variety of both fixed and adjustable roof brackets available. When using adjustable roof brackets, only roof brackets with locking mechanisms should be used. The locking mechanisms available on some adjustable roof brackets will lock the platform support arm into the base section of the roof bracket. When the roof bracket's platform support arm is locked into the base, the hazard of the platform support arm lifting up and out of the base notch is eliminated. This type of hazard is not present with fixed roof brackets. As stated in OSHA's *Compliance Guidance for Residential Construction* (STD 03-11-002), roof brackets, except in extremely rare situations, must be used in conjunction with conventional fall protection (Recommendation #1).

In this case, either a fixed or adjustable roof bracket with a lock might have prevented the roof bracket from folding down flat and the planking from falling from the roof to the ground. In addition, when using roof brackets or any type of equipment, it is important to follow the manufacturer's instructions. It was reported that the roof brackets being used at the time of the incident were spaced 12 feet apart. Most manufacturers of roof brackets state that roof brackets should be used at no more than eight feet apart.

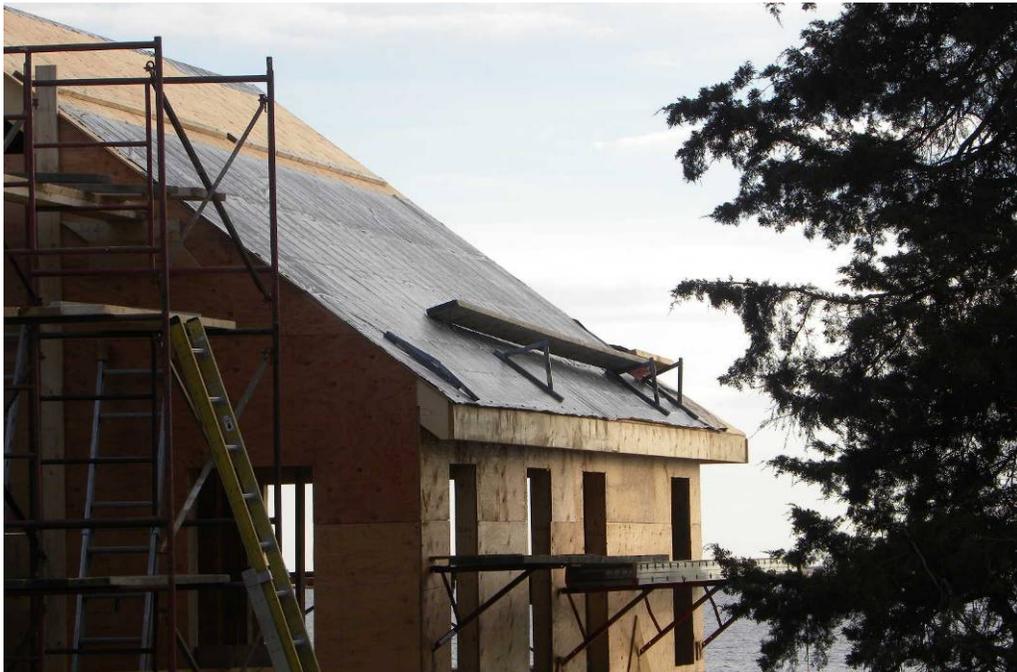
When the plank bounced, it appears that it caused the metal support section of the roof bracket to lift up with the plank. During the bounce, the roof bracket's adjustable wood piece was pulled out of the notch of the roof bracket's wood piece, which is fastened to the roof, causing the roof bracket to fold down flat (Figure 3). When the roof bracket folded down flat, the plank and the victim fell approximately 19 feet to the ground below, where the victim struck his head.

**Figure 3 – Roof with roof bracket folded flat**
