Massachusetts FACE • Occupational Fatality Report

Carpenter Fell from the Roof of a Single Family Home Under Construction - Massachusetts

Investigation: # 10-MA-036-01

Release Date: March 23, 2012

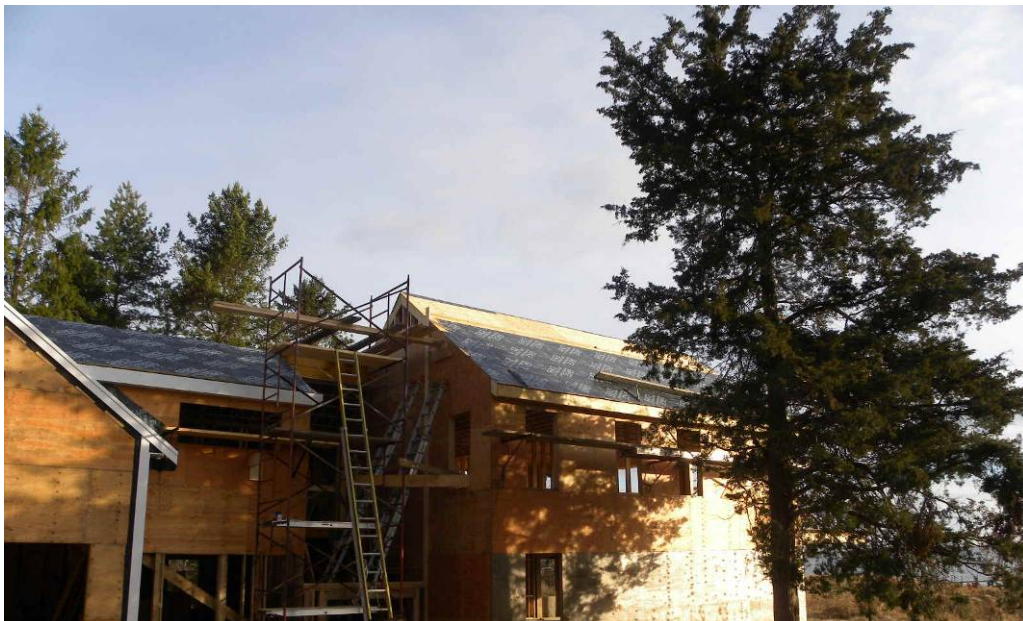
Figure 1 – Incident location

Most of the exterior framing had been completed on the structure, including framing of the main section of the house and a two story garage. The main section of the house is about two and one half stories high, with a 9-in-12 pitch roof and a roof edge height of approximately 19 feet (Figure 1). The one section of the structure that was not yet framed was the breezeway to be located in the front of the house between the house and the garage. The breezeway had not yet been framed because the design of the breezeway had not been completed at the time construction began.

At approximately 3:30 p.m., the victim went to get a plank that was located on the roof of the main house at the roof brackets. According to the police report, the victim climbed from the top level of the tubular scaffolding that was being erected, to the peak of the house's main roof. When the victim climbed onto the roof, he placed his stomach on the roof and grabbed a 2x4 board (cleat) that was nailed approximately four feet down along the peak of the roof of the main house. The victim then slid/lowered himself down to the roof bracket. Although un-witnessed from this point forward, it appears that when the victim reached the plank for the roof bracket, his weight and momentum from sliding down to the roof bracket might have caused the plank to bounce.

Recommendation #1: Employers should provide fall protection for all employees exposed to fall hazards of six feet or more.

Because this job was new construction of a house, a guardrail system may have been a good choice for fall protection. The guardrail system could have been installed early in the project and stayed in place for most of the construction process.

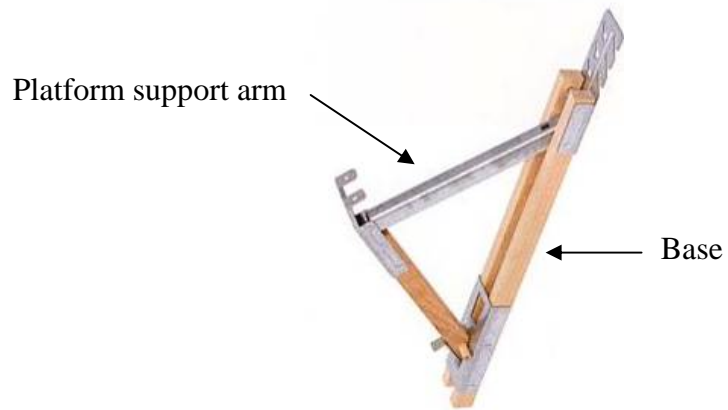
Figure 2 – Similar roof bracket to the one that was being used

The roof bracket scaffold was made of four adjustable roof brackets that were installed approximately 12 feet apart and planked with 2x10 inch boards. The roof brackets are made of galvanized steel and wood (Figure 2). The two main pieces of the bracket are: 1) the base and 2) the platform support arm. The base section consists of a rectangular piece of wood with two notches at one end and a metal plate with nail holes attached to the other end of the wood piece. The metal plate, which is connected to the platform support arm by a hinge, is used to fasten the bracket's base to the roof (Figure 2).

The platform support arm is made up of two rectangular steel pieces connected by a hinge and a rectangular wood piece attached directly to one of the steel pieces (Figure 2). When the roof bracket is in use, the support arm's wood piece is inserted into one of two notches in the base's wood piece to create a 45 or 60 degree angle platform. Wood planking is positioned on the support arm creating the

platform. The support arm has two punctured dimples to grip the wood planking to prevent it from moving.

Recommendation #2: Employers should eliminate the use of adjustable roof brackets that are not equipped with locking mechanisms.

Discussion: There are a variety of both fixed and adjustable roof brackets available. When using adjustable roof brackets, only roof brackets with locking mechanisms should be used. The locking mechanisms available on some adjustable roof brackets will lock the platform support arm into the base section of the roof bracket. When the roof bracket's platform support arm is locked into the base, the hazard of the platform support arm lifting up and out of the base notch is eliminated. This type of hazard is not present with fixed roof brackets. As stated in OSHA's *Compliance Guidance for Residential Construction* (STD 03-11-002), roof brackets, except in extremely rare situations, must be used in conjunction with conventional fall protection (Recommendation #1).

In this case, either a fixed or adjustable roof bracket with a lock might have prevented the roof bracket from folding down flat and the planking from falling from the roof to the ground. In addition, when using roof brackets or any type of equipment, it is important to follow the manufacturer's instructions. It was reported that the roof brackets being used at the time of the incident were spaced 12 feet apart. Most manufacturers of roof brackets state that roof brackets should be used at no more than eight feet apart.

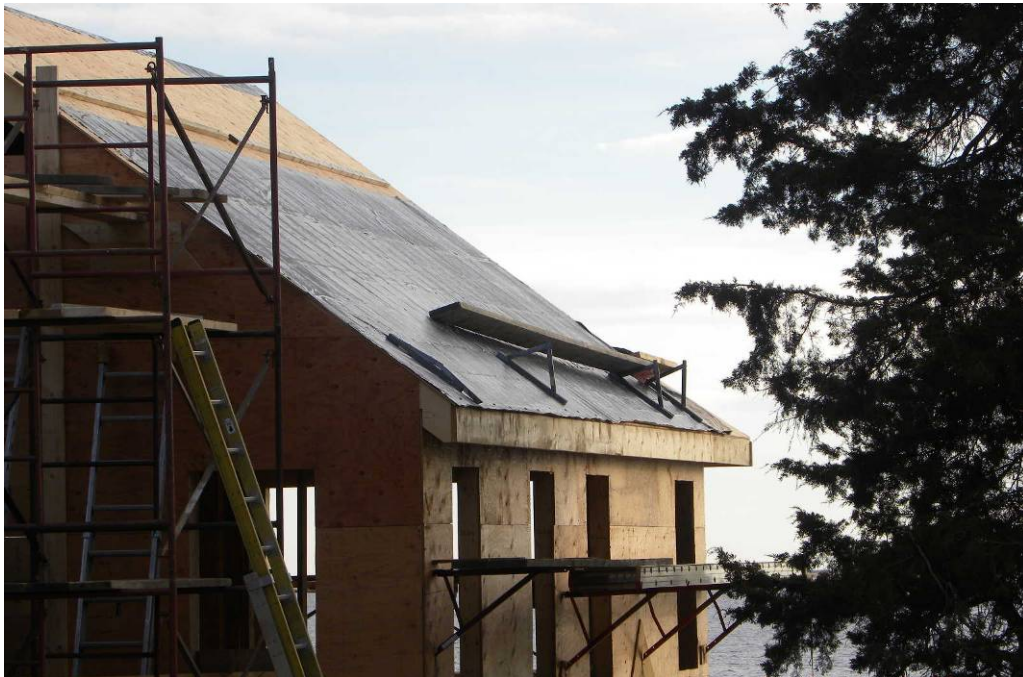
When the plank bounced, it appears that it caused the metal support section of the roof bracket to lift up with the plank. During the bounce, the roof bracket's adjustable wood piece was pulled out of the notch of the roof bracket's wood piece, which is fastened to the roof, causing the roof bracket to fold down flat (Figure 3). When the roof bracket folded down flat, the plank and the victim fell approximately 19 feet to the ground below, where the victim struck his head.

Figure 3 – Roof with roof bracket folded flat
