SUBJECT: A Plumber Dies When He Falls from the Second Floor of a Building after Stepping on Unsupported Plywood Formwork

SUMMARY
California FACE Report #11CA001

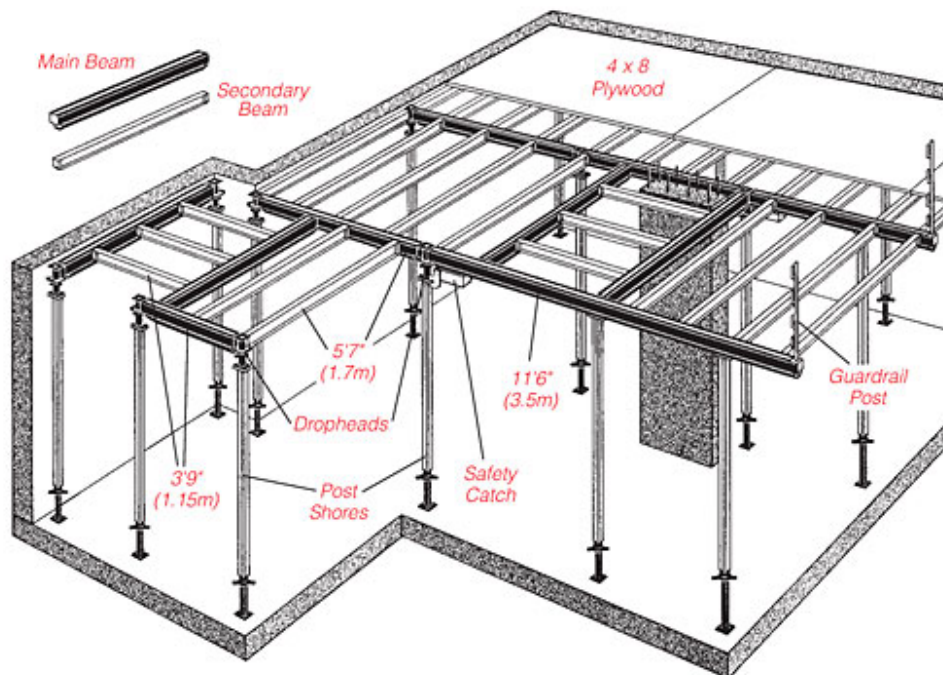
The incident site was a two-story multipurpose building (approximately 126 x 140 feet) under construction. Vertical shoring was used to support horizontal plywood sheet formwork while concrete floors were poured. The vertical shoring involved in this incident was a pre-engineered modular system that used lightweight interlocking aluminum beams and adjustable posts that erect and dismantle very quickly. The vertical shoring system was capable of accommodating shore heights up to 18'10" (see exhibit #1). The vertical shoring for the second floor had been erected earlier in the month.

Exhibit 1. A diagram of a vertical shoring system.

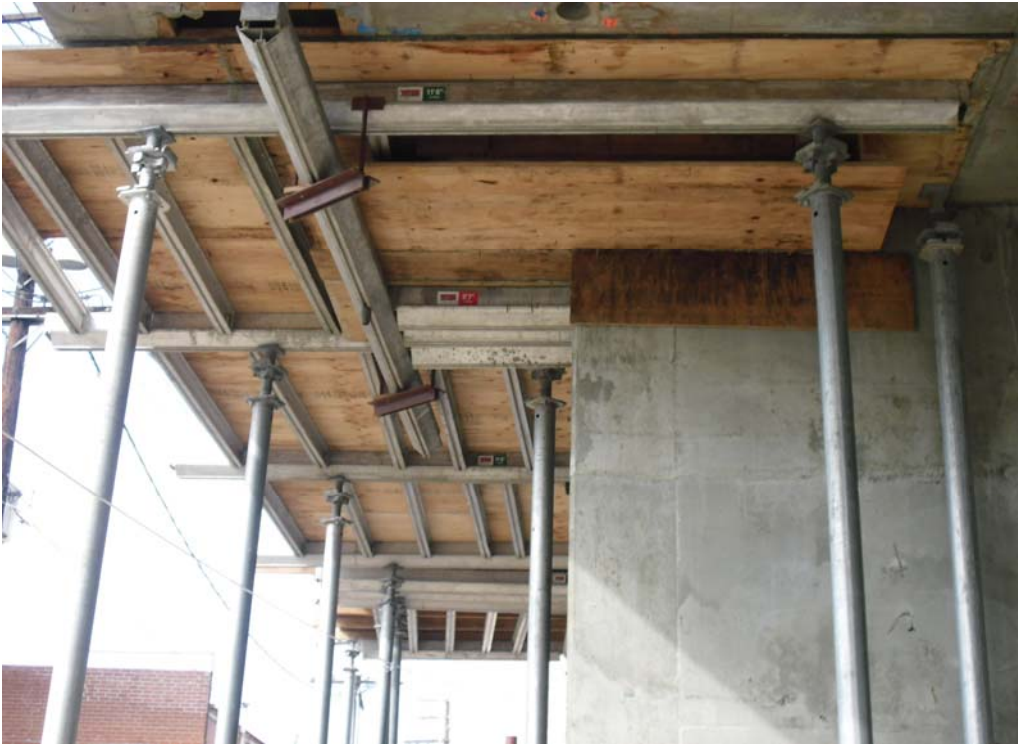
Exhibit 2. The vertical shoring from underneath.

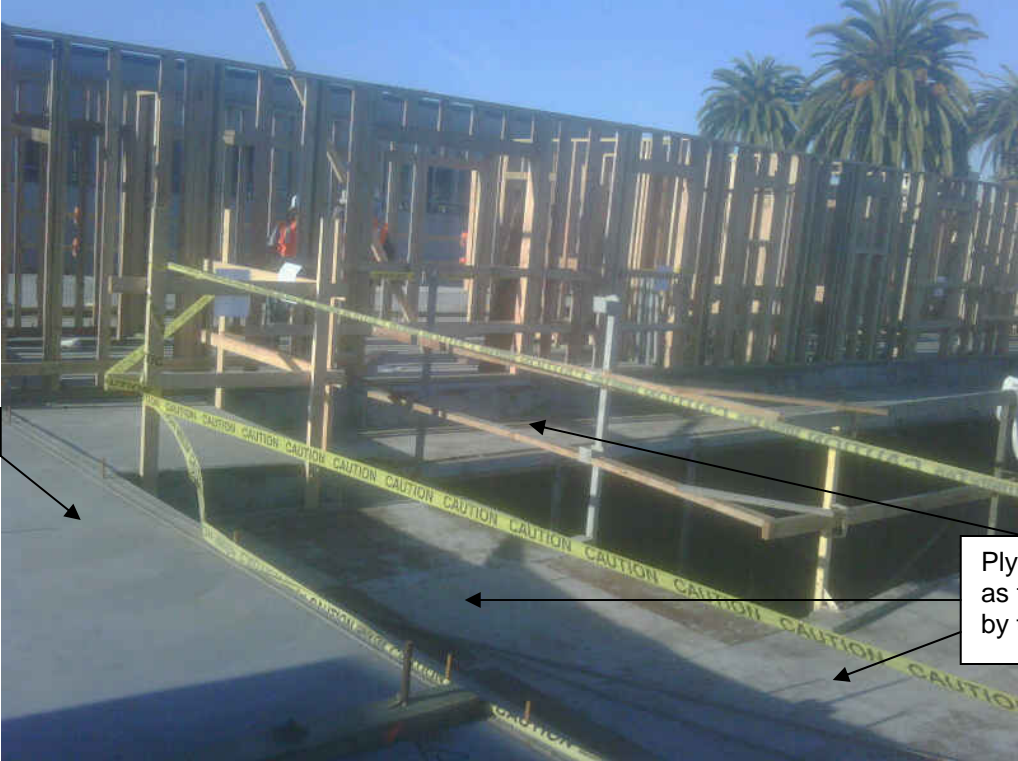
Concrete floor

Plywood sheets used as formwork supported by the vertical shoring

Exhibit 3. The second floor and shoring.

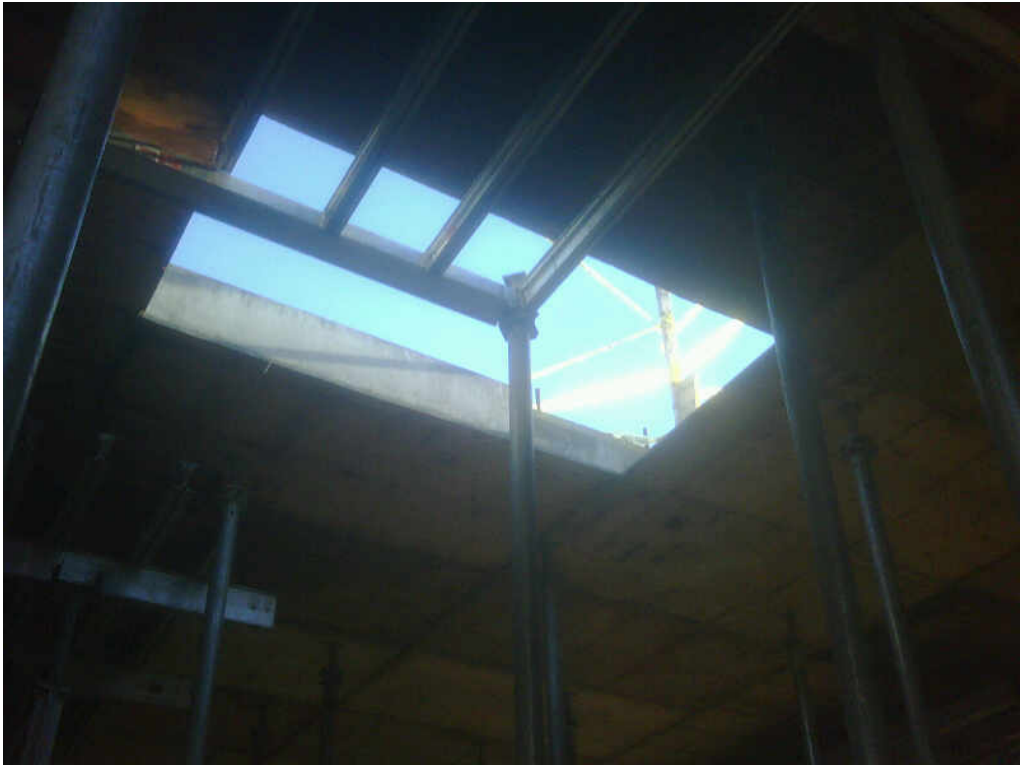
At approximately 3:00 p.m., the concrete worker removed the shoring under some of the plywood around the courtyard perimeter. The victim was walking across the second floor and stepped onto the plywood sheets that extended beyond the edge of the floor. As his foot made contact with the plywood sheets, the plywood dislodged and the victim fell through the opening approximately 25 feet to the concrete floor below.

Discussion: In this incident, the concrete contractor was removing the vertical shoring from underneath the second floor. When the victim stepped off the concrete onto the plywood shoring, he was unaware that the support holding it in place had just been removed. The plywood dislodged and the victim fell to the concrete floor below. When multiple contractors are working together, the action of one contractor often affects the safety of others. In this case, not all of the contractors on the work site were aware that the shoring was being removed. Even though the shoring around the courtyard perimeter was to remain in place for staging purposes, employee traffic and stored material on that remaining portion should have been prohibited until the removal of the vertical shoring was complete and an inspection of the remaining portion been conducted to ensure its stability. One method that could have been used to restrict access to the exposed plywood would have been physical barriers with signs informing other contractors why access was not allowed. The presence of a safety watch would have also been an alternative method for keeping employees off the plywood until the

Exhibit 4. The hole the victim fell through.

Recommendation #1: Ensure that workers do not walk on plywood sheets while vertical shoring is removed.

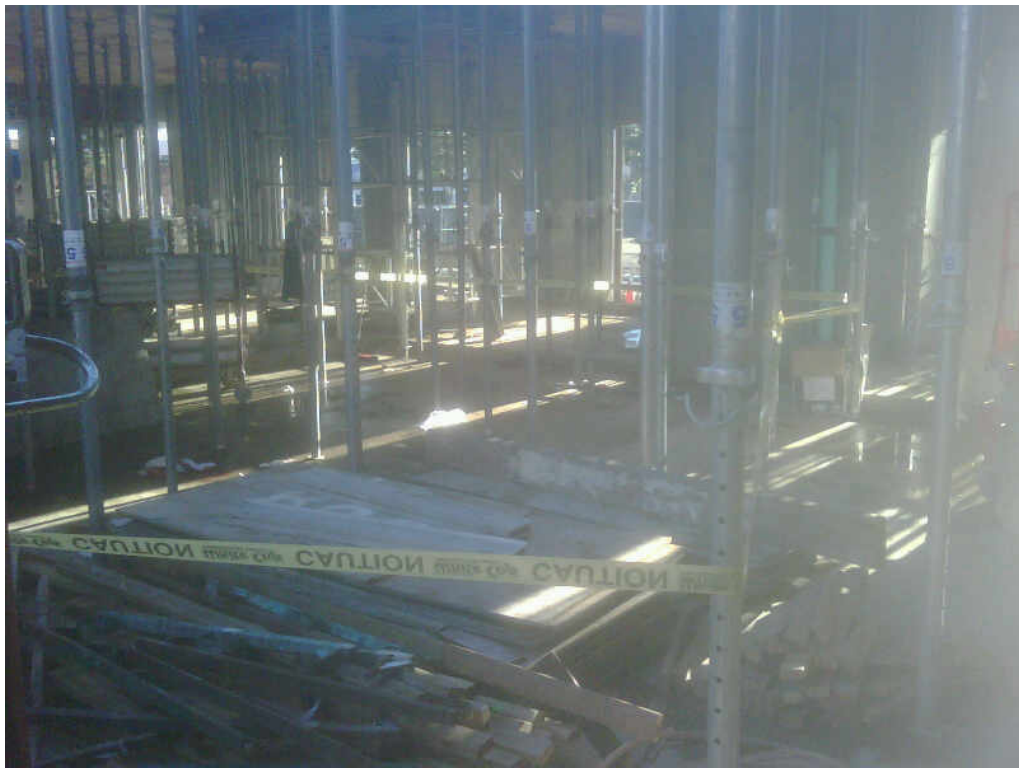
Discussion: In this incident, the construction worker who was removing the vertical shoring from underneath the newly poured concrete second floor was unable to see the entire odd shaped perimeter of the courtyard. As he disassembled portions of the vertical shoring, he unknowingly removed a post under a piece of plywood that was to remain in place. When the victim stepped onto the unsupported plywood, it gave way and he fell through the opening. Because there is no visibility from underneath vertical shoring, a system needs to be developed that clearly identifies which parts of the vertical shoring should stay in place when a partial disassembly is required. The use of tags, flags, or colored tape might be an identifiable method that would prevent the inadvertent removal of vertical shoring parts that would help prevent a future incident similar to this one from reoccurring.

Exhibit 5. The vertical shoring and the support post.

Recommendation #2: Develop and implement a system that clearly identifies the vertical shoring parts that are to be removed and those that are to remain in place.

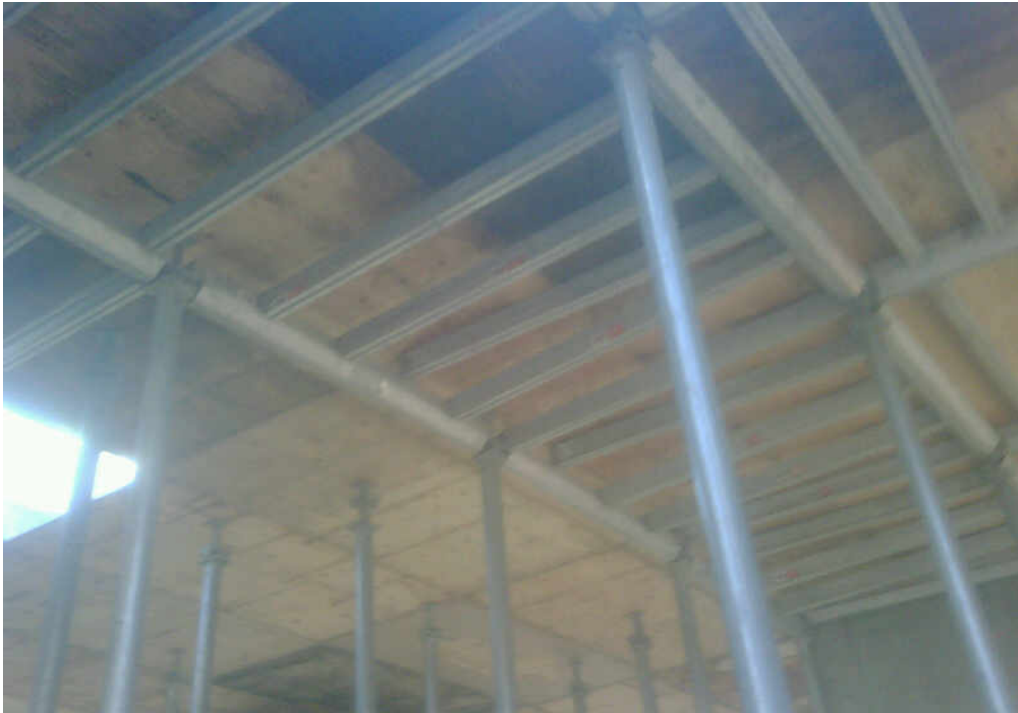
Exhibit 6. The vertical shoring showing the main and secondary beams that held the plywood in place.
