FROM: California Fatality Assessment and Control Evaluation (CA/FACE) Program

SUBJECT: A Plumber Dies When He Falls from the Second Floor of a Building after Stepping on Unsupported Plywood Formwork

SUMMARY
California FACE Report #11CA001

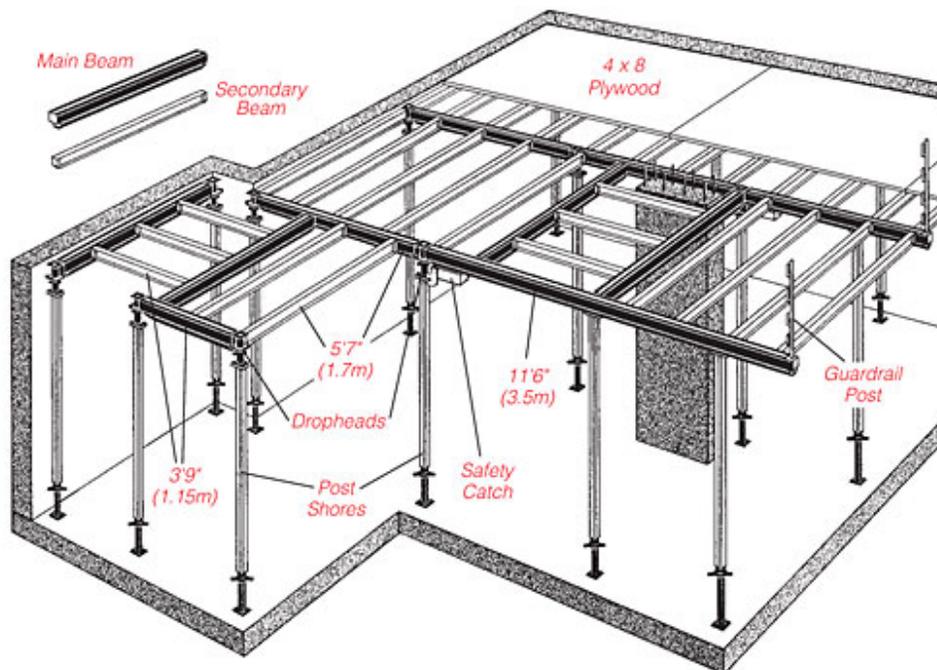
The incident site was a two-story multipurpose building (approximately 126 x 140 feet) under construction. Vertical shoring was used to support horizontal plywood sheet formwork while concrete floors were poured. The vertical shoring involved in this incident was a pre-engineered modular system that used lightweight interlocking aluminum beams and adjustable posts that erect and dismantle very quickly. The vertical shoring system was capable of accommodating shore heights up to 18'10" (see exhibit #1). The vertical shoring for the second floor had been erected earlier in the month.

Exhibit 1. A diagram of a vertical shoring system.

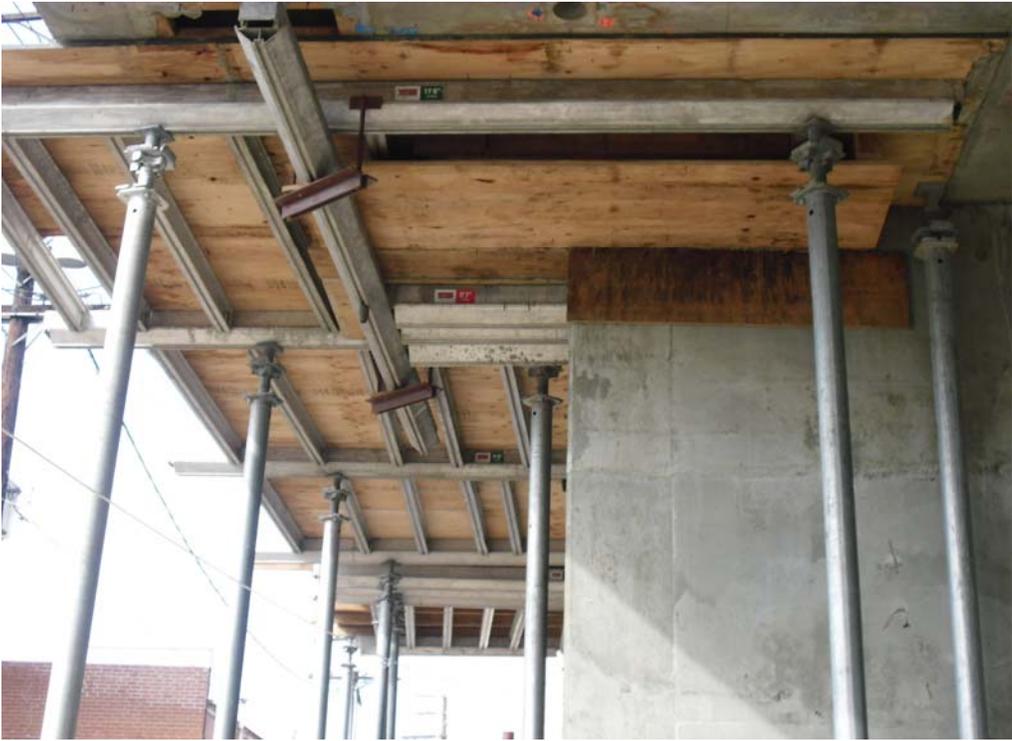
Exhibit 2. The vertical shoring from underneath.

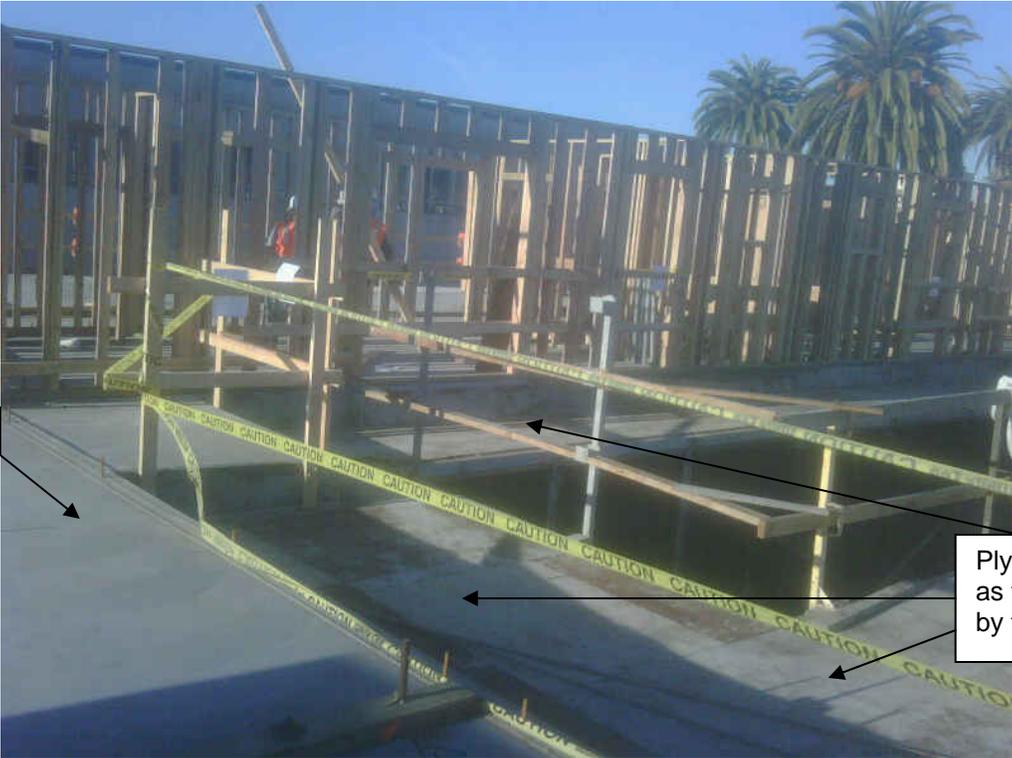
Concrete floor

Plywood sheets used as formwork supported by the vertical shoring

Exhibit 3. The second floor and shoring.

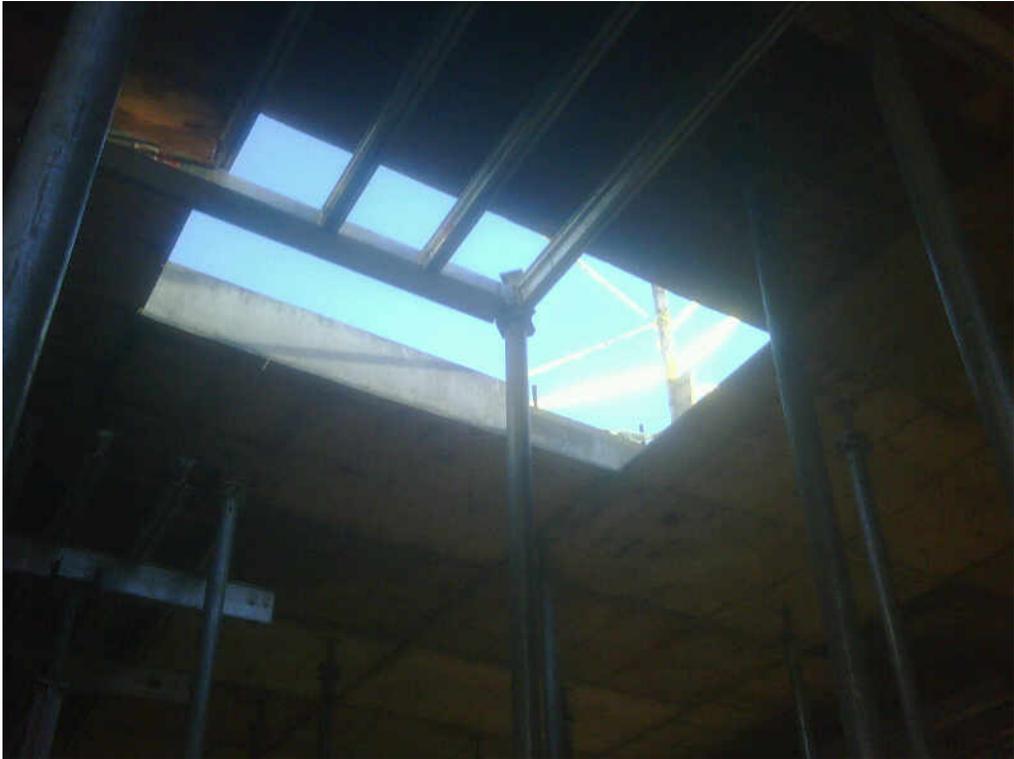
At approximately 3:00 p.m., the concrete worker removed the shoring under some of the plywood around the courtyard perimeter. The victim was walking across the second floor and stepped onto the plywood sheets that extended beyond the edge of the floor. As his foot made contact with the plywood sheets, the plywood dislodged and the victim fell through the opening approximately 25 feet to the concrete floor below.

Discussion: In this incident, the construction worker who was removing the vertical shoring from underneath the newly poured concrete second floor was unable to see the entire odd shaped perimeter of the courtyard. As he disassembled portions of the vertical shoring, he unknowingly removed a post under a piece of plywood that was to remain in place. When the victim stepped onto the unsupported plywood, it gave way and he fell through the opening. Because there is no visibility from underneath vertical shoring, a system needs to be developed that clearly identifies which parts of the vertical shoring should stay in place when a partial disassembly is required. The use of tags, flags, or colored tape might be an identifiable method that would prevent the inadvertent removal of vertical shoring parts that would help prevent a future incident similar to this one from reoccurring.

Exhibit 4. The hole the victim fell through.

Recommendation #1: Ensure that workers do not walk on plywood sheets while vertical shoring is removed.

Discussion: In this incident, the concrete contractor was removing the vertical shoring from underneath the second floor. When the victim stepped off the concrete onto the plywood shoring, he was unaware that the support holding it in place had just been removed. The plywood dislodged and the victim fell to the concrete floor below. When multiple contractors are working together, the action of one contractor often affects the safety of others. In this case, not all of the contractors on the work site were aware that the shoring was being removed. Even though the shoring around the courtyard perimeter was to remain in place for staging purposes, employee traffic and stored material on that remaining portion should have been prohibited until the removal of the vertical shoring was complete and an inspection of the remaining portion been conducted to ensure its stability. One method that could have been used to restrict access to the exposed plywood would have been physical barriers with signs informing other contractors why access was not allowed. The presence of a safety watch would have also been an alternative method for keeping employees off the plywood until the

shoring removal was complete. Had either of these methods been used, this incident might have been prevented.

Recommendation #2: Develop and implement a system that clearly identifies the vertical shoring parts that are to be removed and those that are to remain in place.

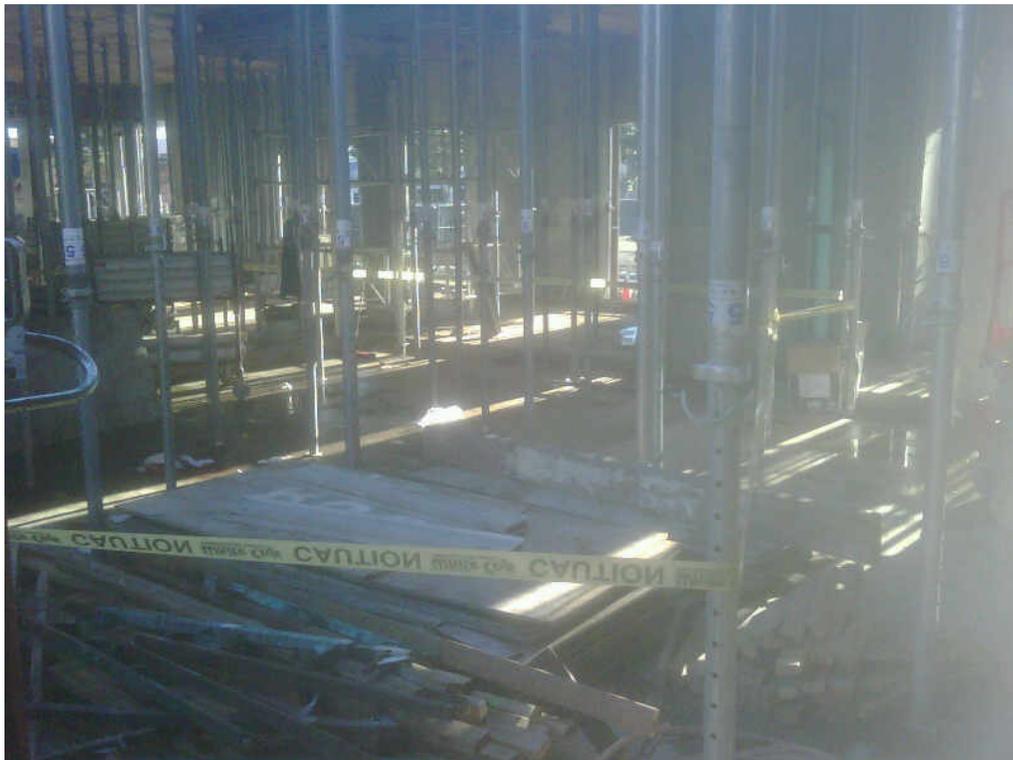
Exhibit 5. The vertical shoring and the support post.

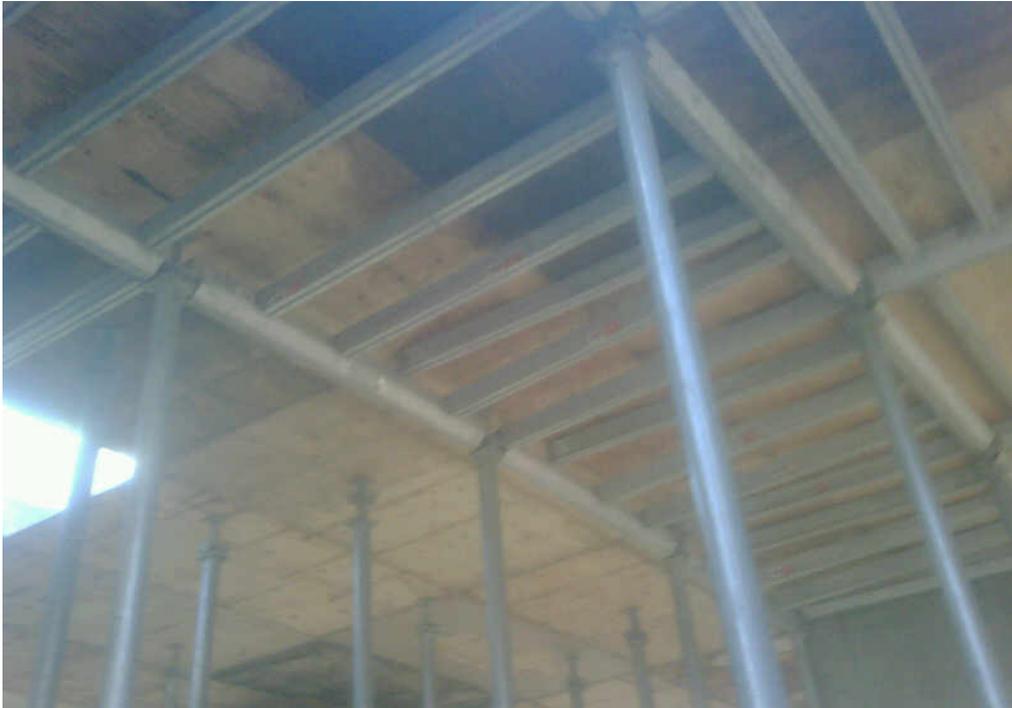
Exhibit 6. The vertical shoring showing the main and secondary beams that held the plywood in place.
