NJ FACE INVESTIGATION REPORT

FACE 07-NJ-077

Construction Laborer Dies After Falling Through Temporary Bridge “Catch” Platform, 75 Feet To Ground

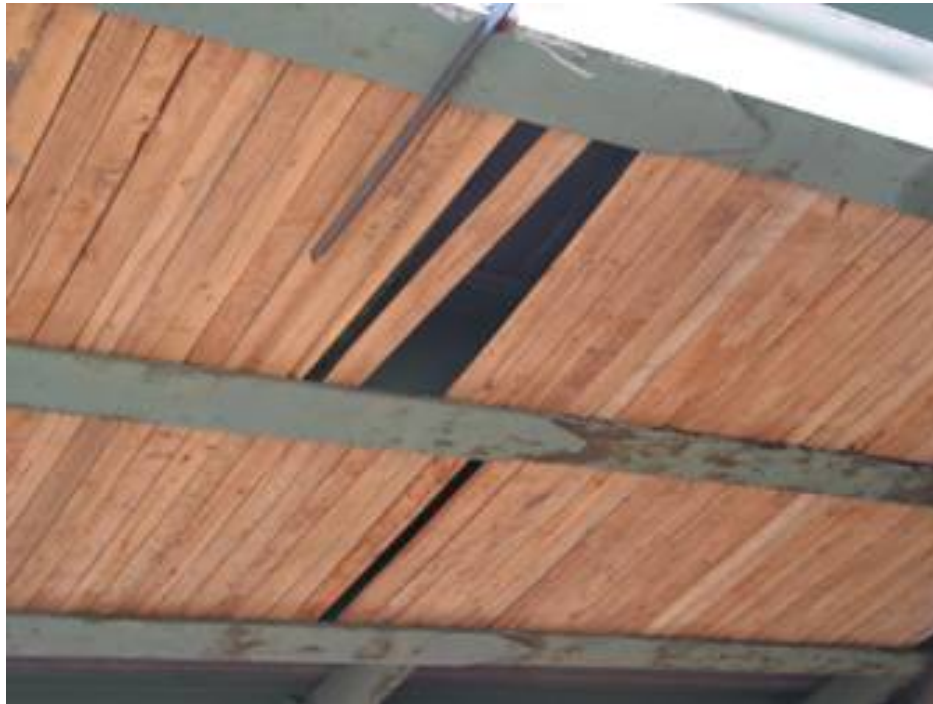
This fatal incident occurred at a large highway bridge construction project. The construction project was typical of other highway bridge projects that involved work on a bridge deck. A “catch” platform below the work area was designed to prevent any construction debris generated on site from falling to the ground below. Debris can be generated from a multitude of activities, including the breaking up of concrete or other surface material that is to be replaced or the installation of support structures and concrete for a new or expanded bridge. The “catch” platform is typically a set of wooden planks (e.g. 2’ X 10’) that are placed from the bottom of one I-beam to the bottom of another I-beam, with the end of the planks set to simply rest on the lip of the I-beam. The planks are typically not secured to the I-beam and it is common to observe gaps and shifting of the planks in a “catch” platform (See Figure 1).

Figure 1. Example of shifting bridge deck “catch” platform wooden planks (view from ground).

Recommendation #5: Catch designs and/or construction procedures that hold individual planks together to prevent shifting of the planks should be employed.

Discussion: Devices and/or designs for catch platforms to hold individual planks together to prevent shifting of the planks should be used. In this incident, although the plank that failed was only 9-³/₄" wide several planks shifted allowing the victim to fall through the bridge "catch" platform. If the planks were affixed together, this may have prevented the victim from falling through the bridge "catch" platform. This can be accomplished through several means, including nailing the edges of the wooden planks together. However, it is important to note that OSHA 29 CFR 1926.451(b)(9) prohibits the use of any material that will obscure a visual inspection of the top or bottom surface of the wood planks. Some contractors have suggested covering the entire "catch" platform with plywood, however this would eliminate the ability to visually detect and replace defective or damage wood planks. This could be a particularly problematic if the plywood alone can not support four times the weight potentially placed upon it.

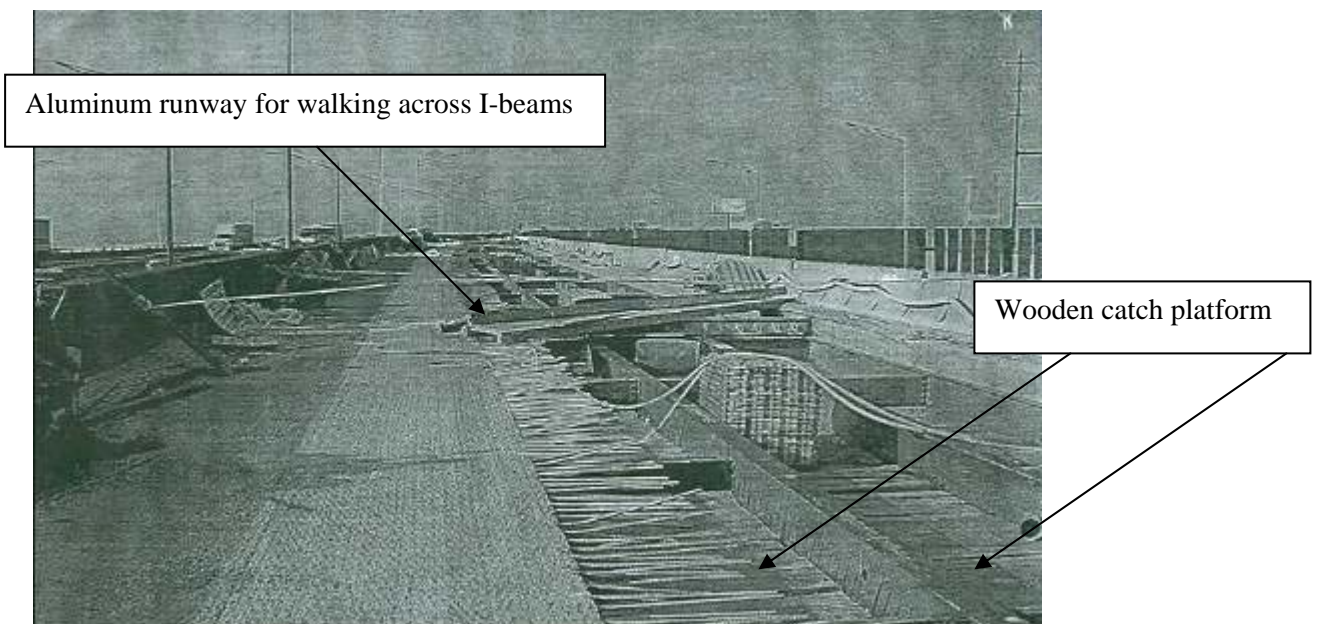
The fatal incident occurred on a typical work day in 2007 shortly after the morning shift began. An OSHA Compliance Safety and Health Officer (COSHO) who had visited the work site several times since the fatal accident reported that it was not uncommon for employees to walk and work on the platform. The victim was not using any fall protection devices at the time of the incident. According to the COSHO, the victim stepped down from the I-beam onto the wooden catch platform to move a “pic” board, a metal runway used to transport concrete between work areas on the bridge. The distance from the top flange of the I-beam to the bridge “catch” surface was 16 inches. Immediately after the victim stepped down, one plank broke across its width, resulting in the employee falling partially through the platform. As the employee fell, other wooden planks making up the platform shifted because the planks were not affixed to one another, and the victim fell completely through the platform (see Figure 2, incident site).

The wooden plank that failed was a nominal 2' X 10' piece of economy-grade, white pine that was 67¹/₂ inches long. The height and width of the failed plank was 1⁷/₈ by 9³/₄ inches, respectively. The plank broke with a curved split at approximately 29 to 29¹/₂ inches from its end, near the location where the victim stepped onto it. This curved split caused the board to break into two large sections and one smaller triangular section. A failure analysis of the broken plank by OSHA revealed that the major strength reducing feature of the plank was the Slope-of-Grain (SOG), which was 1:2 (i.e., the grain along the length of the board deviated from the long axis of the plank by a distance of 1 inch for every 2 inches in length). Acceptable SOG for scaffold-grade lumber is a minimum of 1:12. The OSHA failure analysis demonstrated that the wood used in this platform was inadequate as a walking/working surface. In addition, the COSHO observed planks being reused on the bridge “catch” that had been previously removed from service due to structural concerns, and noted visibly damaged wooden planks as well as planks that had shifted, leaving open spaces in the platform.

Figure 2. Bridge deck where incident occurred
