Occupational Fatality Report

Municipal Electrician Dies after Falling out of an Aerial Lift Truck's Raised Bucket after It Was Struck by a Semi-Tractor Trailer – Massachusetts

Release Date: April 15, 2014
Investigation: # 12-MA-013-01

Massachusetts Department of Public Health
Occupational Health Surveillance Program

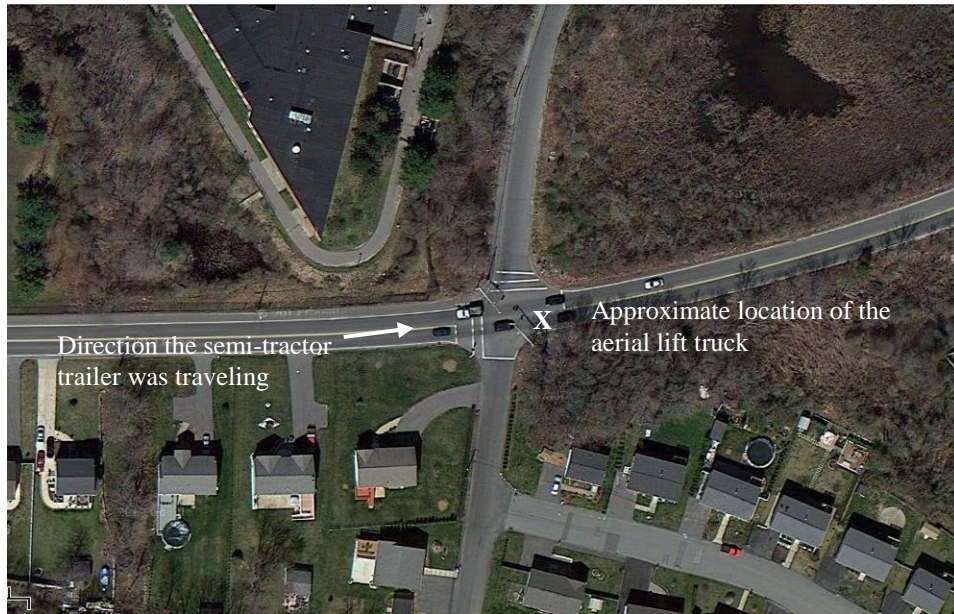
The incident occurred at a four-way intersection located in a primarily residential section of the city. The intersection is made up of a main roadway and side street that crosses the main roadway (Figure 1). The area around the intersection has no significant grade, is relatively straight and is designated as a 30 mile-per-hour speed zone. The main roadway has one travel lane for each direction. The primary travel direction of the main roadway is north and south, but at the incident location the roadway runs east and west. There are multiple painted roadway markings in the area. The main roadway's two travel lanes are separated by solid double yellow painted lines and there are painted fog lines at the main roadway edges. The side street runs north and south and does not have many roadway markings. At the intersection, each travel lane has painted white traffic stop lines and there are two crosswalks; one across the main roadway and one across the side street. The incident location is a heavily traveled area with houses on the south side of the intersection and a school and an undeveloped lot on the north side.

Figure 1 – Aerial view of the intersection

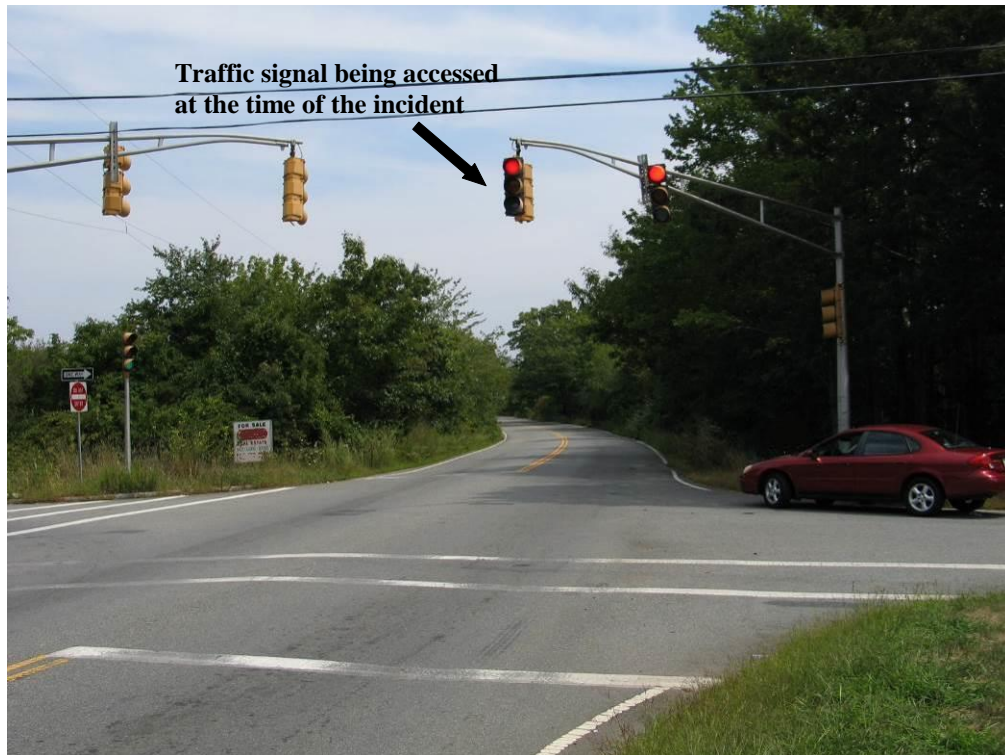
The intersection has two cantilevered traffic signal structures, one of which was being accessed at the time of the incident. The base of the cantilevered structure that was being accessed is located beyond the shoulder of the roadway on a grassy area. The vertical pole section of the base reaches a height of approximately 18 feet (Figure 2). The cantilevered section is fastened to the top of the vertical pole and extends out over the eastbound lane of the main roadway. The end of the cantilevered section over the intersection has two traffic signals attached. The distance between the bottom of these traffic signals and the roadway below is 15 feet seven inches. At the time of the incident the traffic signals were operating on a regular cycle.

Figure 2 – Street view of the intersection looking east on the main roadway

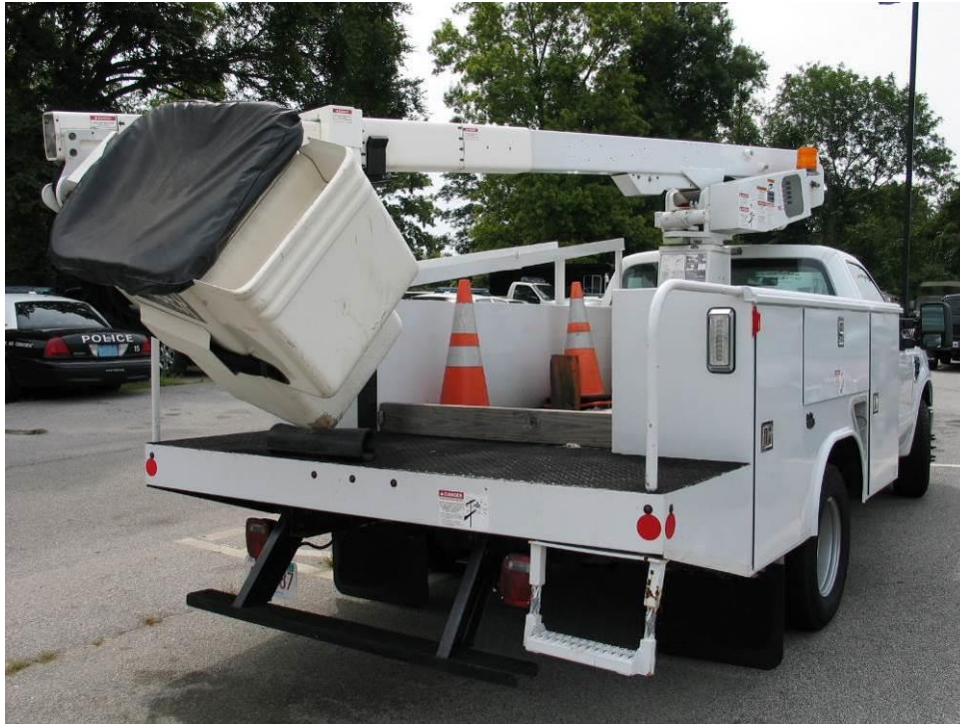
The aerial lift truck's chassis and aerial lift body were both manufactured in 2009 and were white in color (Figure 3). The truck was equipped with dual rear wheels and had a gross vehicle weight rating of 5,897 pounds. The truck's telescoping and articulating boom platform had a height rating of 35 feet. There were two sets of controls for the movement of the truck's boom/bucket. One control was mounted to the bucket itself and the other control was mounted on the truck's body at the ground level along with an emergency stop. The vehicle was equipped with blue light-emitting-diode (LED) strobe lights located at the front and rear of the truck and two rotating orange beacon lights at the base of the boom. There was a fall protection anchor point located at the truck's bucket along with a danger decal warning of the fall hazard and the need to use fall protection (Figure 4). A body harness and lanyard were stored in the aerial lift truck.

Figure 3 – Aerial lift truck involved in the incident

Recommendation #8: Manufacturers of aerial lifts and employers should consider using contrasting colors and installing strobe lights along the booms of aerial lifts.

Aerial lift trucks are often used in and around roadways, which can place the truck in close proximity to moving vehicles. To help make aerial lift trucks, including their booms and buckets, as visible as possible, consideration should be given to adding contrasting colors, which could also be florescent and/or reflective, to both the boom, bucket and to some areas of the truck. In addition, adding some light-emitting-diode (LED) strobe lights to sections of the boom, bucket and truck might increase both the visibility of the truck and the actual location of workers when they are working from the truck's raised bucket.

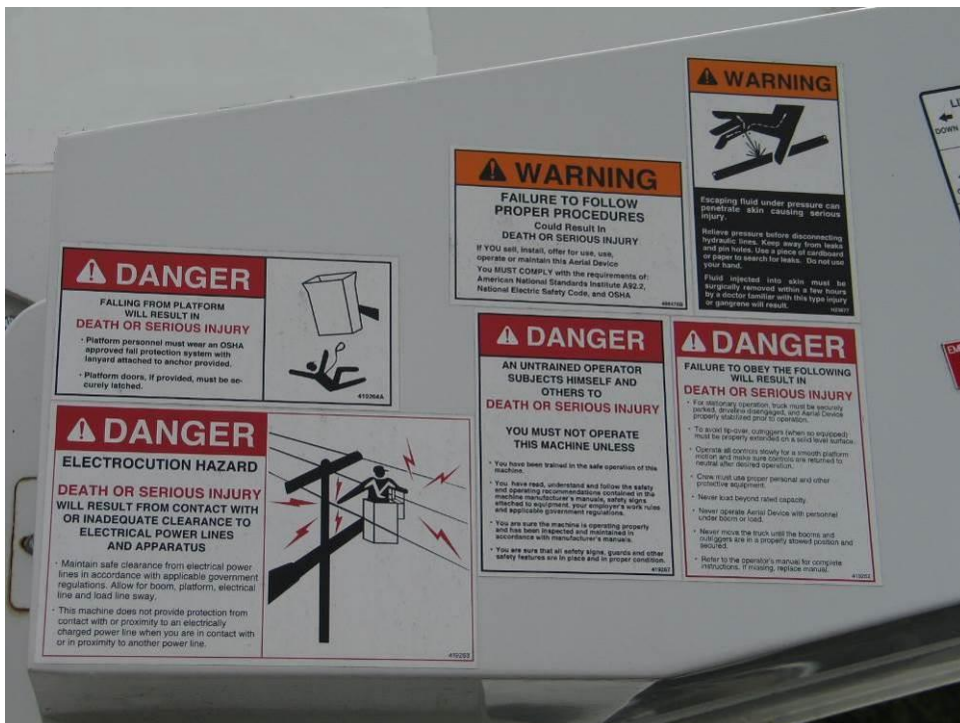
Figure 4 – Aerial lift truck's danger decals

Recommendation #1: Municipalities should provide and ensure that fall protection is used when working from an aerial lift truck's raised bucket/platform.

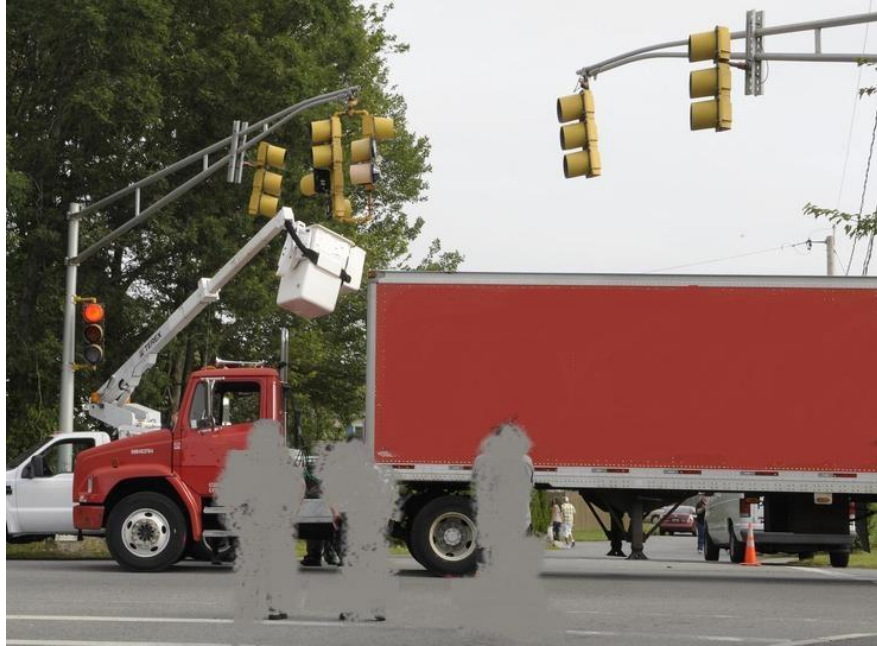
As the victim was working on the traffic signal a semi-tractor trailer was traveling east on the main roadway in the eastbound lane approaching the intersection and had a green traffic light at the intersection. According to the police report, the tractor trailer driver reported that he noticed the aerial lift truck parked on the side of the roadway, but did not notice the raised bucket. The tractor trailer driver veered to the left of the roadway's center line to keep away from the parked truck. As the tractor trailer entered the intersection the cab passed underneath and cleared the raised bucket. When the semi's trailer section reached the raised bucket, the trailer impacted the bucket causing the bucket to bounce up. The victim was ejected out of the bucket and fell approximately 16 feet to the asphalt roadway below.

- No fall protection used when working from a raised aerial lift.
- Positioning of the aerial lift truck that allowed vehicles to pass under the raised bucket.
- Improper work zone design and set up, including inadequate positioning and quantity of temporary traffic control devices to warn motorists of the work occurring within the roadway.

Figure 5 – Incident location after the incident showing the traffic signal, the aerial lift's raised buck and the semi-tractor trailer

Recommendation #3: Municipalities should ensure that employees' exposure to moving traffic is minimized when working in and around roadways by developing temporary traffic control plans, including never allowing traffic to pass underneath raised aerial lift buckets/platforms.
