Occupational Fatality Report

Municipal Electrician Dies after Falling out of an Aerial Lift Truck's Raised Bucket after It Was Struck by a Semi-Tractor Trailer – Massachusetts

Release Date: April 15, 2014
Investigation: # 12-MA-013-01

Massachusetts Department of Public Health
Occupational Health Surveillance Program

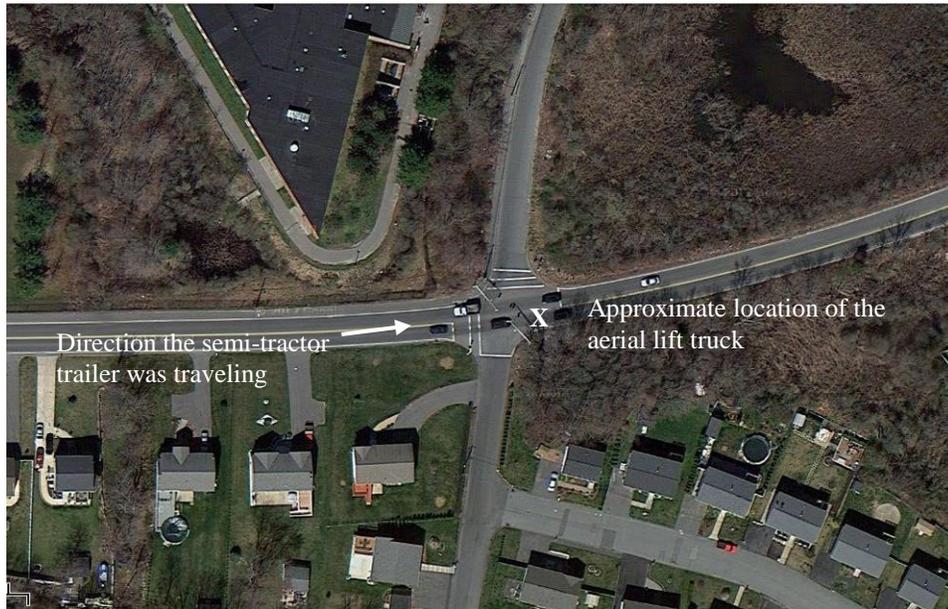
Figure 1 – Aerial view of the intersection

The incident occurred at a four-way intersection located in a primarily residential section of the city. The intersection is made up of a main roadway and side street that crosses the main roadway (Figure 1). The area around the intersection has no significant grade, is relatively straight and is designated as a 30 mile-per-hour speed zone. The main roadway has one travel lane for each direction. The primary travel direction of the main roadway is north and south, but at the incident location the roadway runs east and west. There are multiple painted roadway markings in the area. The main roadway's two travel lanes are separated by solid double yellow painted lines and there are painted fog lines at the main roadway edges. The side street runs north and south and does not have many roadway markings. At the intersection, each travel lane has painted white traffic stop lines and there are two crosswalks; one across the main roadway and one across the side street. The incident location is a heavily traveled area with houses on the south side of the intersection and a school and an undeveloped lot on the north side.

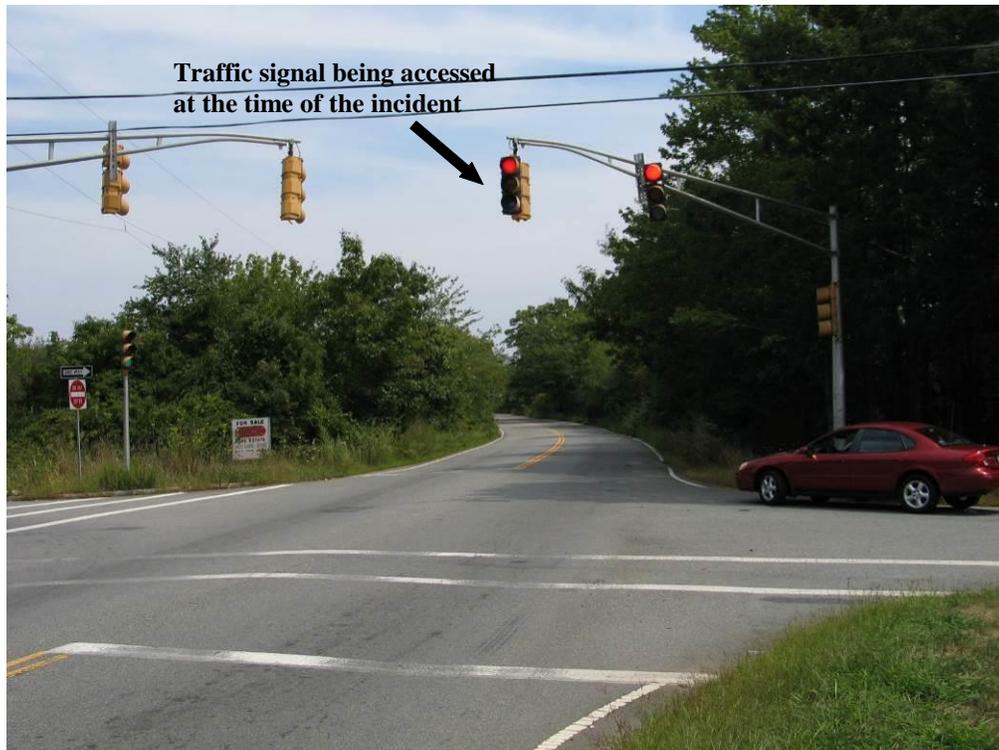
Figure 2 – Street view of the intersection looking east on the main roadway

The intersection has two cantilevered traffic signal structures, one of which was being accessed at the time of the incident. The base of the cantilevered structure that was being accessed is located beyond the shoulder of the roadway on a grassy area. The vertical pole section of the base reaches a height of approximately 18 feet (Figure 2). The cantilevered section is fastened to the top of the vertical pole and extends out over the eastbound lane of the main roadway. The end of the cantilevered section over the intersection has two traffic signals attached. The distance between the bottom of these traffic signals and the roadway below is 15 feet seven inches. At the time of the incident the traffic signals were operating on a regular cycle.

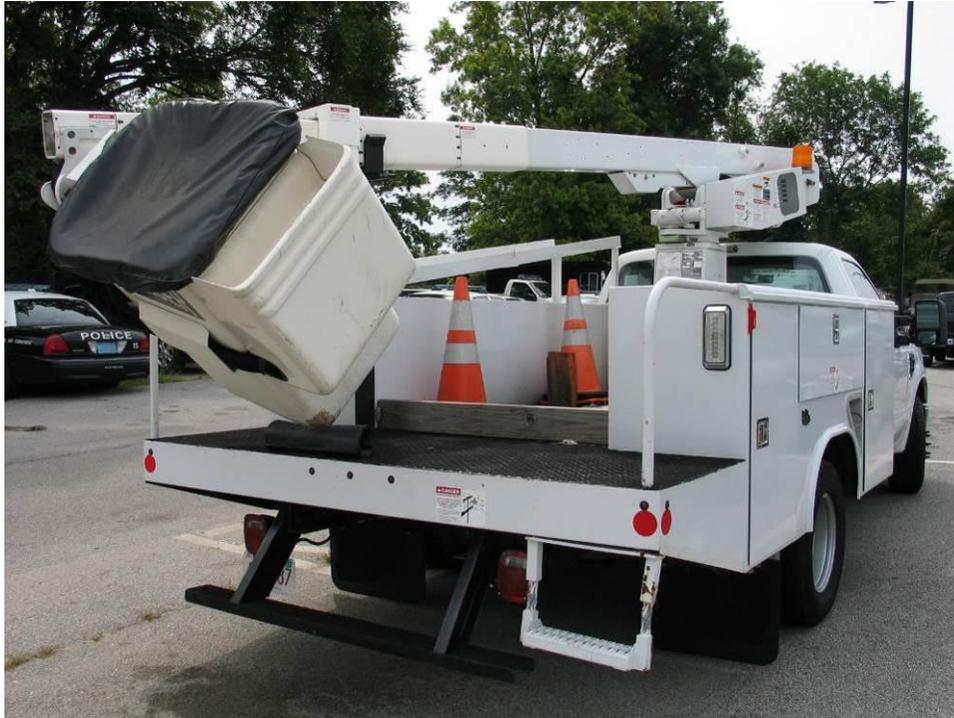
Figure 3 – Aerial lift truck involved in the incident

The aerial lift truck's chassis and aerial lift body were both manufactured in 2009 and were white in color (Figure 3). The truck was equipped with dual rear wheels and had a gross vehicle weight rating of 5,897 pounds. The truck's telescoping and articulating boom platform had a height rating of 35 feet. There were two sets of controls for the movement of the truck's boom/bucket. One control was mounted to the bucket itself and the other control was mounted on the truck's body at the ground level along with an emergency stop. The vehicle was equipped with blue light-emitting-diode (LED) strobe lights located at the front and rear of the truck and two rotating orange beacon lights at the base of the boom. There was a fall protection anchor point located at the truck's bucket along with a danger decal warning of the fall hazard and the need to use fall protection (Figure 4). A body harness and lanyard were stored in the aerial lift truck.

Recommendation #8: Manufacturers of aerial lifts and employers should consider using contrasting colors and installing strobe lights along the booms of aerial lifts.

Aerial lift trucks are often used in and around roadways, which can place the truck in close proximity to moving vehicles. To help make aerial lift trucks, including their booms and buckets, as visible as possible, consideration should be given to adding contrasting colors, which could also be florescent and/or reflective, to both the boom, bucket and to some areas of the truck. In addition, adding some light-emitting-diode (LED) strobe lights to sections of the boom, bucket and truck might increase both the visibility of the truck and the actual location of workers when they are working from the truck's raised bucket.

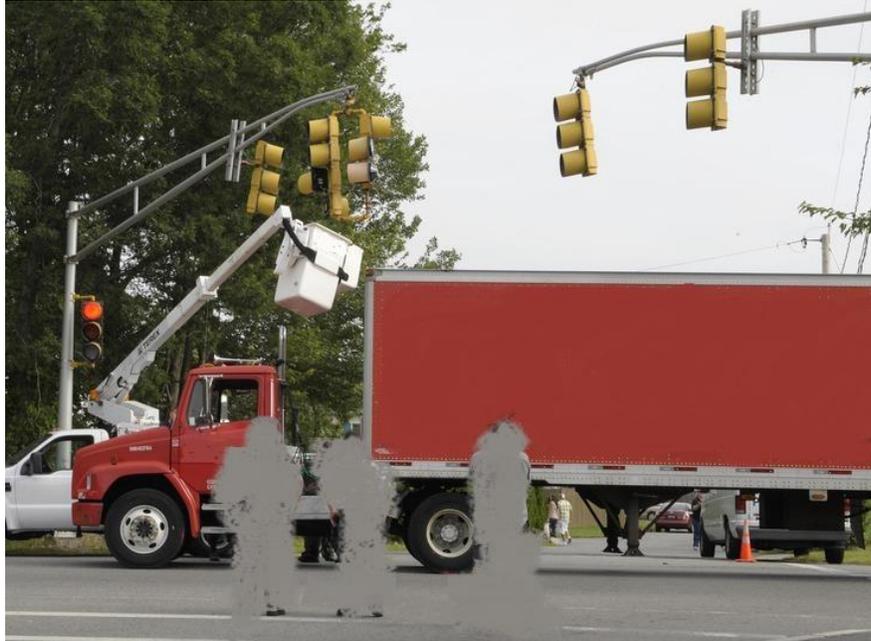
As the victim was working on the traffic signal a semi-tractor trailer was traveling east on the main roadway in the eastbound lane approaching the intersection and had a green traffic light at the intersection. According to the police report, the tractor trailer driver reported that he noticed the aerial lift truck parked on the side of the roadway, but did not notice the raised bucket. The tractor trailer driver veered to the left of the roadway's center line to keep away from the parked truck. As the tractor trailer entered the intersection the cab passed underneath and cleared the raised bucket. When the semi's trailer section reached the raised bucket, the trailer impacted the bucket causing the bucket to bounce up. The victim was ejected out of the bucket and fell approximately 16 feet to the asphalt roadway below.

Figure 5 – Incident location after the incident showing the traffic signal, the aerial lift's raised buck and the semi-tractor trailer

Recommendation #3: Municipalities should ensure that employees' exposure to moving traffic is minimized when working in and around roadways by developing temporary traffic control plans, including never allowing traffic to pass underneath raised aerial lift buckets/platforms.
