MIFACE Investigation Report: #13MI091

Subject: Painter Died When Elevated Scissor Lift Tipped to Side When Tire Entered Pavement Depression

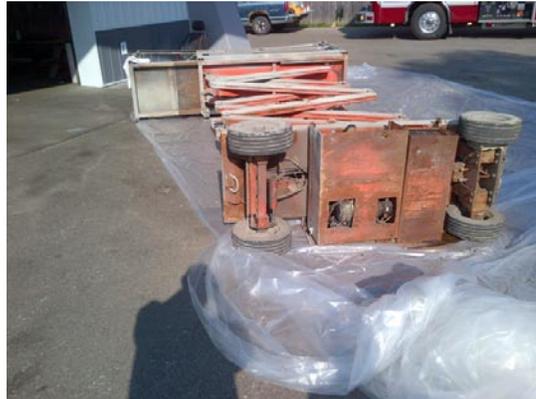
In the summer of 2013, a male painter in his 30s died when the tire of the elevated Skyjack 3220 scissor lift in which he was working entered a depression in a parking lot caused by a recessed storm drain and tipped to its side (Figure 1). The decedent and his coworker were elevated approximately 15 feet in the scissor lift while they painted a building's eaves/fascia. To protect the ground from paint overspray, the workers laid opaque plastic on the asphalt pavement. The plastic covered a storm drain grate, which was recessed 4½ inches. The workers noticed an area that had been missed during their painting work, so the lift had to be moved back to the

Figure 1. Incident site showing overturned scissor lift

it from paint splatter while painting. The plastic also covered the storm drain grate. The decedent and his coworker did not mark the location of the grate and could not view the grate through the plastic (Figure 1). The decedent positioned the lift and elevated himself and his coworker approximately 15 feet to begin painting (Figures 3, 5). The workers were not required to be tied-off because the lift had guardrails which were compliant with MIOSHA regulations.

- Assure work areas are inspected for hazards and take corrective actions to eliminate the identified hazards before and during operation of an aerial lift.

An inspection of the work area is critical when operating a scissor lift due to the mechanical dynamics of an elevated scissor lift aerial working platform. Possible hazards to consider include but are not limited to drop-offs or holes, including those concealed by water, ice, mud, etc.; slope(s); bumps and floor obstructions; debris; overhead obstructions; high voltage conductors; inadequate surface and support to withstand all load forces imposed by the aerial platform in all operating configurations (including wind and weather conditions) or other unsafe conditions. When hazards are indentified, corrective actions should be taken to minimize the identified

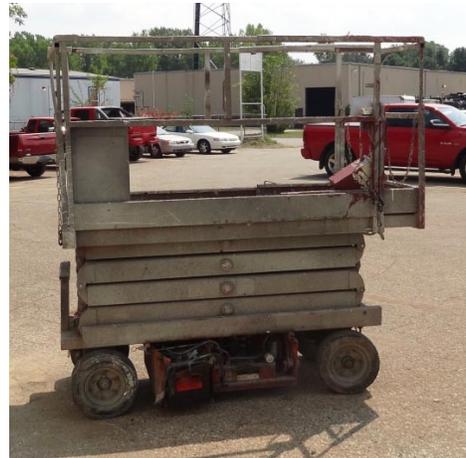
The company owned and maintained scissor style self propelled work platform (scissor lift) involved in the incident was a Skyjack 3220. The lift had been used during spray painting operations and the control box and other informational labels on the machine were covered with paint overspray making them illegible (Figure 2). The safety director indicated that platform controls operated the scissor lift as designed and there were no operational issues with the lift. It is unknown if the lift had tilt sensing equipment installed by the manufacturer.

Figure 2. Scissor lift involved in the incident

The lift had been used during spray painting operations and the lift and control box were covered with paint overspray making the informational labels illegible and the indicator lights indiscernible. These conditions may not have had a direct impact on the incident; however, the general condition of the machine indicated a lack of appreciation for maintaining equipment in safe working condition. Employers should ensure that equipment receive regular preventative maintenance and service according to the manufacturer’s recommendations to ensure it is in good working condition.

- Employers should maintain equipment in accordance with the manufacturer’s recommendations.

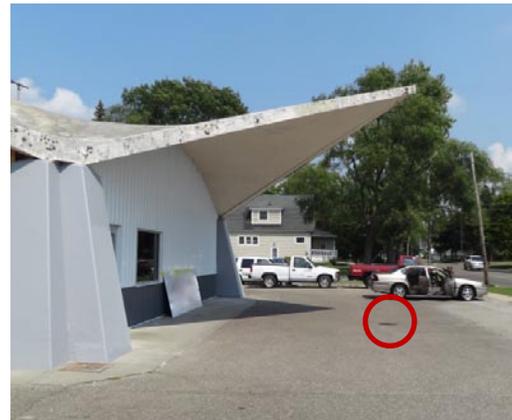
The incident site was a building with four concrete overhang points that extended approximately 25 feet away from the building. Under each overhang point was a round wastewater storm drain. The overhangs were approximately 16 feet in elevation at the building and approximately 21 feet in height at the tip of the point (Figures 3 and 5).

Figure 3. Example of building construction. Circle indicates drain location under tip of overhang

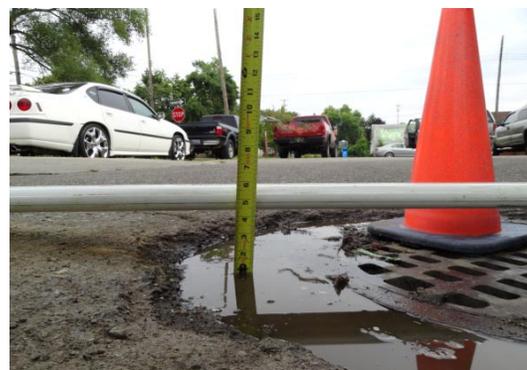
The pavement around the wastewater storm drain involved in the incident had deteriorated and the grate recessed into the asphalt approximately 4 ½ inches (Figure 4). The pavement sloped toward the drain to provide parking area drainage.

Figure 4. Storm drain cover/pavement condition at incident

- Elevated driving must only be done on a firm level surface.
- b) The storm drains and their associated deteriorating surrounding pavement had been identified as a work site hazard by management and discussed with the decedent. Management did not implement any engineering controls, such as covering the drain with material to withstand the weight/load of the scissor lift and/or barricading the drain. The corrective action to minimize the hazard posed by the storm drain depression taken by the decedent and his

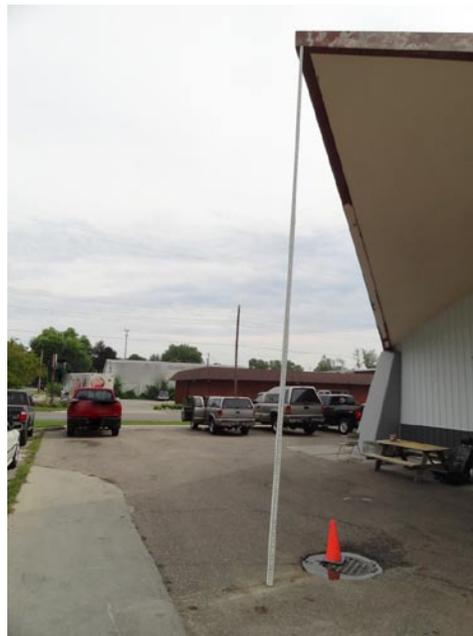
Figure 5. Incident scene following equipment removal
