FATALITY ASSESSMENT AND CONTROL EVALUATION

Tower Technician Killed When Guyed Tower Collapsed Case Report 09NY095

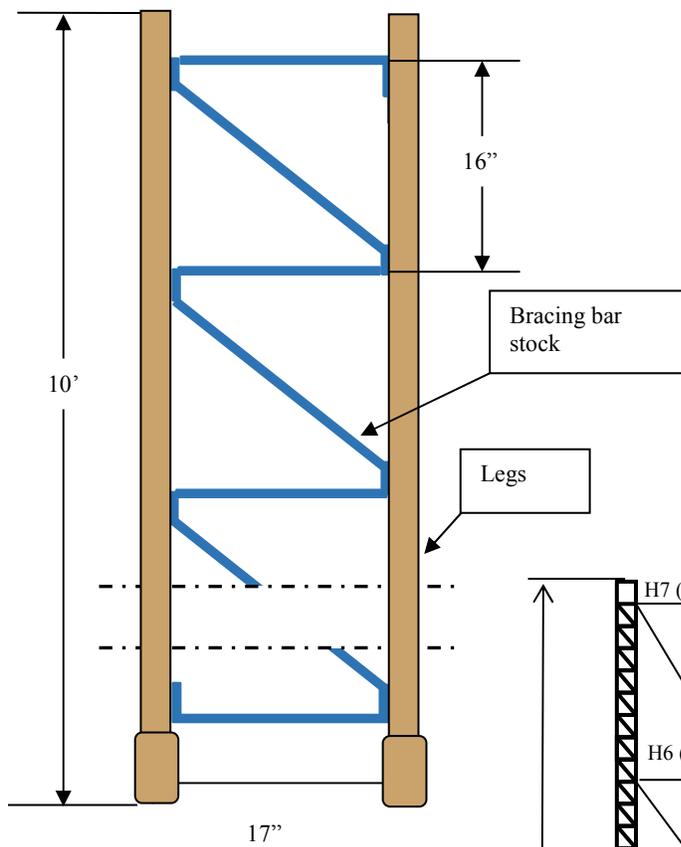
The tower was a 380 foot tall equilateral triangle column with 17 inches on each side (Figures 1 and 2). The tower column was formed by multiple 10-foot-long sections connected by friction fits with two bolts and nuts per connection. Each section was made of three vertical steel pipes or legs that were braced with round steel bars into the triangular column. The steel pipes were 1.5 inch in (outside) diameter and 0.12 inch thick. Round steel bars that were 7/16 inch in diameter braced the three legs in a continuous zigzag pattern.

Figure 1*. A section of the tower

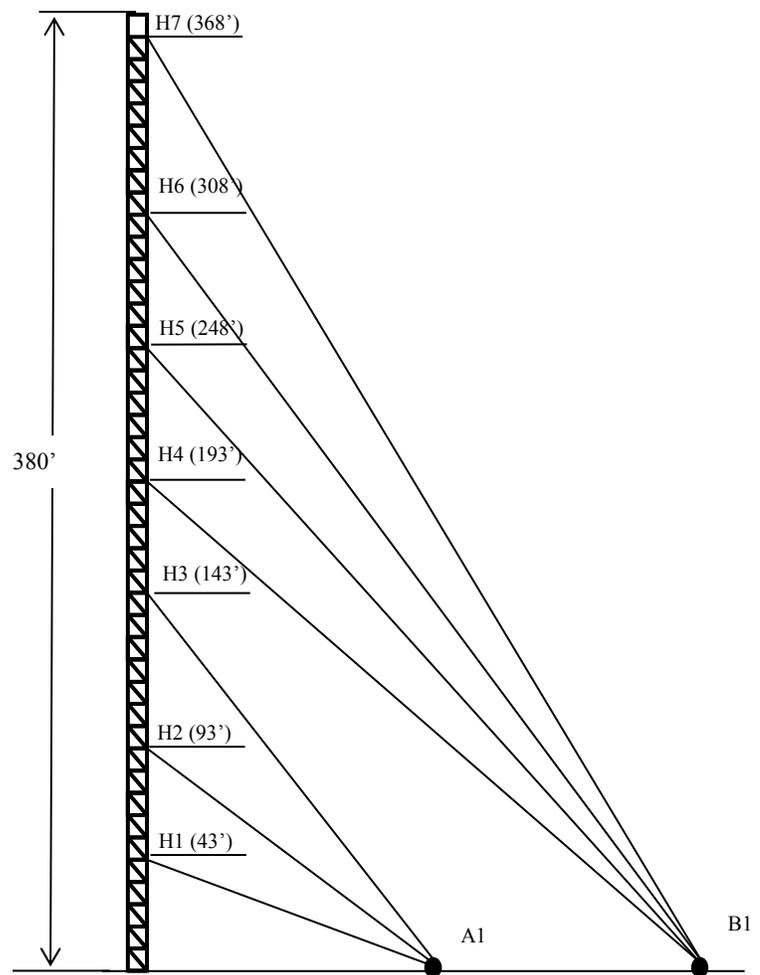
The base of the tower was mounted on a metal pin that was embedded into a concrete base in the ground (Photos 3 and 4). The tower was guyed at three corners of the triangle at seven elevations ranging from H1 to H7 respectively at 43, 93, 143, 193, 248, 308 and 368 feet (Figure 3). All guy wires were 1/4 inch diameter cable, with the exception of the three at H7 (368 ft). The H7 guy wires were 5/16 inch diameter.

Figure 3*. The guyed tower, the guy wires and the ground guy anchors. Each set of three guy wires were attached to the tower at seven elevations (H1-H7).

The existing tower in this case deviated from the manufacturer’s construction criteria in many aspects. The number of guy wires, the elevations to which the guy wires were attached, and the locations of the ground anchors as well as the tension on the guy wires were all different from the manufacturer’s original design. A structural analysis may have helped to assess whether these deviations predisposed the tower to structural instability.
