FROM: California Fatality Assessment and Control Evaluation (CA/FACE) Program

SUBJECT: A House Painter Dies When He Falls Through a Roof Opening

SUMMARY
California FACE Report #11CA005

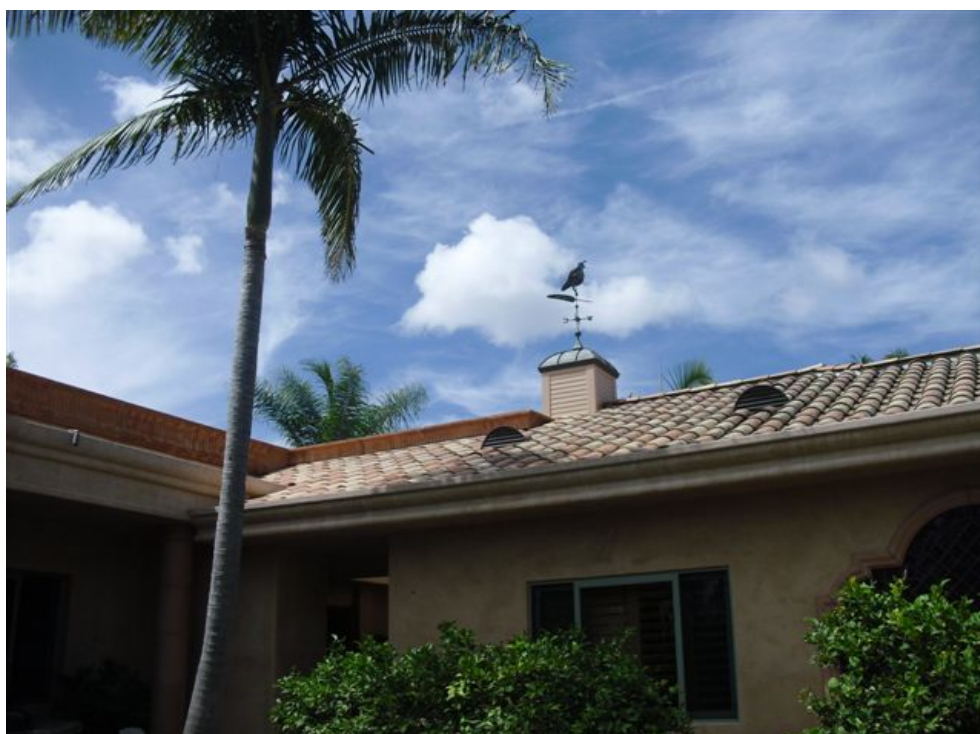
On the morning of the incident, the crew planned to paint the weather vane which was located on the roof of the garage, immediately adjacent to an opening (see Exhibits 1 2). In order to match the paint sample, the victim climbed a ladder and walked across the roof to the weather vane. As he neared the roof opening, he tripped and fell forward through the opening 15 feet to the floor below. The owner of the painting company and his son saw the victim fall through the opening and ran to his assistance. Workers from one of the other contractors onsite heard the fall and called 911. The fire department and paramedics were contacted and arrived within minutes of the call. The victim was air lifted to a local hospital where he died from his injuries the following day.

Exhibit 2. The weather vane on top of the garage.

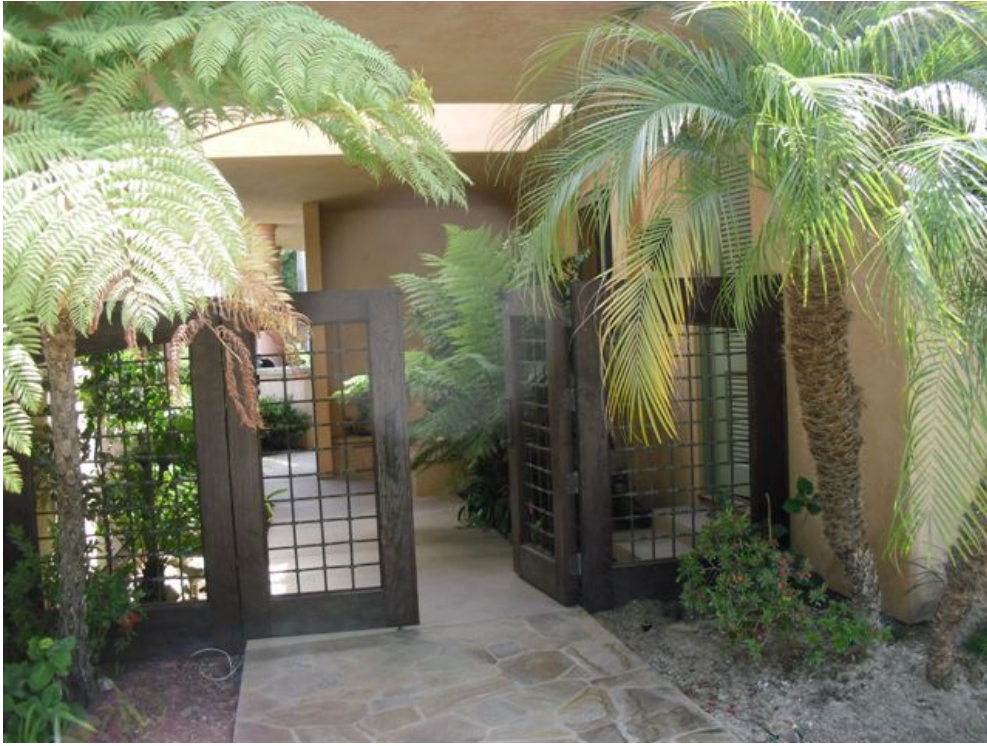
Exhibit 3. The breezeway entry where the victim fell through the opening in the roof.

A fall protection plan in this incident should have included the use of personal fall protection equipment, guardrails around the roof opening, or if these were not feasible,

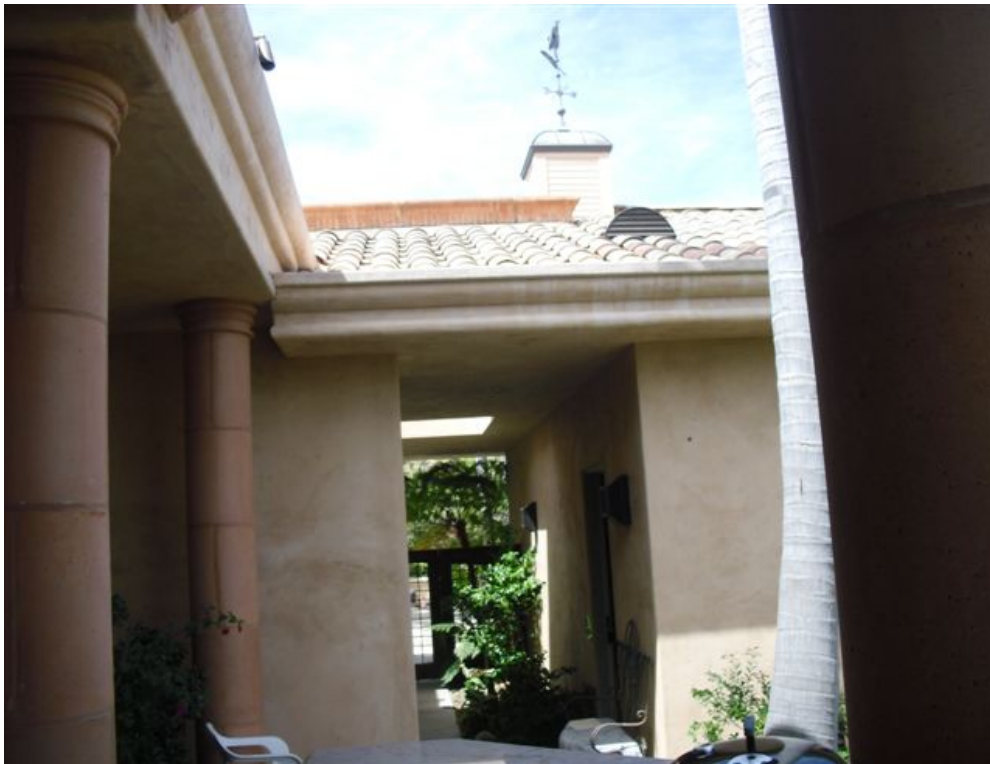
Exhibit 4 - The breezeway from the rear of the house.

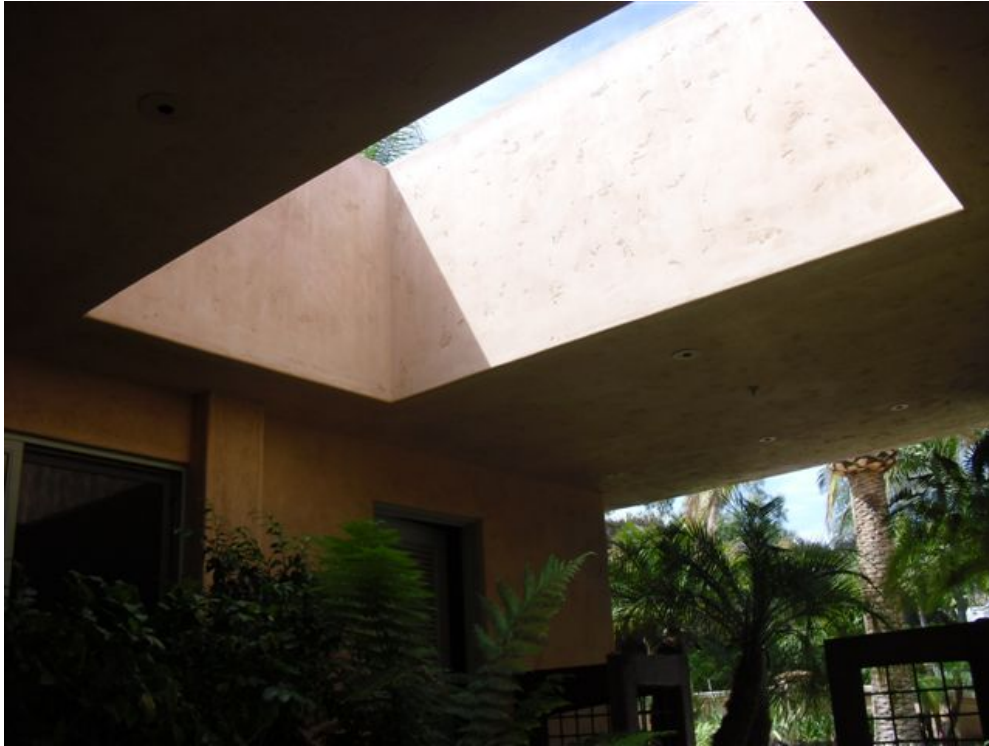
The location of the incident was a custom-built single-story private residence that was undergoing renovations to the exterior. A breezeway connected the house to the garage. There was a permanent 3 x 5 foot opening in the roof of the breezeway that served only as an architectural element. Additional work was being done on the home by other contractors.

Exhibit 5 - The roof opening as seen from below.

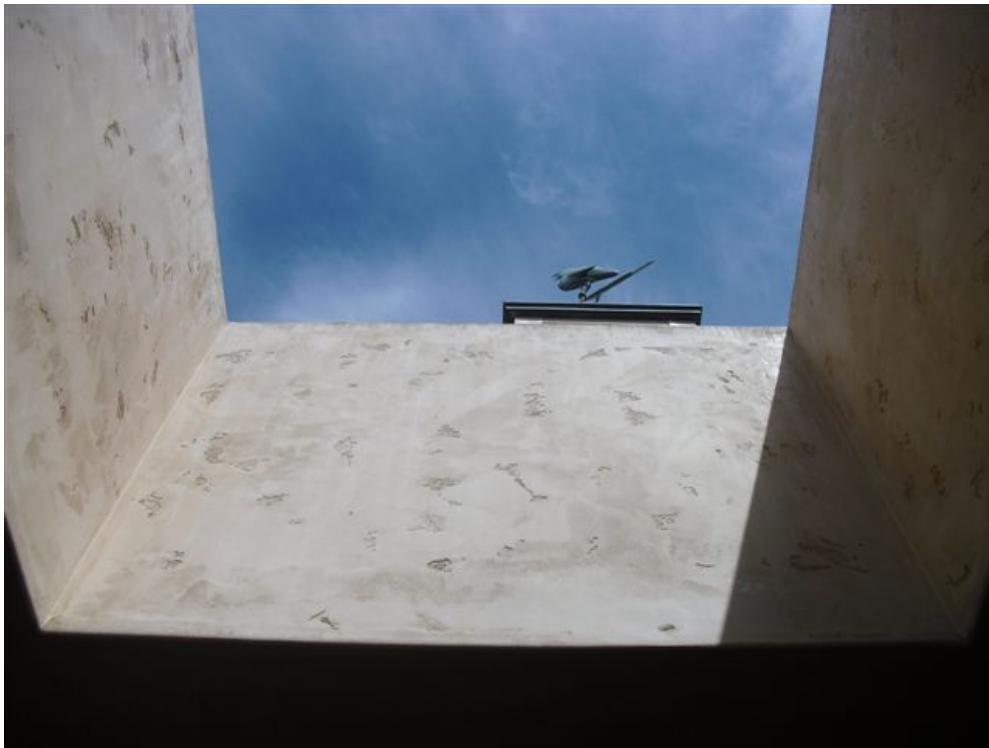
fatality. The CA/FACE investigator identified the unguarded roof opening, lack of a job hazard analysis prior to the start of the job to determine potential risk factors, and the lack of training as contributing factors in this incident that ultimately led to the fatality.

Exhibit 6. The roof opening and the weather vane mounted on the residence garage.
