# MIFACE Investigation Report #10MI137

## Subject: Carpenter Died From Extension Ladder Fall

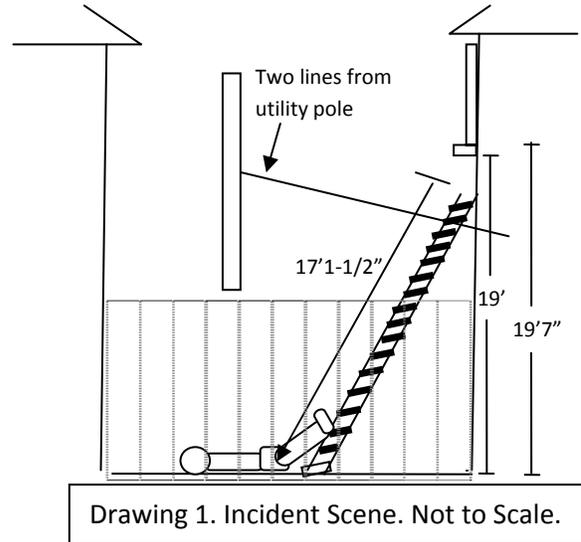
In the fall of 2010, a male carpenter in his 50's who worked for a home restoration company died when he fell an estimated 13 feet (exact height unknown) onto a concrete driveway from a 20-foot aluminum extension ladder. The decedent was performing window repairs at a residence. The decedent used a neighbor's 20-foot aluminum extension ladder rather than the company-issued 28-foot fiberglass ladder located on the work truck. Two lines from a nearby utility pole entered the home at this location. One of the two lines was a cable TV line and the second line was thought to be a phone line but this could not be confirmed. He placed the ladder against the outside of the home under the entering lines to reach a second story window located 19 feet 7 inches above the ground. The ladder was extended to its working height of 17 feet and positioned 4 feet 6 inches from the wall. The ladder was rated for a 200 pound individual; the decedent weighed 231 pounds. The lines were located between the decedent and the ladder. The decedent had an unwitnessed fall. The decedent lived directly next door to the jobsite and was scheduled to have computer work done at his home on the day of the incident. When the computer repair person arrived and did not find the deceased at home, he called his cell phone. The repairman heard the decedent's cell phone ringing. He followed the sound to the incident location and found the decedent on the driveway. He called for emergency response. The ladder was propped against the home and an unidentified line had been disconnected from the home (Drawing 1). The decedent was declared dead at the scene.

The decedent fell backward from the ladder and was found lying on his back with his right foot on the second ladder rung (Drawing 1). In his hand he was holding either nails or screws (one police officer described he was holding nails and one police officer described he was holding screws). A hammer and a pry-bar were lying on the driveway near the decedent's head. The ladder was still propped against the home. The cable line had been detached from the home. The decedent was declared dead at the scene.

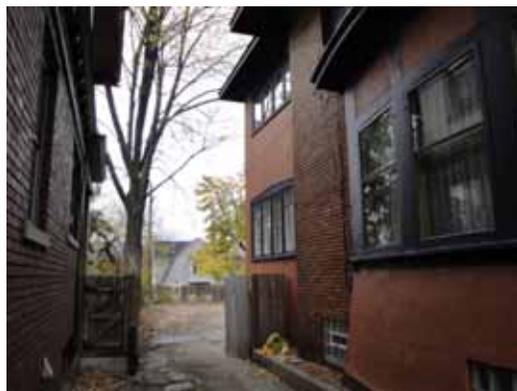
Figure 1. Overview of incident scene

Behind the home was a utility pole, which had two wires coming from it. One of the wires was a cable TV wire. The second wire was thought to be a phone line. The decedent placed the ladder on the south side of the home such that when he ascended the ladder, the wires were placed between his body and the ladder. Other homeowners saw the decedent set up the ladder approximately one hour prior to when he was found. The fall incident was unwitnessed.

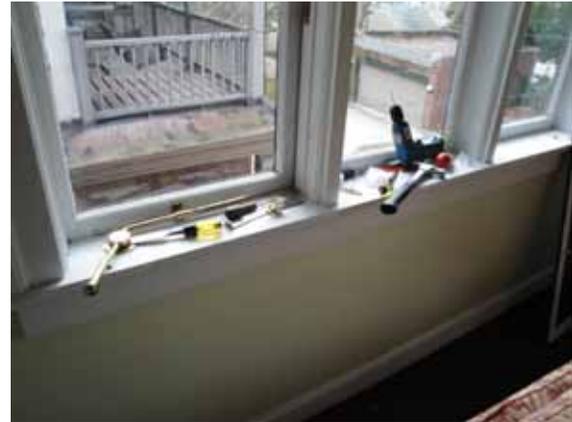
Figure 2. Work performed inside of home

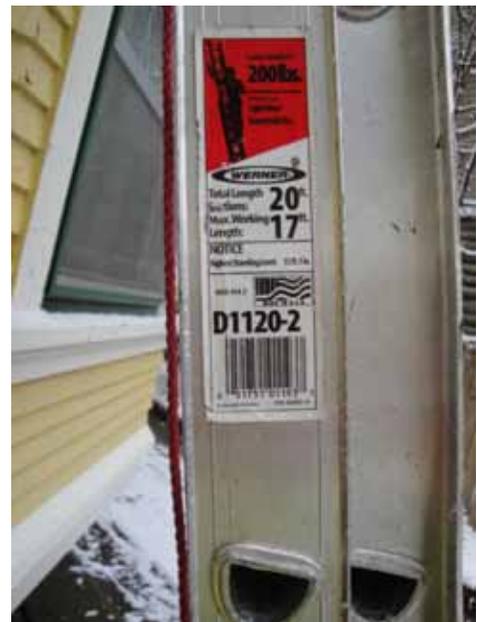
Figure 3. Incident Ladder label. Ladder at ladder owner's home.

feet tall). The ladder was rated for an individual weighing 200 pounds or less; the decedent weighed 231 pounds.

The fiberglass ladder provided by the decedent's employer was available on the ladder rack on the top of the truck. The ladder the decedent selected was not an appropriate ladder for the task. The ladder was not long enough to permit the decedent to safely work at the window. The decedent was six feet tall, and to reach the window, he would have to stand on a higher rung than allowed by the manufacturer to reach the window. An additional issue with the ladder selection was that the decedent exceeded the weight limit for the ladder. The excess weight may have caused the aluminum ladder to flex excessively as the decedent climbed. The flex may have caused him to lose his balance or may have caused the ladder feet to slip causing ladder movement and thus causing him to lose his balance. Additionally, it was unknown how the decedent was carrying the pry-bar and hammer as he ascended. If he was carrying them in his hand, it would have been very difficult to maintain a three point contact with the ladder because one of his hands was holding the nails/screws.

- Employers should ensure employees using ladders receive training on safe use of the ladder.

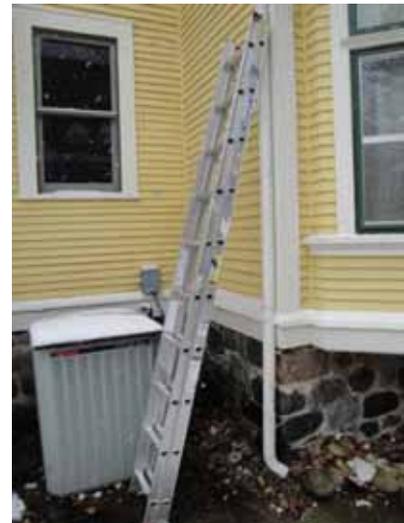
Figure 4. Ladder involved in incident at ladder owner's home

After the incident, an insurance company hired an engineering firm who examined the ladder and determined that it was in good working condition; safety feet intact, latches and rungs not cracked, etc. Figure 4 shows the incident ladder propped against the home of the ladder owner.
