NJ FACE INVESTIGATION REPORT

FACE 07-NJ-077

June 21, 2011

Construction Laborer Dies After Falling Through Temporary Bridge “Catch” Platform, 75 Feet To Ground

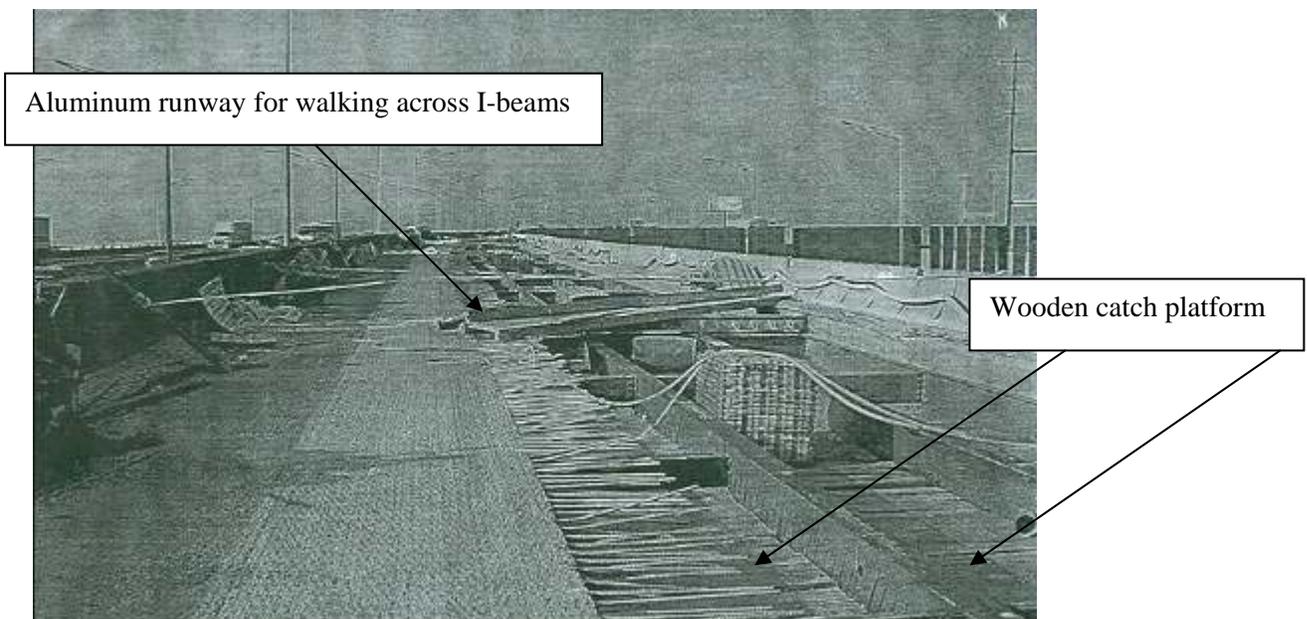
Figure 2. Bridge deck where incident occurred

The fatal incident occurred on a typical work day in 2007 shortly after the morning shift began. An OSHA Compliance Safety and Health Officer (COSHO) who had visited the work site several times since the fatal accident reported that it was not uncommon for employees to walk and work on the platform. The victim was not using any fall protection devices at the time of the incident. According to the COSHO, the victim stepped down from the I-beam onto the wooden catch platform to move a “pic” board, a metal runway used to transport concrete between work areas on the bridge. The distance from the top flange of the I-beam to the bridge “catch” surface was 16 inches. Immediately after the victim stepped down, one plank broke across its width, resulting in the employee falling partially through the platform. As the employee fell, other wooden planks making up the platform shifted because the planks were not affixed to one another, and the victim fell completely through the platform (see Figure 2, incident site).

The wooden plank that failed was a nominal 2' X 10' piece of economy-grade, white pine that was 67¹/₂ inches long. The height and width of the failed plank was 1⁷/₈ by 9³/₄ inches, respectively. The plank broke with a curved split at approximately 29 to 29¹/₂ inches from its end, near the location where the victim stepped onto it. This curved split caused the board to break into two large sections and one smaller triangular section. A failure analysis of the broken plank by OSHA revealed that the major strength reducing feature of the plank was the Slope-of-Grain (SOG), which was 1:2 (i.e., the grain along the length of the board deviated from the long axis of the plank by a distance of 1 inch for every 2 inches in length). Acceptable SOG for scaffold-grade lumber is a minimum of 1:12. The OSHA failure analysis demonstrated that the wood used in this platform was inadequate as a walking/working surface. In addition, the COSHO observed planks being reused on the bridge “catch” that had been previously removed from service due to structural concerns, and noted visibly damaged wooden planks as well as planks that had shifted, leaving open spaces in the platform.

Recommendation #1: Personnel working at heights of six feet or greater should have effective fall protection and prevention.

Recommendation #2: Surfaces that are accessed and used by personnel must be designed, maintained, and inspected to assure that they are safe.
