FACE Report Number 2012-02

January 12, 2015

## Hispanic worker falls from residential roof – North Carolina

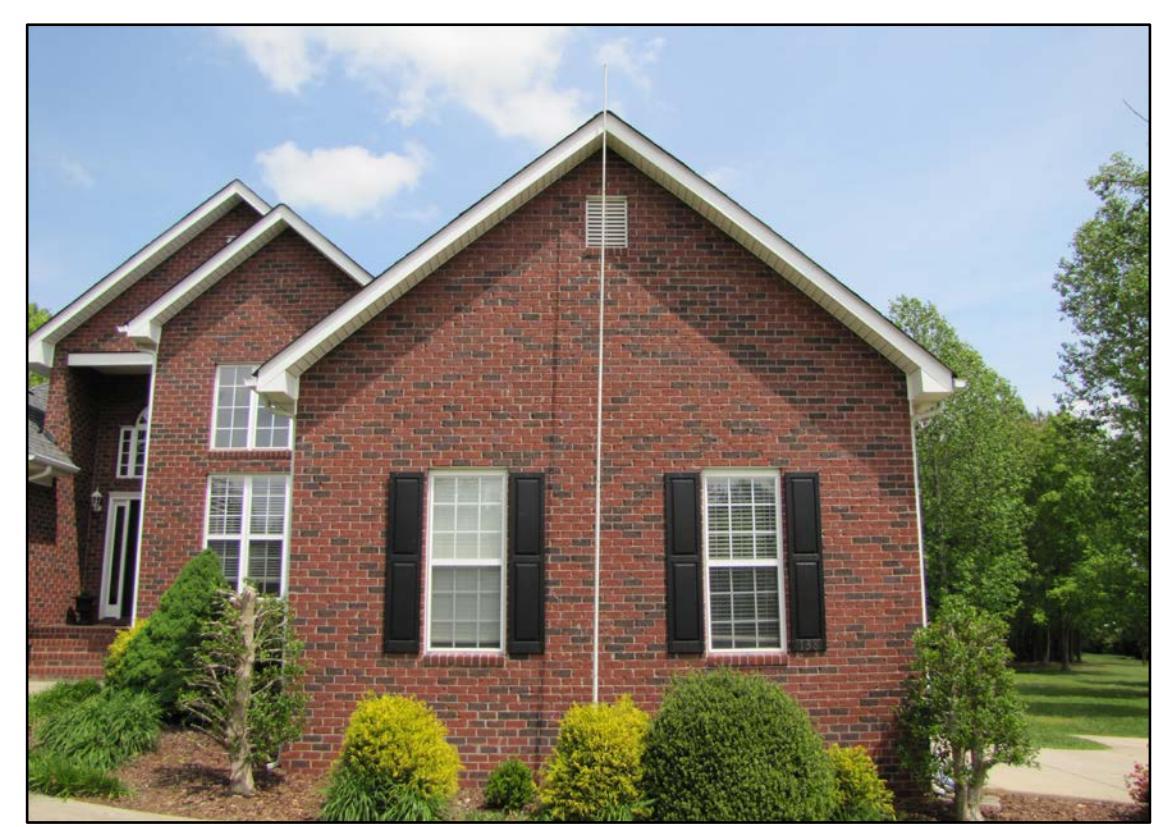
Photo 1. Roof pitch of the garage was determined to be 10/12 (Photo courtesy of NCDOL/OSH)

He was working alone on the garage roof at the time of the incident. The garage roof had a 10/12 pitch roof with a height of 23.1 feet at the peak and 13.5 feet at the eave (Photos 1 & 2). The other employees were working on other portions of the roof and on the ground. It is believed the laborer lost his footing then slipped and slid down the roof, falling more than 13.5 feet to the

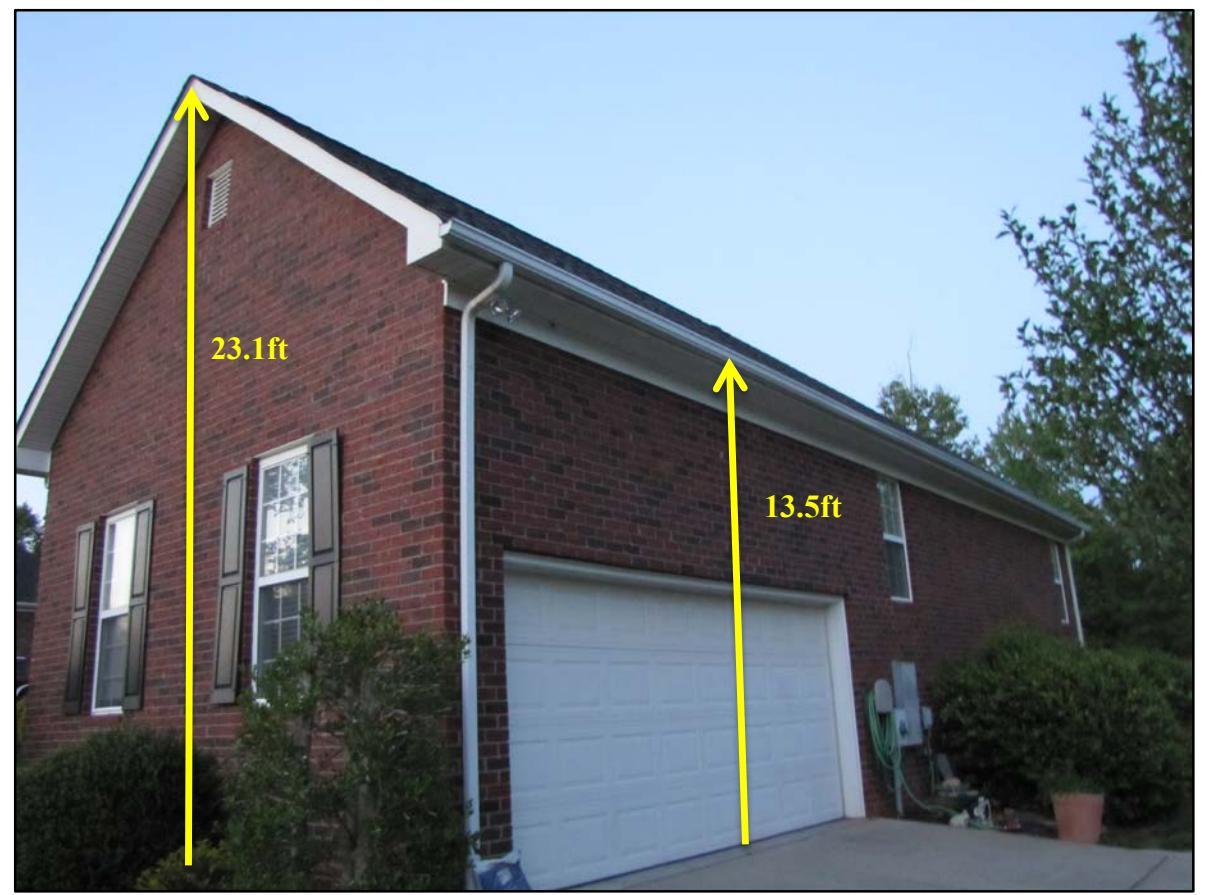
Photo 2. Garage where laborer was working (Photo courtesy of NCDOL/OSH)

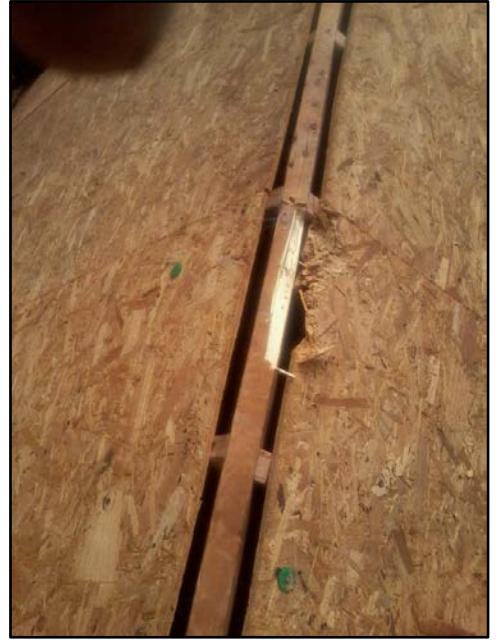
Based on photos retrieved from the scene, the anchor for the laborer's PFAS had pulled from the peak (Photo 3). Further investigation of the anchor suggests that it had been installed laterally along the ridge of the roof with two or three nails of unknown size. The lifeline was found coiled near the laborer's hand. The rope grab was attached to the right leg webbing of his harness rather than the D-ring anchor, and the energy-absorbing lanyard was attached to the roof anchor. The harness, lanyard, rope grab, and connectors appeared to be in good condition and were within the 5-year recommended service life. There were damaged fibers at the 25-foot mark on the 50-foot lifeline (Photo 4).

Photo 3. PFAS anchor location after incident (*Photo courtesy of NCDOL/OSH*)

According to 29 CFR 1926.502(d)(15)<sup>6</sup> the anchorage points used for attachment of personal fall arrest equipment shall be independent of any anchorage being used to support or suspend platforms and capable of supporting at least 5,000 pounds (22.2 kN) per employee attached, or shall be designed, installed, and used as part of a complete personal fall arrest system which maintains a safety factor of at least two under the supervision of a qualified person. The anchor for the PFAS used in this incident is believed to have been installed horizontally along the ridgeline of the roof, secured with 3 roofing nails into the sheathing (Photo 3). To meet the 5,000 pounds per employee support requirement, the manufacturer recommends installing the anchor over the ridgeline, with a minimum of 10 to12, 3-inch, 16d nails through the holes, into the truss (Photo 7).

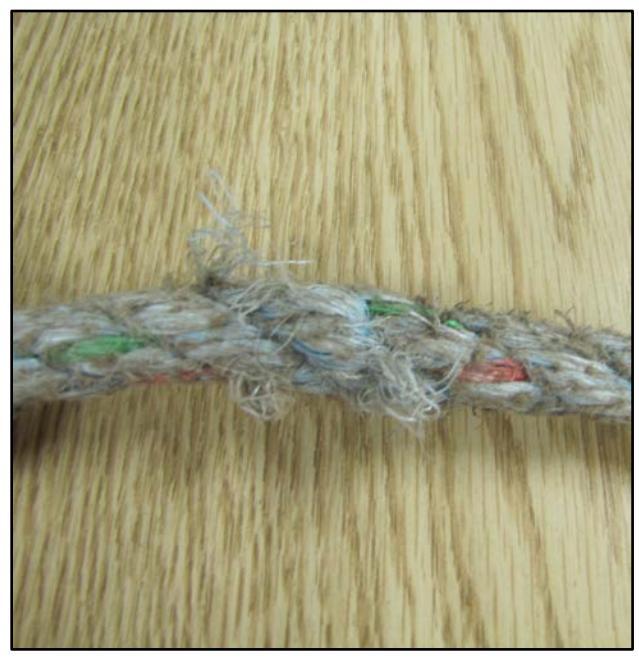
Photo 4. Damaged fibers in laborer's 50-foot lifeline (*Photo courtesy of NCDOL/OSH*)

According to 29 CFR 1926.502(d)(21)<sup>6</sup> personal fall arrest systems shall be inspected prior to each use for wear, damage and other deterioration, and defective components shall be removed from service. In this case, the 50-foot lifeline was damaged at the 25-foot mark and should have been removed from service.

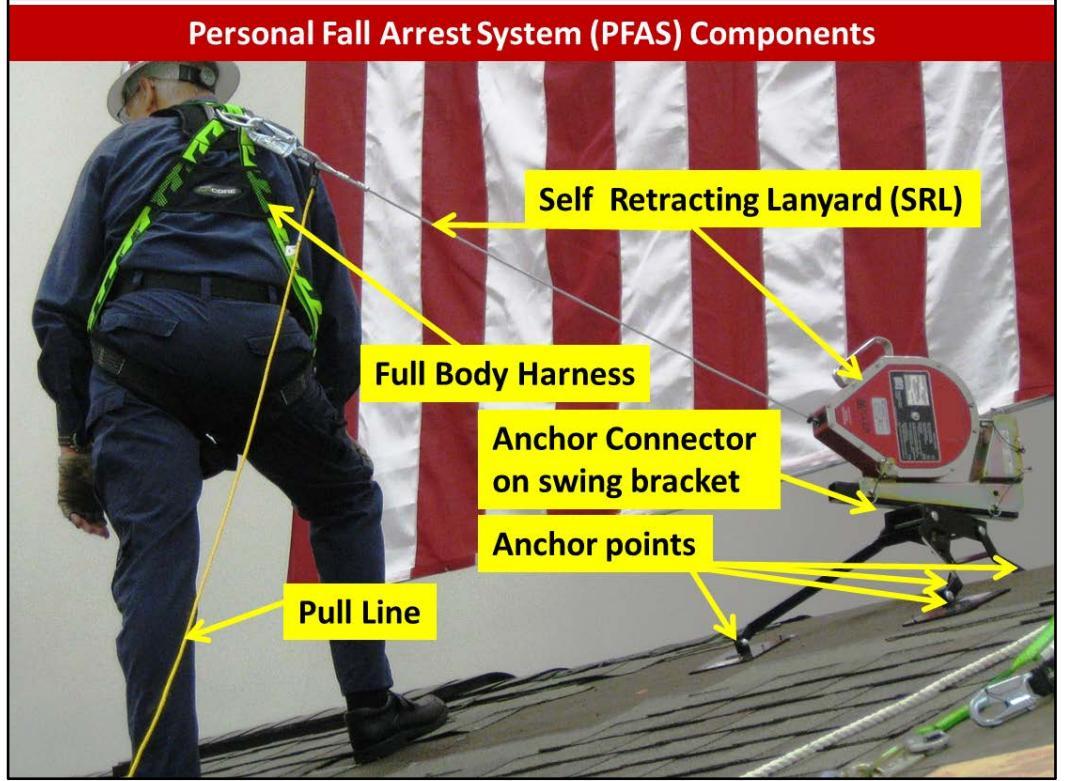
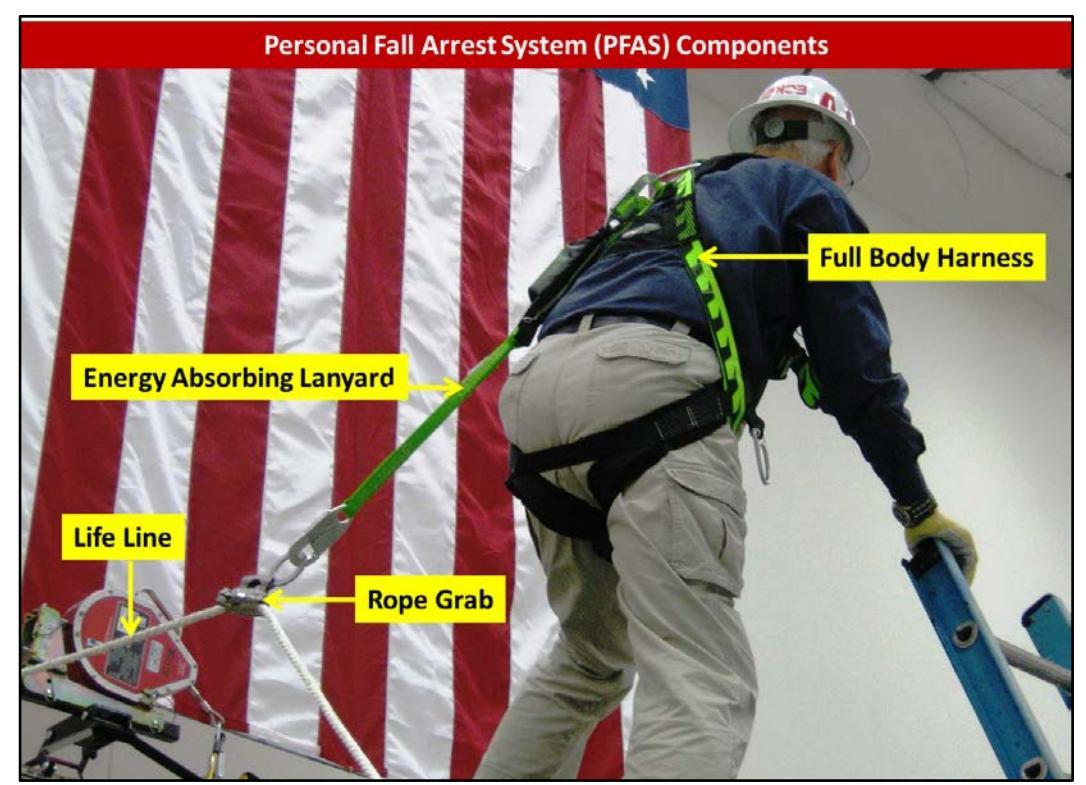
Photo 5. Proper components of a PFAS (Photos courtesy of John Eckel, Honeywell)

Photo 6. Proper components of a PFAS (Photos courtesy of John Eckel, Honeywell)

Discussion: Employers in residential construction, including subcontractors, are required to provide employees with a fall protection system (e.g. guardrail systems, safety net systems, or personal fall arrest systems) when employees are walking/working on a surface, horizontal and vertical, with an unprotected side or edge which is 6 feet or more above a lower level. A Personal Fall Arrest System (PFAS) is designed to stop a worker's fall before they strike a lower level

(Photo 5 & Photo 6). According to OSHA regulations the general contractor who has control of the work site has a responsibility to ensure workers on the site are in compliance with OSHA standards found in 29 CFR 1926.501<sup>5</sup>. This fall protection system must be in accordance with the fall protection criteria, requirements for fall protection systems, criteria, and practices that are found in 29 CFR 1926.502<sup>6</sup>.

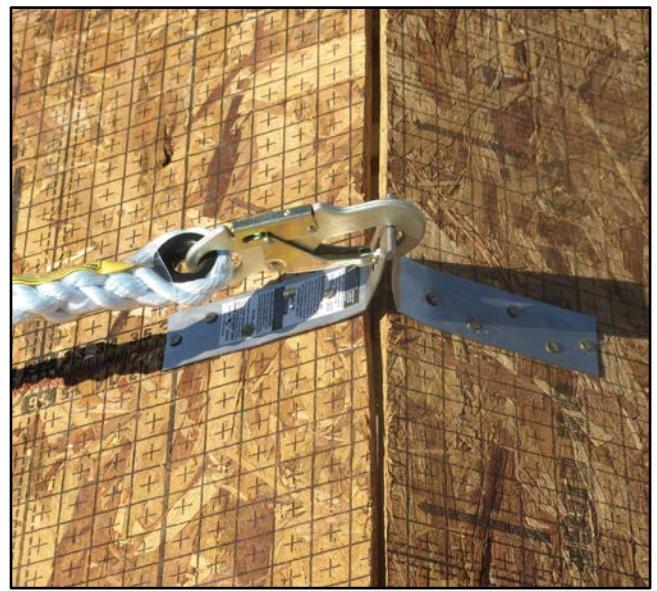
Photo 7. Proper installation of PFAS anchor (Photo courtesy of NAHB)<sup>Z</sup>
