**SUBJECT:** A Day Laborer Dies When He Falls Off a Scaffold

# SUMMARY California FACE Report #11CA002

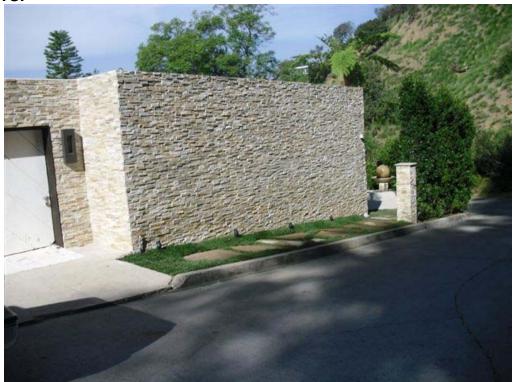
Exhibit 1. The stone and stucco work at the incident site.

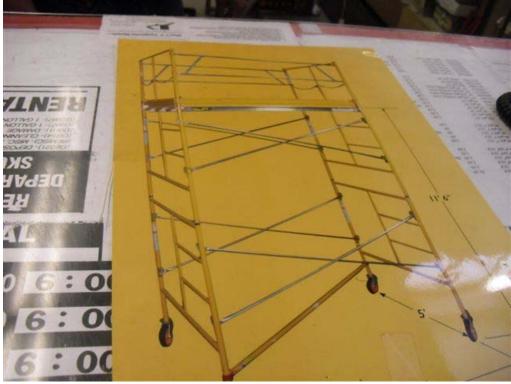
The victim erected the scaffold but it was leveled using improper methods. The walk board was not properly secured, and the guard rails on the top portion were not attached. He then used the scaffold to gain access to the upper portions of the home's exterior wall. The victim was working alone off the scaffold walk board, approximately 12 feet above ground level and was not wearing any fall protection devices. The victim worked for two days performing the job. On the third day, he continued applying the stucco and stone façade. At one point, the victim reached for a cell phone that was being handed to him by the homeowner's gardener. The walk board shifted and he fell off the scaffold to the ground below. The homeowner's gardener immediately came to his assistance and called 911. Paramedics responded within minutes and treated the victim and then transported him to a local hospital where he died from his injuries.

Exhibit 2. A schematic of the scaffold involved in the incident.

In this incident the unstable walking board, lack of guardrails and fall protection allowed the victim to fall off the scaffold to the ground below. In California, workers who are elevated more than 7 ½ feet off the ground are required to use fall protection. In this case the use of guard rails would have been adequate fall protection. In lieu of guard rails, the victim should have worn a personal fall arrest or personal fall restraint system. In either case, the use of fall protection would have prevented this incident from occurring. Had the victim been properly trained and made aware of the safety hazards associated with the job, he might have assembled the scaffold correctly and secured the walk board, installed guard rails, or worn a personal fall arrest or restraint system.
