FROM: Iowa FACE Case No. 2010 IA 054 Report Date: 10 October 2012

SUBJECT: Construction laborer fell from ladder

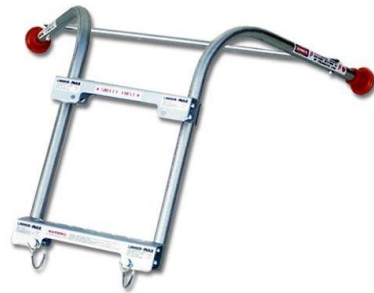
Exhibit 2. Examples of ladder stabilizers

approximately 3 feet beyond the roof eaves. The ANSI duty rating of the ladder was not known. A stabilizer bar (Exhibit 2) was affixed to the upper section of the ladder with pins and clips. A nylon tie-down strap (Exhibit 3) attached to the stabilizer bar was screwed onto the roof deck to secure the top of the ladder in position. The type and size of the tie-down strap and the screw used to secure the strap to the roof was not known. The bottom of the cleated ladder rested on dry level ground of earth and gravel, but was not staked to the ground or secured to a permanent fixture.

Neither the owner nor the coworker witnessed the helper fall, but the owner noted that in the course of the fall, the nylon tie-down strap broke and that one end of the strap still remained screwed to the roof deck. The stabilizer bar had come free of the ladder. There were grooves in the earth approximately one-half inch deep and several inches long where the ladder cleats slid sideways. The ladder itself was not found to be faulty. The owner suspected the victim lost his balance as he put the tarp on the roof or shortly thereafter and may have tried to jump to the elevated area next to the foundation retaining wall. No information was available regarding the victim's footwear or whether his footwear played a part in the fall.

In this fall, the stabilizer came free of the ladder when the single nylon tie-down strap broke. A more secure fixture would have been to use appropriate-strength rated nylon straps (selected according to safe load limit and breaking strength) to affix the top end of each ladder rail to the roof. The ladder should also have been secured at the bottom, by tying or staking both bottom rails to the ground or to fixed structures (Exhibit 5). Securing the ladder at the bottom as well as the top may have prevented this ladder from lateral movement if the victim reached or leaned to the side while climbing or placing the tarp.
