SUBJECT: Laborer Dies When He Falls 35 Feet From a Scaffold After Being Electrocuted

SUMMARY
California FACE Report #08CA006

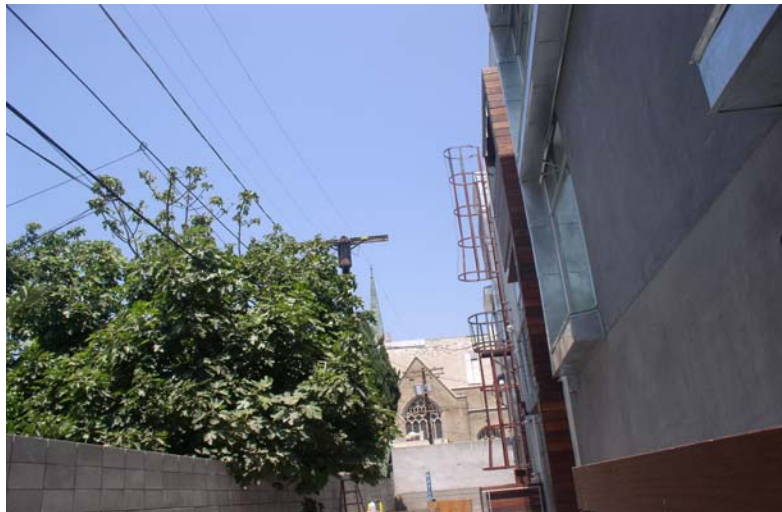
Exhibit 1. The high voltage lines in relation to the building under construction.

The site of the incident was a three-story commercial building that was under construction. Utility power poles with 4,800 voltage power lines were located at the rear of the building approximately 10 feet away from the roof where the solar installation was to be performed. On the day of the incident, the victim and two co-workers were sent by their supervisor to the building site to strap a solar hot water tank to the roof of the building. The strapping material was an aluminum channel bracket that measured approximately 20 feet in length, and weighed approximately 20 pounds. The crew climbed an existing scaffold that was in place at the rear exterior of the building, and a rope was secured to the metal bracket on the ground. The victim was standing on the top of the scaffold and raised the bracket from the ground with the rope. As the victim pulled the bracket to the top of the building, he turned the bracket to a horizontal position with his back towards the nearby power lines. One end of the bracket made contact with the high voltage power lines sending electric current through the victim. The victim fell off the scaffold approximately 35 feet to the ground below. Emergency response personnel transported the victim to the local hospital where he died the following day.

Discussion: When installing solar equipment on roofs, workers may use conductive equipment that can come into contact with nearby high voltage power lines. In this incident, a high voltage power line was located about 10 feet from the scaffold and roof edge. The twenty-foot long metal bracket, as it was being lifted, easily spanned the distance between the scaffold and the power line. A daily job hazard analysis would have identified the risk of the metal bracket contacting the high voltage power line, and safe work procedures could have been implemented to bring the bracket to the roof. The metal bracket could have been cut into smaller sections on the ground and then brought to the roof, or a different means of roof access could have been used.

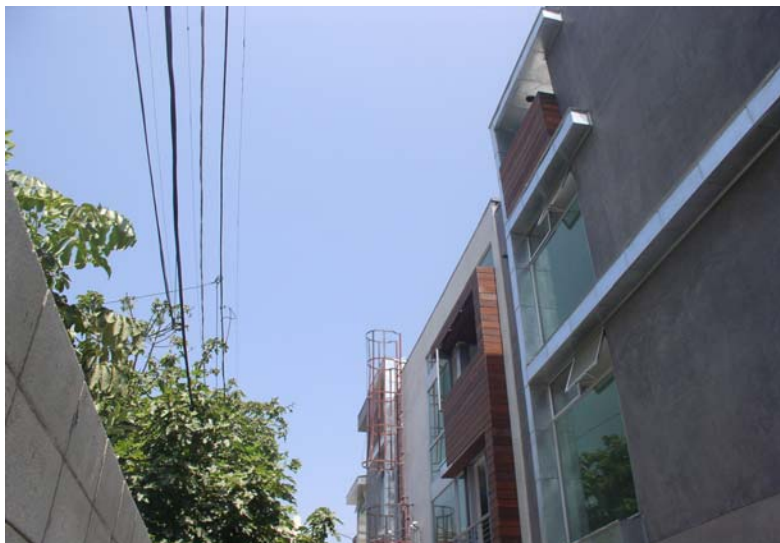
Exhibit 2. The top of the building under construction where the victim was working.

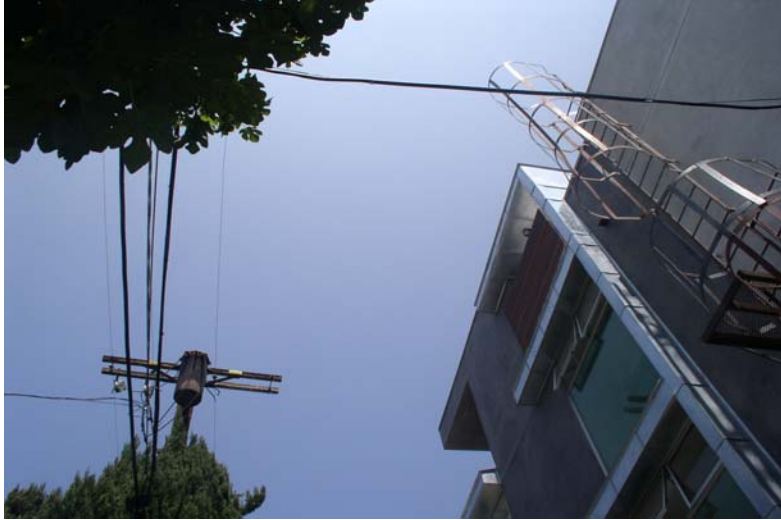
Exhibit 3. Looking up from the ground to where the victim was working.
