FATALITY NARRATIVE

Laborer Falls through Roof Opening

Type of Incident: Fall through roof opening

SHARP Report No.: 71-117-2013

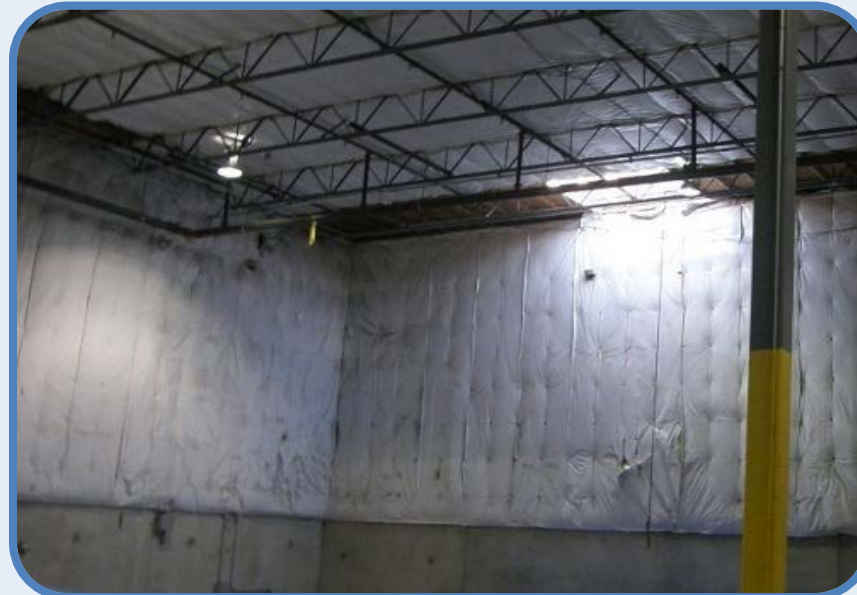
On Oct. 31, 2011, an 18-year-old laborer was fatally injured when he fell through a roof opening. He was an employee of a contractor who was replacing rotten plywood sheathing and joists on a warehouse roof.

The victim, a foreman, and another laborer were working on the building's flat roof tearing out 4'x8' plywood sections and nailing new ones in place. The victim was wearing a full-body harness with a lanyard and using two lifelines hooked together with one of the lines looped around a skylight frame, which served as an anchor point. The other two employees were not using fall protection.

When the victim moved aside, he stepped onto two pieces of rotten plywood that were not nailed down, and the plywood pieces and unattached joist supporting them gave way. An investigation determined that his rope grab was attached near the end of his lifeline which left too much slack in the line allowing him to fall 30 feet to a concrete floor.

- Employers should
 - Conduct a daily hazard assessment to identify and eliminate hazards, such as roof openings and rotten areas of roofs incapable of supporting the weight of employees.
 - Closely supervise and monitor young and less experienced workers.
 - Consider assigning hazardous tasks to more experienced workers.
 - Train workers to continually inspect fall prevention systems to ensure they are protective.

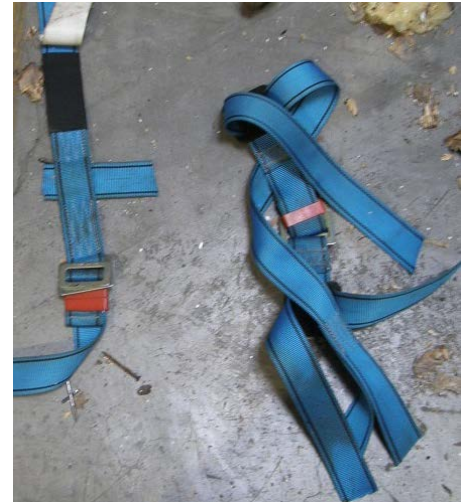
Harness cut from laborer

- Body harness systems must be rigged to minimize free fall distance with a maximum free fall distance allowed of 6 feet, and such that the employee will not contact any lower level. See WAC 296-155-24510(2)(a)(v).

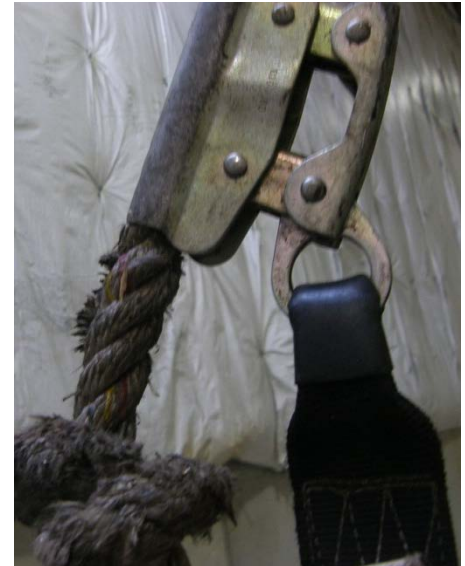
Rope grab at end of rope
