STATE OF NEW YORK DEPARTMENT OF HEALTH

FATALITY ASSESSMENT AND CONTROL EVALUATION

Master stonemason dies in a 30-foot fall from a handmade work platform attached to a powered industrial truck Case Report: 07NY107

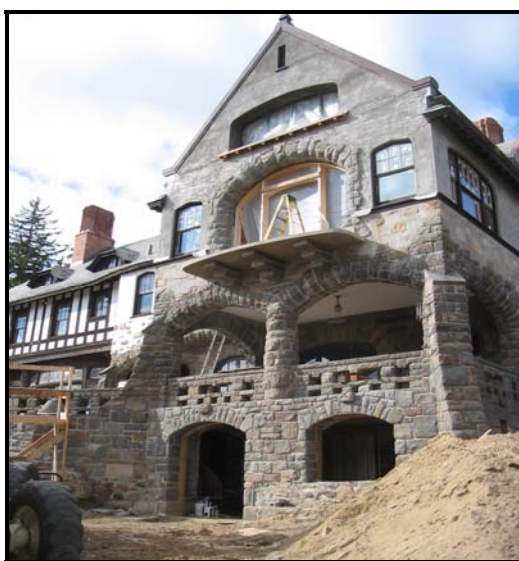
Photo 1 Second story addition
(courtesy of OSHA)

The renovation project included the construction of a second story addition at the northeast corner of a stone and masonry mansion (Photo 1). The terrain around the mansion was sloped and uneven; the rear side of the second story addition was 3 full floors above the ground level (Photo 2).

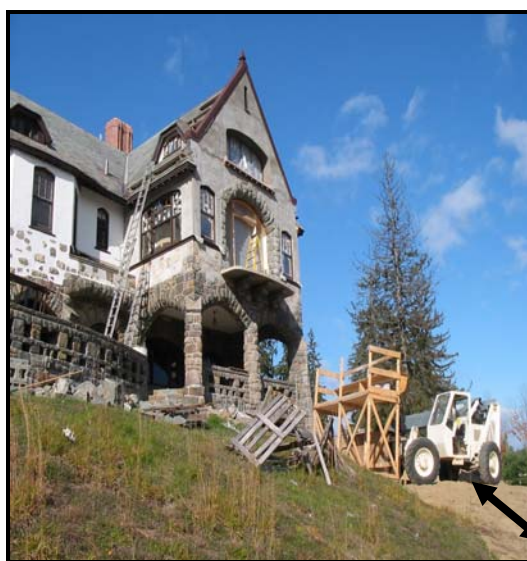
Photo 2 Sloped terrain
(courtesy of OSHA)

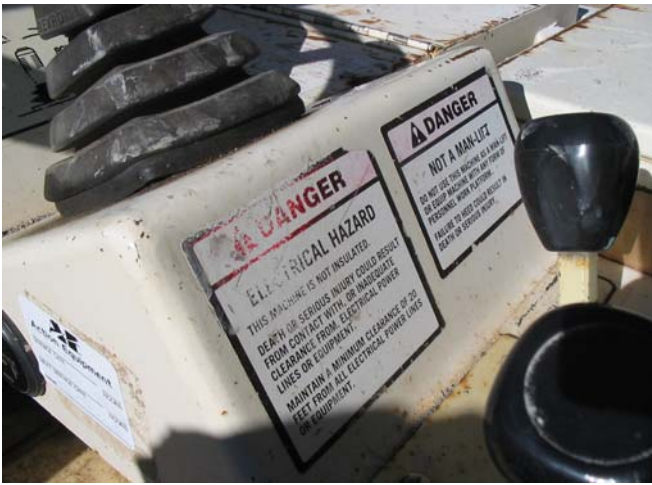
Photo 3 Warning Plate Inside Cab(courtesy of OSHA)

The telescopic handler involved in the incident was owned by the GC. This powered industrial truck (PIT), also referred to as a telehandler, rough terrain forklift or all-terrain forklift, had a maximum lift capacity of 6000 pounds and a telescopic boom with a maximum working height of 36 feet to reach higher elevations or access otherwise hard-to-reach spaces. At the time of the incident the boom was extended vertically about 25 feet and also extended horizontally approximately 16 feet, with a 9 foot high, double tiered platform attached. The manufacturer's warning plate inside the telescopic handler stated that the machine must not be used as a man-lift or equipped with any form of personnel work platform as it could result in death or serious injury (Photo 3). The manufacturer warned in the General Safety section of the operating manual that unauthorized modifications to the machine may impair the safety and machine function. The telescopic handler was observed by the OSHA investigator to be well-maintained in appearance, the operating manual was in the cab, and no operational problems were found when it was tested on the ground after the incident. The platform stability and the guardrail strength were not tested after the incident.

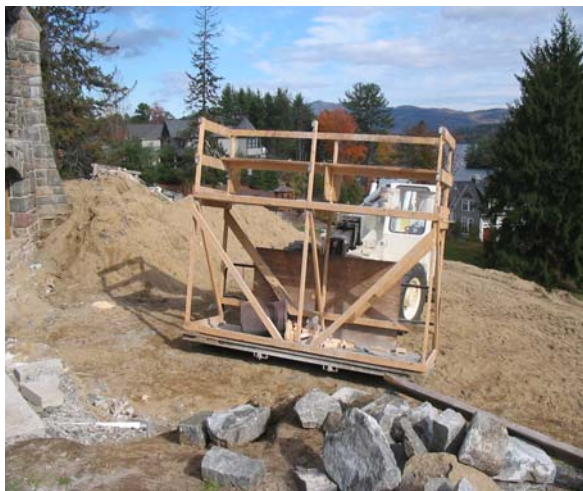
Photo 4 Two-tier Platform
(courtesy of OSHA)

Numerous deficiencies were noted in the design, construction and operation of the platform.

- The two tier design resulted in a platform occupant floor height of 5 feet above the forks. The floor of the platform may not be located more than 8 inches above the normal load supporting surface of the forks per ANSI standards (B56.6).

- The floor of the platform was not a slip resistant surface, as required by ANSI standards.
- The length of the platform floor at 12' exceeded the maximum total allowable platform dimension of 9' 8". ANSI B56.6 8.25.1(b) requires a maximum length to be determined by measuring the width of the PIT across the load bearing tires plus 10" on either side. The width of the PIT in this incident measured 8 feet.

- No lanyard anchorage points for fall protection systems were installed on the platform.
- The design of the platform required that the platform be positioned from the cab of the telescopic handler and did not allow for any control by the occupant of the platform. This is not considered to be a deficiency, provided that when there is an occupant working at elevation in the platform, the operator is on the PIT or within 25 feet with the PIT visible. At the time of the incident, the GC employee was in the cab. During other work periods however, there was no operator in the cab or within 25 feet with the PIT visible.

- The wheels of the PIT were not chocked as the victim worked on the elevated platform.
- A ledge was built on the upper tier and had the potential to be used to achieve additional height in the platform. ANSI standards (B56.6) prohibit the use of railings, planks, ladders, etc. on the platform for the purpose of achieving additional reach or height.

- The materials and tools on the platform were not secured to prevent any displacement or movement.
- 100% tie-off during platform to structure transfers and entry/exit three point contact safety procedures were not used. The platform was not lowered to the ground to allow for personnel to enter/exit. The victim had been observed climbing on parts of the telescopic handler, attempting to enter and exit the platform without any fall protection.

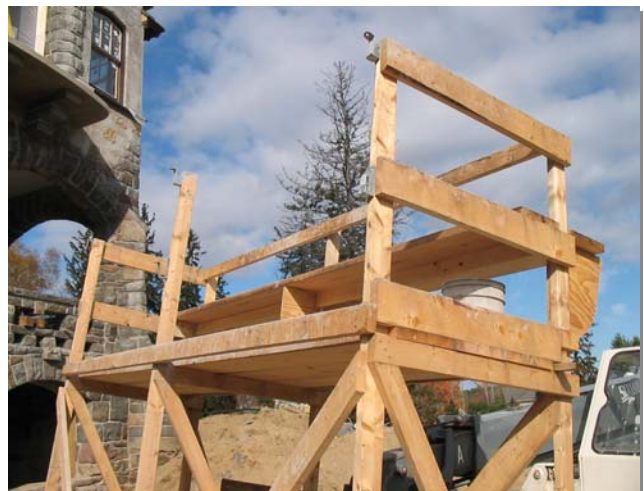
Photo 5 Upper Tier
(courtesy of OSHA)

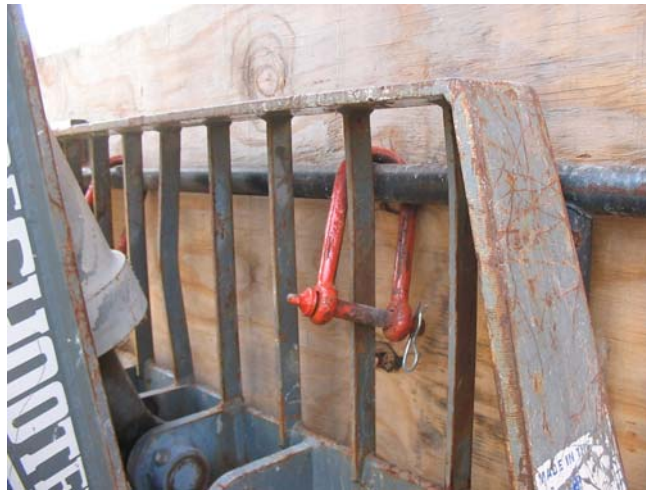
Photo 6 Platform fastened to forks (courtesy of OSHA)

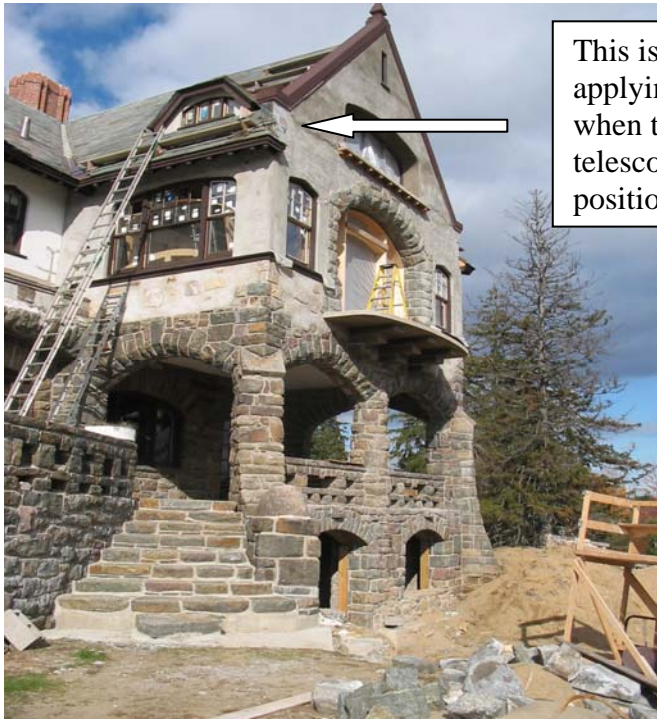
This is the area where the victim was applying stucco and painting trim when the incident occurred. The telescopic handler platform was positioned to the left of this area.

Photo 7 Note the stepladder on the balcony and extension ladder access to the roof. (courtesy of OSHA)

The victim had been observed by the GC employee on site positioning the platform with the telescopic handler and then accessing the platform from a step ladder on the balcony or by climbing down into the platform from the roof jacks (Photo 7). The front guardrails were not installed on the platform. The victim was working with the unprotected front side of the platform facing the building; he was not wearing any type of personal fall protection.

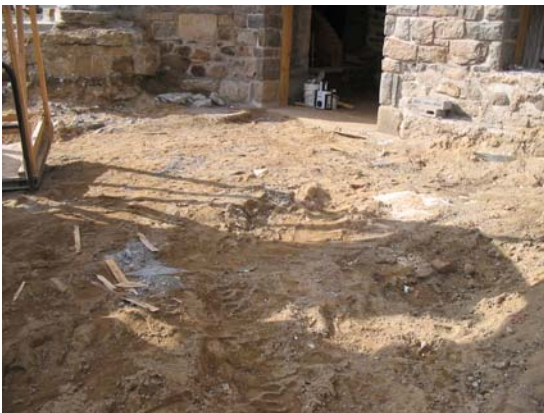
- The telescopic handler was positioned on a small, sandy area at the rear of the building. Although the area was relatively flat, the surface was rutted and irregular, another condition that is known to contribute to increased instability of an elevated platform (Photo 9).

Photo 8 Rutted, uneven surface where the telescopic handler was positioned (photo courtesy of OSHA)
