A Metal Fabrication and Finishing Foreman Dies After 25 Foot Fall at a Commercial Building Site

Incident Number: 13KY042

**Kentucky Fatality Assessment and Control Evaluation (FACE) Program
Incident Number: 13KY042
Release Date: February 10, 2014
Subject: A Metal Fabrication and Finishing Foreman Dies after 25 Foot Fall
at a Commercial Building Site**

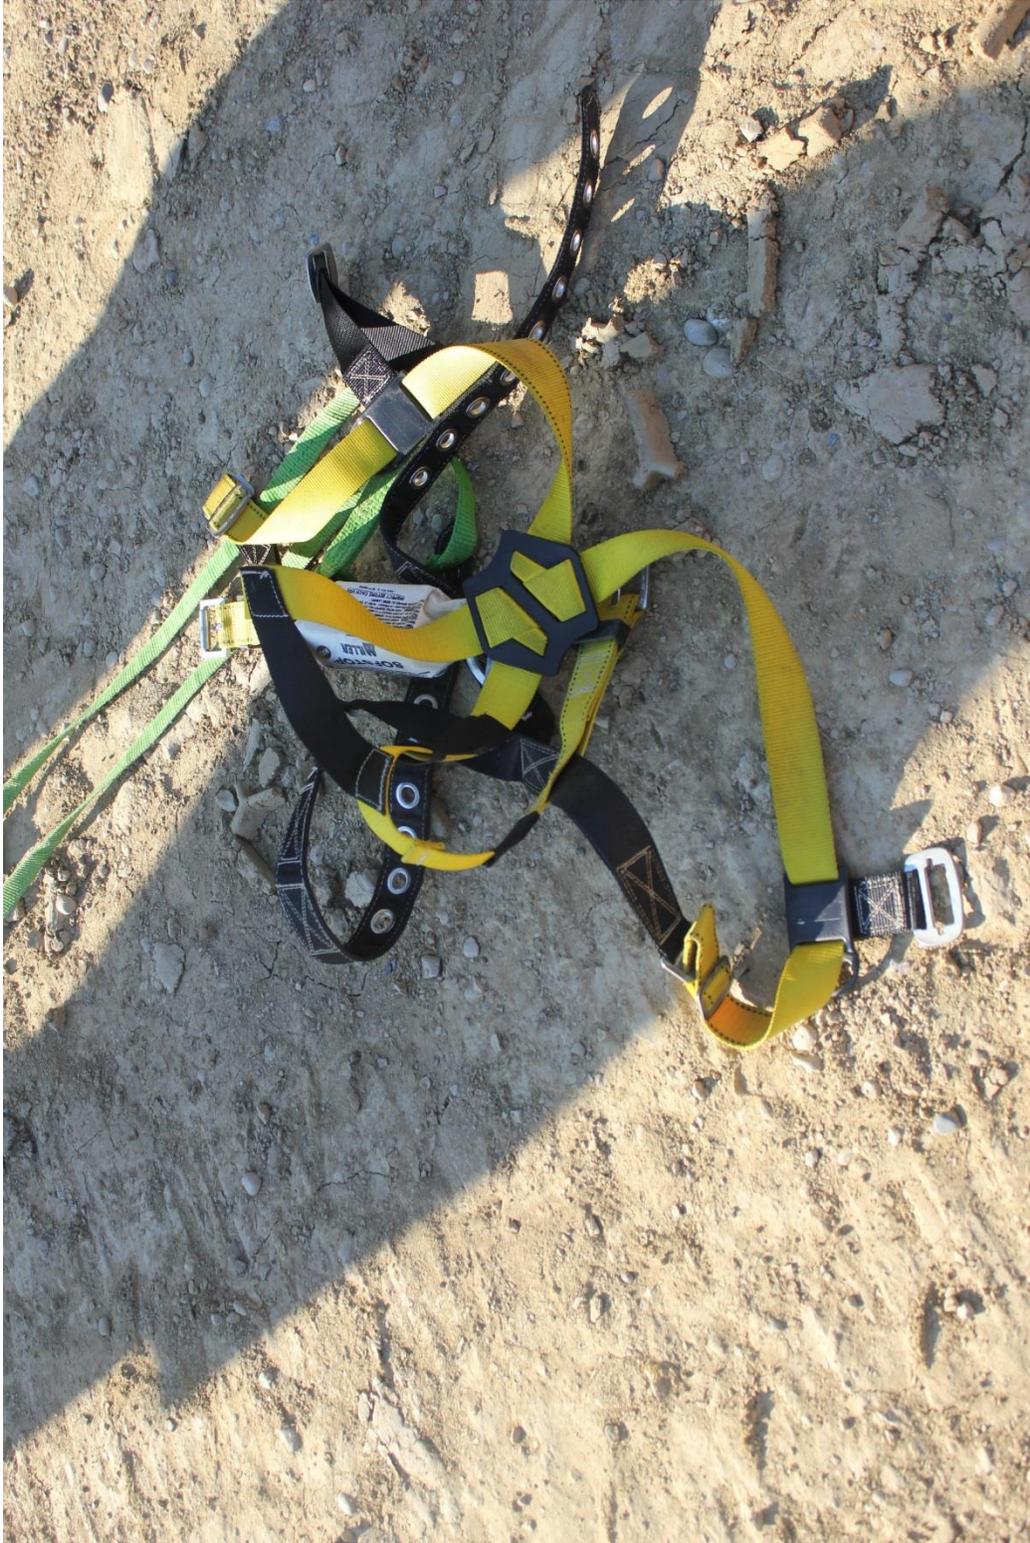
Picture of harness worn by foreman. Photograph courtesy of KYOSH

A fourth employee of the same company was also on the roof doing clean-up work. All four (4) company employees were wearing fall protection harnesses. The employee doing clean-up work and the employee on the South side were tied off on the roof. They had a life line running across the North and the South sides of the roof. The tie-off stand in the North West corner of the roof had been moved at some point, because it was interfering with the stacking of the decking materials. The employee on the South end tied off to the life line, but the other two (2) employees, the foreman and the North side employee, could not reach the zip line that ran across the length of the roof, and were not tied off.

Recommendation No. 4: Employers should implement and enforce a written safety policy which states the consequences of not following personal fall arrest policies.

Occupational Safety Health Standard 29 CFR 1926.503(a) (1) states that the employer is responsible for providing a training program for each employee that might be exposed to fall hazards. The company involved in this fatality had written safety procedures and most employees were trained and certified on how to use personal fall arrest systems. All training should be documented, and employees should be required to sign that they understand the safety and training program. Enforcement and consequences for failure to follow safety systems should be part of the standard operating procedures.
