INJURY NARRATIVE

Construction Worker Falls 14 Feet from a Beam onto Concrete and Suffers Serious Brain Injury

Incident Date: May 12, 2014
Release Date: April 10, 2015
SHARP Report No.: 71-137-2015

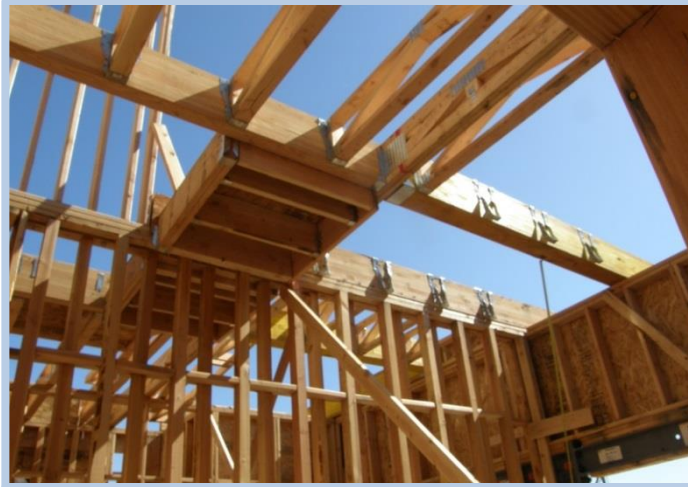
Photo of incident scene showing the opening the worker fell through while installing floor trusses.

Although the injured worker was wearing fall protection, there had been too much slack in the rope, and it was not able to stop his fall. The foreman had warned him about having too much slack in the rope one week before the incident. He was taken to the hospital where he was found to have multiple skull fractures, brain hemorrhaging, and a spinal fracture. He underwent emergency surgery to relieve brain swelling. Nearly a year later, the injured worker is still in rehabilitation for his brain injuries and requires 24-hour-a-day living assistance.

- Make sure the appropriate fall protection system is provided, installed, and implemented according to requirements when employees are exposed to fall hazards of ten feet or more to the ground or lower level while working on any surface that does not meet the definition of a walking/working surface. See [WAC 296-155-24611\(1\)\(c\)](#).
- Develop and implement a written fall protection work plan that includes each area of the work place where the employees are assigned and where fall hazards of ten feet or more exist. See [WAC 296-155-24611\(2\)](#).
- Provide retraining for employees exposed to fall hazards when inadequate use indicates that they have not retained the knowledge of how to use fall protection systems safely. See [WAC 296-155-24621](#).

- Consider using aerial work platforms or scaffolds to reduce the risk of falls when installing trusses, rather than having workers stand on the beam edge.
- Reduce exposure to falls by placing and securing plywood over the already installed trusses to create a walking/working surface to which an anchor can be secured for a personal fall restraint system.
