# **Laborer Falls 55 to 75 Feet to the Ground While Spray Painting Grain Bins**

**Incident Number: 13KY061**

**Kentucky Fatality Assessment and Control Evaluation (FACE) Program**  
**Incident Number: 13KY061**  
**Release Date: November 11, 2014**  
**Subject: Laborer Falls 50 to 75 Feet to the Ground While Spray Painting Grain Bins**

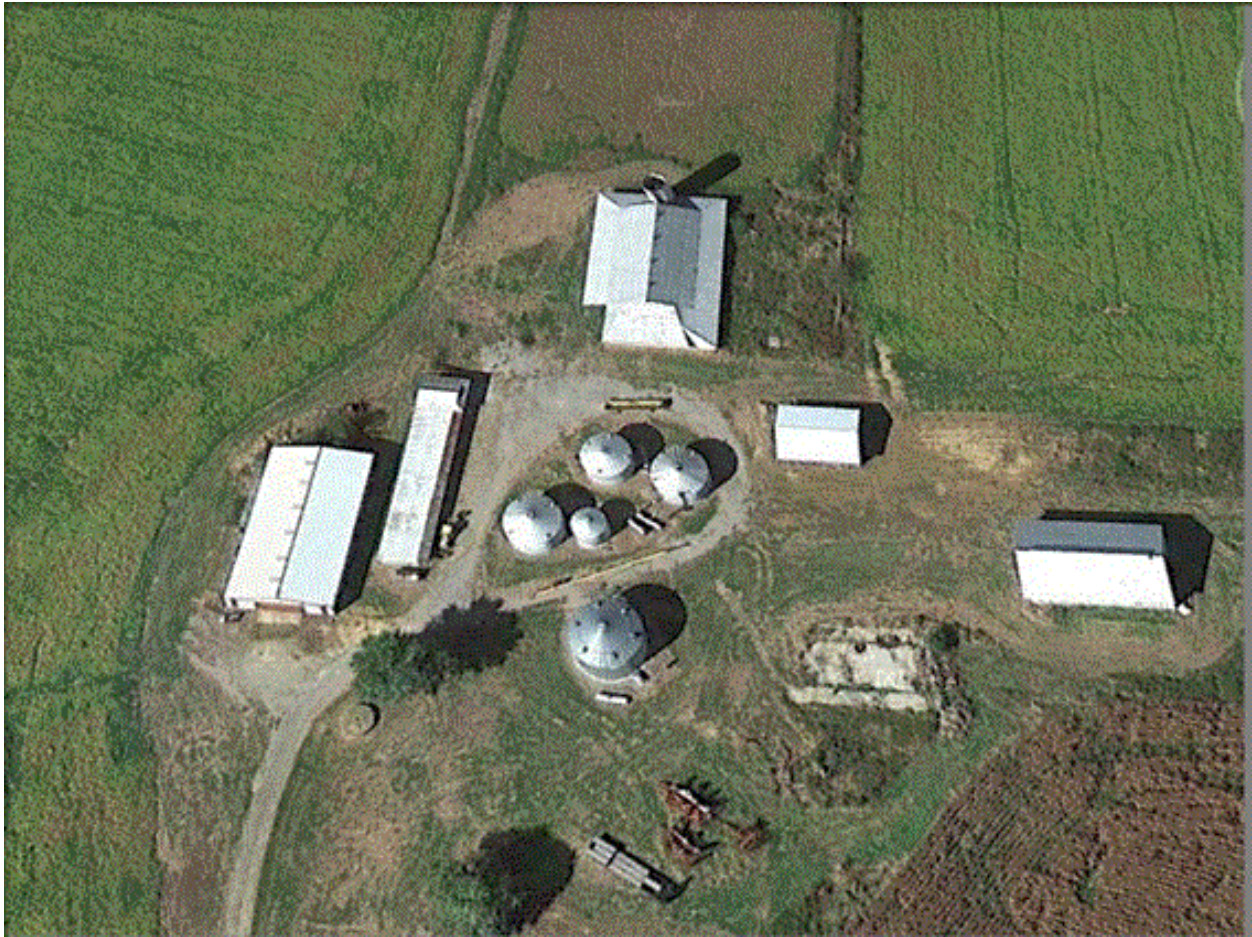
Photo #1 overall view of incident scene

The incident scene was a large farm (see photo #1). The site consisted of three 300,000-bushel bins, one 100,000-bushel bin, one 30,000-bushel wet bin, one 5,000-bushel load out-bin, a dryer bin, a feed mill and a control room/office. The grain elevator system ran from ground level to platforms 30 ft. above the bins. Downspouts running from the elevator delivered grain to the bins. The top of the elevator was approximately 130 feet high off the ground and the grain bins were 55 to 60 feet in height (see photo #2). The dryer bin was equipped with a walking platform with railings. The employee was sliding down a 10 inch diameter down spout above the dryer bin, when he fell to the ground below, landing on the ground between the dryer bin, a wet bin and the control office.

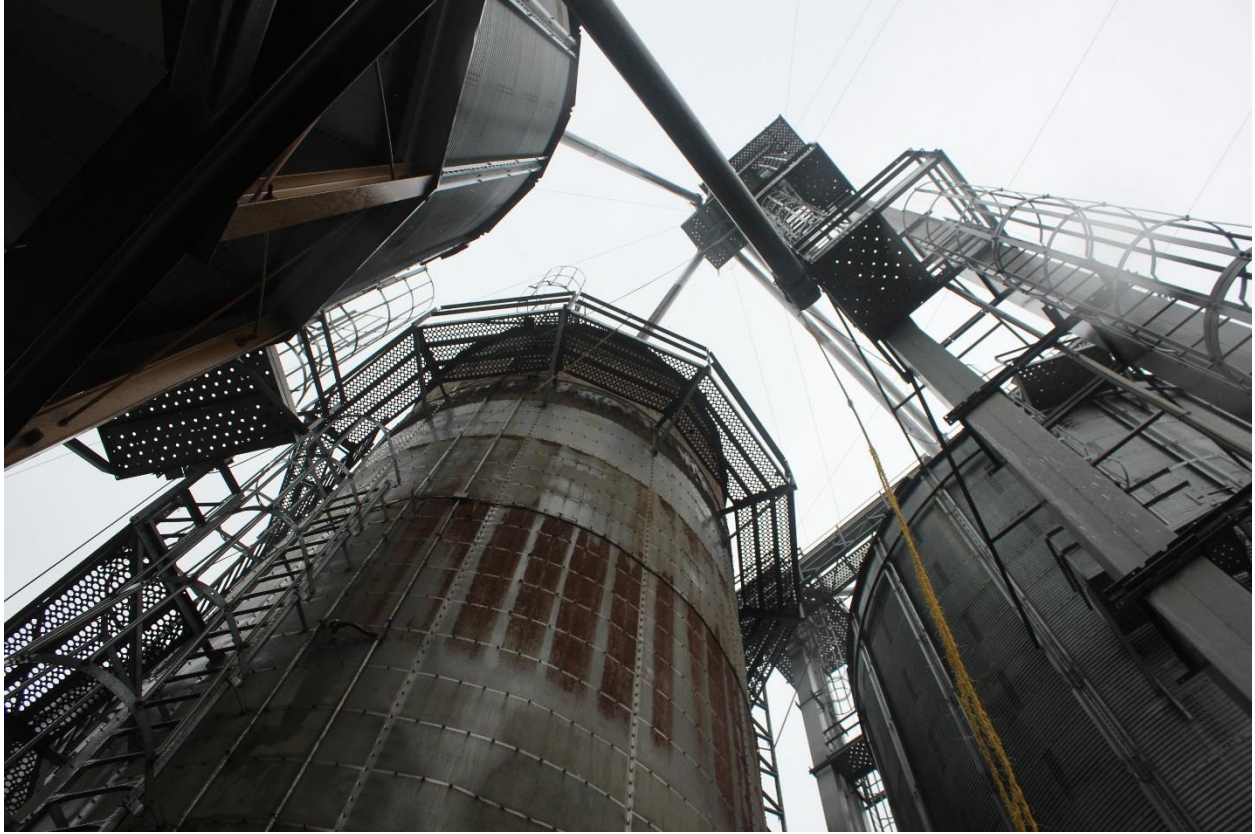
Photo #2 of the grain bin being painted.

It had been raining the previous day and was overcast the day of the incident; the surfaces of the grain bins were still damp. On November 21, 2013, between 7:00 and 7:30 a.m., the victim started painting the dryer bin, which was equipped with a walking platform with railings. It is unclear why the victim decided to hang from a 10 inch diameter downspout above the dryer bin without any type of fall protection. It was from this downspout that he lost his grip and fell 50-

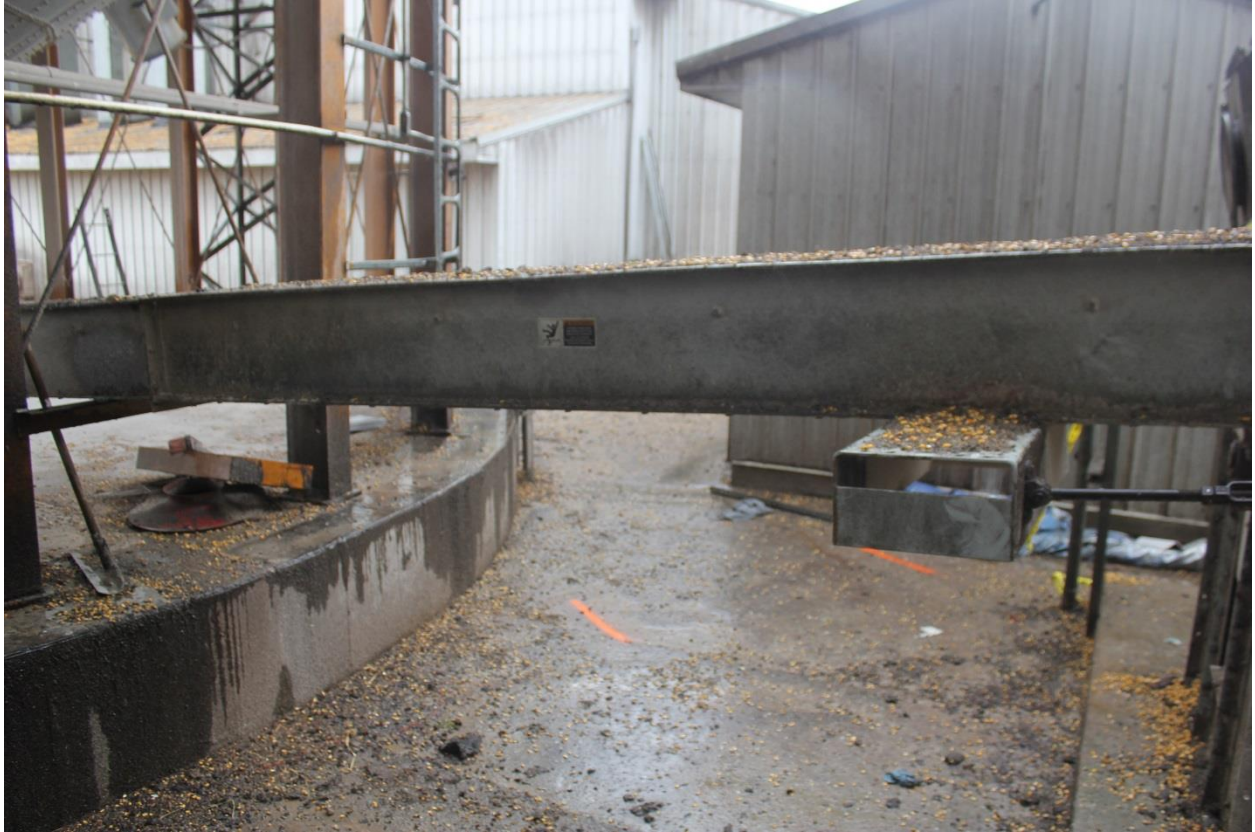
Photo #3 is where the victim landed.

75 feet below to the concrete, between the dyer bin, a wet bin and the control office (see photo #3).
