NJ FACE INVESTIGATION REPORT

FACE 04-NJ-034

Rofer Killed After Falling From a Ladder Lowered From a School Roof

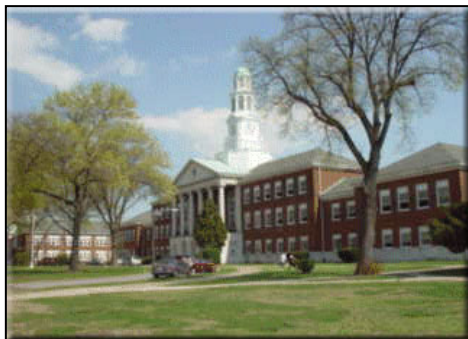
Photo 1
Front of School
(website photograph)

The incident occurred outside a large high school located in an urban area. Approximately 2,300 students were enrolled in grades 9 through 12 at this school. The high school building was a 72-year-old, three-story, brick central structure with a sloped roof (Photo 1). Over time, additional

buildings were constructed, resulting in a sprawling wing of several buildings on the west side of the school and a smaller wing on the east side. The wings were a combination of single- and two-story brick buildings with flat tar roofs. The school was undergoing extensive renovations as part of the New Jersey Educational Facilities Construction and Financing Act, which established \$8.6 billion to overhaul hundreds of schools throughout the 21 state counties. This

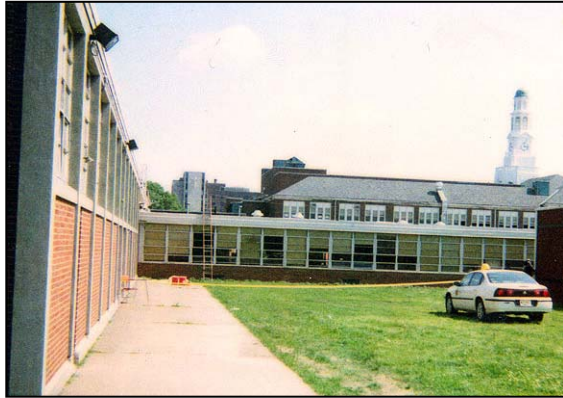
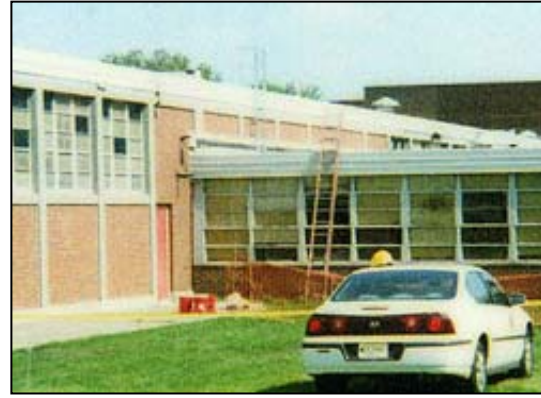
Photos 3 & 4

found and carried a 28-foot, two-section fiberglass extension ladder to his worksite (Photo 2). A school surveillance camera just below his worksite recorded the ladder as the victim lowered it from the roof of the building. The victim apparently lowered the ladder to get back down to the ground, or to possibly work on the roof from a different angle. After placing and adjusting the ladder, the victim climbed onto it. Apparently, the fly-lock mechanism that locks the ladder sections together was not properly set, causing it to slip when the victim placed his weight on the ladder. The top section of the ladder slid down several rungs until it hit the ground, causing the victim to fall from the ladder. The police report stated that the sliding ladder was seen in the video, although the camera angle was such that the victim's fall was not seen. As he fell, the victim's head struck a piece of angle iron which protruded about 18 inches from the building, before landing on the concrete sidewalk below (Photos 3 & 4).

**Incident Site, victim landed near box on sidewalk.
Ladder was originally raised near the doorway on the left.**

Recommendation #1: Employees must be trained in the proper use of ladders.

Discussion: The victim's decision to retrieve a ladder and set it up from the top of a building indicates a lack of training and supervision in the use of ladders. The American National Standards Institute (ANSI) prohibits this practice, noting in section 9.3.13.1 of their ANSI Standard A14.5 1992 for reinforced plastic ladders:

To prevent similar incidents, NJ FACE recommends that employers develop and implement a comprehensive training program that provides detailed instruction in the set-up, use, and care of ladders. At a minimum, this training should cover the topics outlined in the OSHA publication, *Stairways and Ladders, a Guide to OSHA Rules*.
