## **Roofer Falls 20 Feet from Roof**

**Type of Incident: Fall from roof**

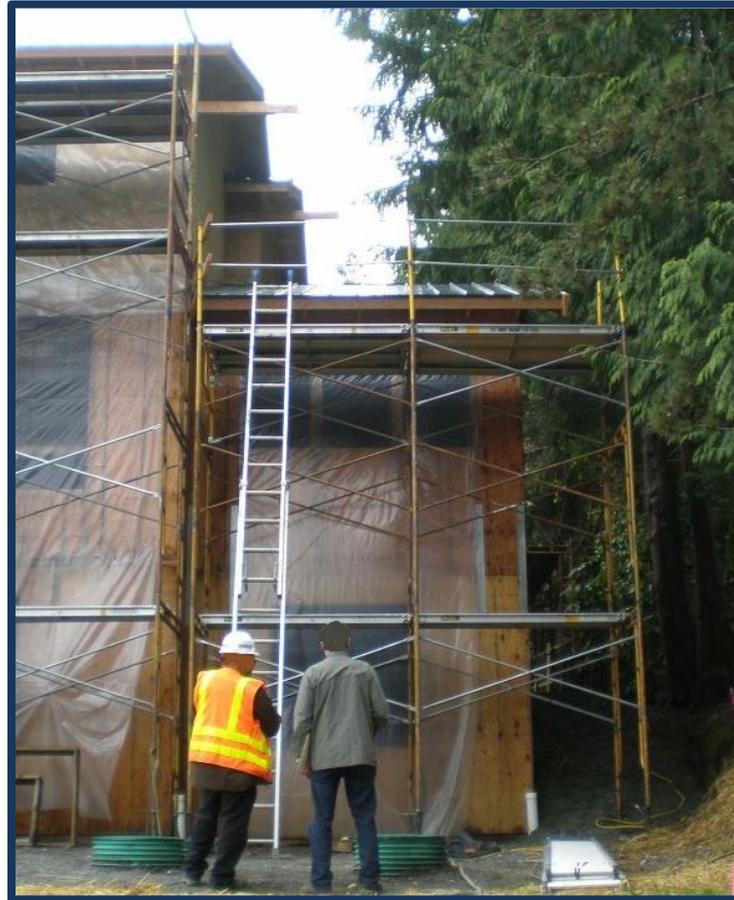
At about 1:35 p.m., the injured worker was on the 5:12 pitch metal roof when he slipped and rolled off the roof onto a scaffold and then rolled off it and fell 20 feet to the ground. A neighbor found the victim lying on the ground and alerted the crew who then summoned emergency medical services. Medics transported the victim to a hospital. He suffered multiple broken ribs, a broken clavicle, a collapsed lung, and a traumatic brain injury which resulted in a coma. More than a year later, he still suffers from conditions caused by his injuries and is unable to work.

Investigators found that the injured worker was not using fall protection.

Incident scene showing the sheet metal roof deck from which the roofer slipped and rolled off onto the scaffold and then rolled off it and fell 20 feet to the ground.

- Regardless of work activity, employers must ensure that employees exposed to fall hazards of four feet or more while working on a roof with a pitch greater than four in twelve use one of the following: fall restraint system, fall arrest system, or positioning device system.  
See [WAC 296-155-24609\(7\)\(a\)](#)
- Develop and implement a written fall protection work plan that includes each area of the work place where the employees are assigned and where fall hazards of ten feet or more exist. See [WAC 296-155-24611\(2\)](#).
- Substantial footwear made of leather or other equally firm material and that provide firm footing shall be worn by employees. Tennis shoes, shoes with canvas tops, or thin or soft-soled shoes shall not be worn.  
See [WAC 296-155-212](#)

- When working to get a job done according to a schedule, do not compromise safety.
- Avoid working on wet metal roofs.
- Wear footwear with slip-resistant soles.

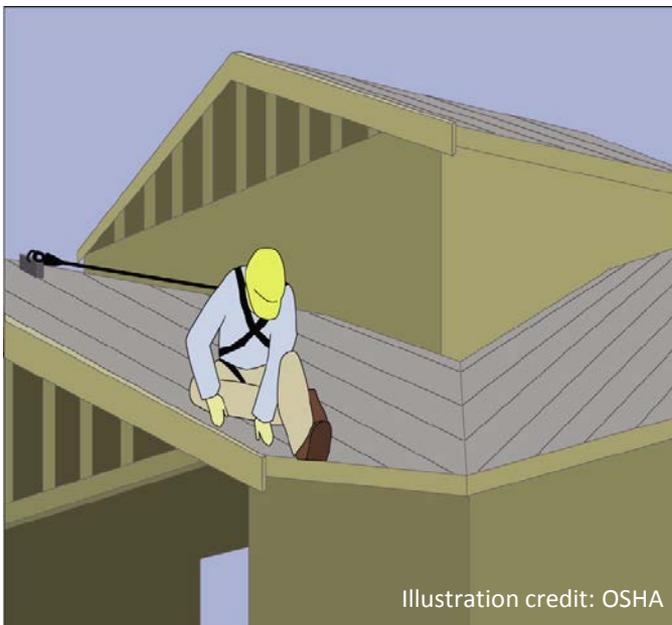
Illustration 1: Roofer using fall protection system

Use of fall protection systems can reduce the risk of falls for roofers installing metal roofs.

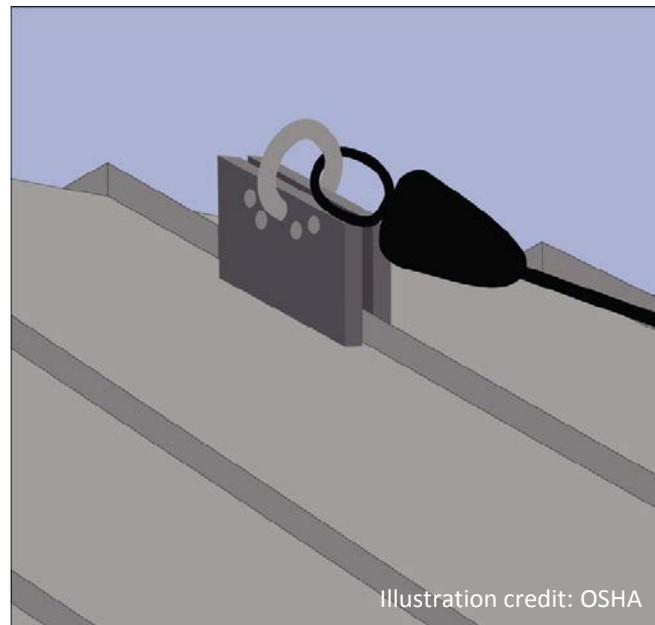
Illustration 2: Fall protection anchor on metal roof.
