Occupational Fatality Report

Temporary Worker Fell from a Fixed Ladder inside a Building Being Renovated - Massachusetts

Release Date: June 26, 2015
Investigation: # 13-MA-026-01

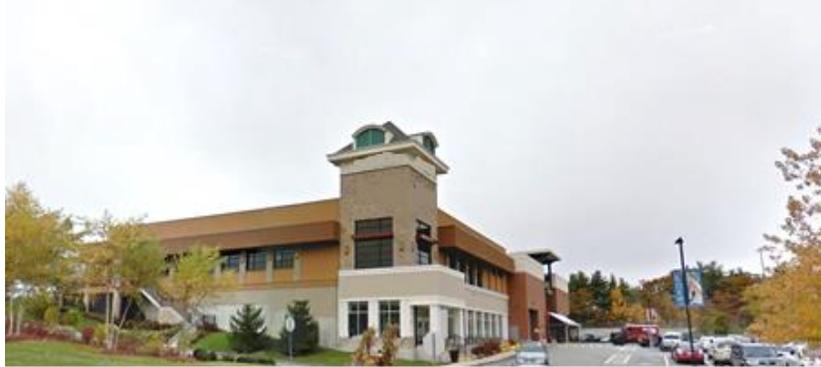
Figure 1 – Building where the incident occurred

The incident location was a suburban open-air shopping area with retail and restaurant space. The shopping area was comprised of five buildings, totaling 193,000 square feet of space and 32 retail units. The location of the incident was inside an existing retail unit that was previously being used to house a store (Figure 1). The unit was going through a complete renovation to accommodate a restaurant that was moving into the space. The restaurant had opened for service the day before the incident occurred.

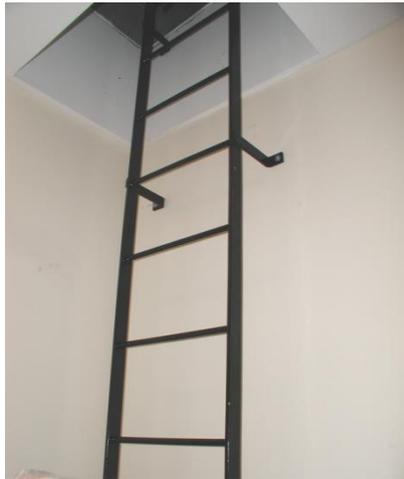
Figure 2 – Example of a fixed ladder

The incident occurred inside a small room at the back of the restaurant. This room had a concrete floor and an 18 ½ foot vertical fixed ladder that was permanently attached to a wall. The fixed ladder had a 90 degree pitch and was used to access the building's roof through a roof hatch (Figure 2 and 3).

At the time of the incident, the victim was standing on the fixed ladder, near the top, approximately 17 feet high. The host employer's superintendent climbed up a couple of rungs on the fixed ladder and handed the victim some filters. The victim placed these filters onto the roof through the roof hatch. The superintendent then, standing on the concrete floor with his back to the fixed ladder and the victim, leaned over to pick up some more filters when he heard a loud crash. The superintendent turned around to see the victim lying on the ground behind. The victim landed within three feet of the base of the fixed ladder between the ladder and the superintendent.

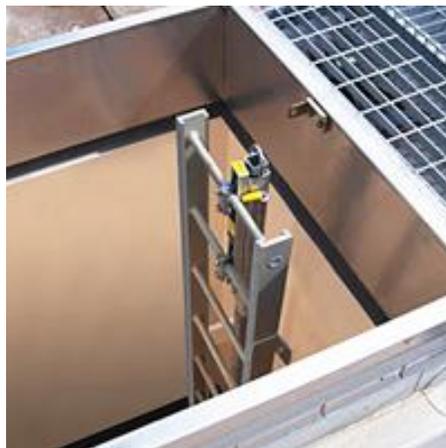
Figure 3 – Example of a roof hatch with a fixed ladder

Discussion: In this case, the only access to the building's roof was through a roof hatch via a fixed ladder. If a hoist or another mechanism was available to get the filters to the roof, this would have eliminated using the ladder to accomplish this task and might have prevented the incident. A hoist would have limited the amount of time the victim spent on the ladder, especially standing at the top of the ladder twisting his body placing the filters on the roof and grabbing the next load of filters, which contributed to his fall.
