Massachusetts Department of Public Health
Occupational Health Surveillance Program
Fatality Assessment and Control Evaluation Project

Municipal Lead Custodian Dies in Fall from Mobile Scaffolding – Massachusetts

Investigation: # 11-MA-008-01

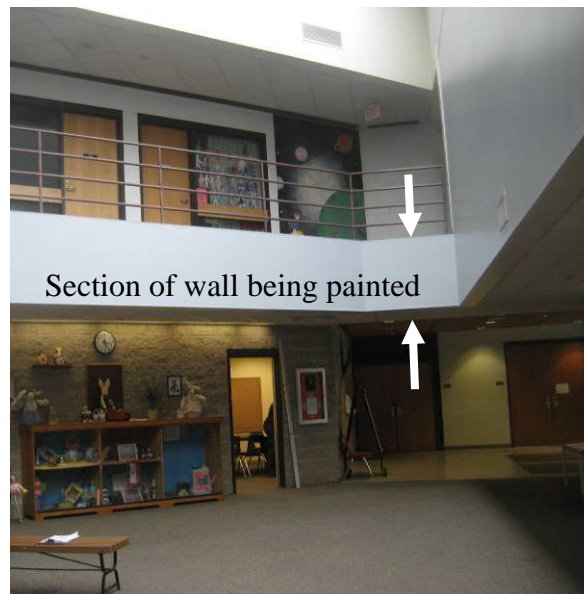
Figure 1 – School lobby.

At the time of the incident, the victim had been painting an interior section of the school lobby (Figure 1). The school's lobby has a carpeted floor and the middle section of the lobby is an open foyer with a two story high ceiling. Two sides of the lobby have a second story hallway with a railing that overlooks the lobby area. Painting the lobby was one of the many projects scheduled to get completed using the supplies from the grant. Painting started the day before the incident, a Saturday, but the work crew, which included the victim, was not able to finish

The section of wall that the victim was going to paint was located in the open foyer section of the school's lobby. The wall started at the first floor ceiling height, approximately 12 feet above the floor level of the lobby, and was approximately four feet high (Figure 1). A plastic drop cloth had been placed on the lobby floor to cover the carpet prior to the painting task, and the scaffolding was positioned on the plastic.

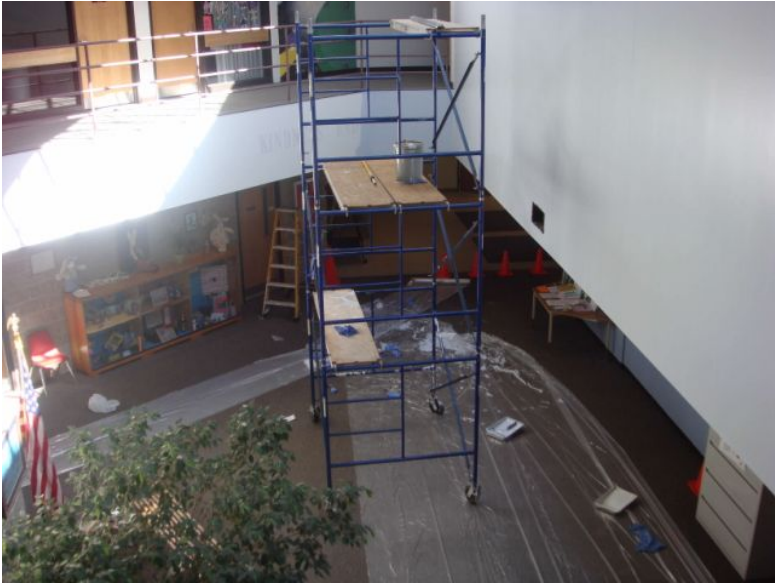
Figure 2 – Scaffolding involved in the incident.

There were three pieces of equipment located in the lobby that had been used during the painting tasks. These included a step ladder, a man lift, and mobile tubular frame scaffolding. Although the incident was un-witnessed, it appears that the main piece of equipment involved in the incident was the mobile scaffolding (Figure 2). The mobile scaffolding was approximately eight years old and appeared to be in good condition. The scaffolding had been donated to the school. The school did not have the owner's manual for the scaffolding.

The scaffolding found in the lobby on the day of the incident was assembled three levels high. It had four lockable caster wheels, some cross bracing, and some aluminum and plywood planking. None of the three scaffold levels were fully planked. The lowest level and the highest level of the scaffold had one plank each and the middle level of the scaffold had two planks. Cross bracing was missing on one side of the top level of the scaffold. Each section of scaffold was a little more than five feet high and approximately six and one half feet long. Therefore, both the middle and the highest sections that were planked would have been more than ten feet high. (Fall protection for scaffolding is needed on scaffold more than 10 feet above the ground or floor.) It appeared that only two of the four caster wheels were locked during the incident.

According to the time that the school alarm had been turned off, the victim had arrived at the school at 8:00 a.m. on the day of the incident. It appears that the victim was on one of the planked sections of the scaffolding when he fell from the scaffolding and landed on the floor below. There was a large amount of paint spilled covering some of the lowest level of the scaffolding, the plastic drop cloth, and the victim. There was a closed five gallon bucket of paint located on the scaffold's middle level and two paint trays with paint in them on the floor.

Recommendation #1: Municipal schools should ensure scaffolds are erected according to the manufacturer's guidelines and OSHA standards.

Discussion: In this case, the school did not have the owner's manual for the scaffold. The first step to ensure that a product is being set up and used as it was intended is to follow the procedures outlined in the manufacturer's owners manual. Therefore, in this case, an owner's manual for the specific scaffolding involved in the incident should have been obtained.

OSHA has regulations for the safe erection, use, and dismantling of scaffolding (29 CFR 1910.28, 29 CFR 1926.451 and 1926.452). OSHA requires that scaffolding is erected and dismantled under the supervision of a competent person. OSHA defines a competent person as a person who is capable of identifying existing and predictable hazards in the surroundings or working conditions which are unsanitary, hazardous, or dangerous to employees, and who has authorization to take prompt corrective measures to eliminate them. OSHA's general requirements for mobile tubular frame scaffolding includes, but is not limited to:¹

- Installing cross bracing;
- Ensuring all levels to be accessed are fully planked;
- Providing safe ladder access;
- Locking the scaffolding wheels;
- Installing guardrails along all open sides and ends of platforms;
 - Toprails must be installed at a height between 38 inches and 45 inches high and must be able to withstand a force of at least 200 pounds applied in any downward or horizontal direction;
 - Midrails must be installed at a height approximately midway between the toprail and the platform surface; and
 - Toeboards must be installed on all open sides of the scaffolding more than 10 feet above a lower level and that the toeboards are a minimum of at least three and one half inches in height.

In this case, a JSA might have identified elements of the scaffolding that were not properly erected, including the levels that were not fully planked, the lack of fall protection available for accessing scaffolding levels higher than ten feet above the lower level, and that not all four of the scaffold wheels were locked. Once these hazards were identified during the JSA, the hazards could have been eliminated or controlled.
