Spot the Hazard.

Can you spot the hazards?

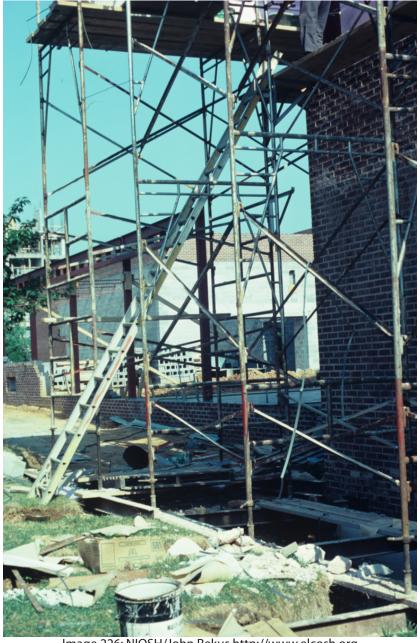
Image 226: NIOSH/John Rekus http://www.elcosh.org

Ladder used is the top of an extent ion ladder, does not have feet

Improper ladder use (less than 3 feet above the point of support, not secured)

Look ponsekeeping

Scaffold footing not properly braced

Scattold set up on top of unsecured excavation (no caution tape)

Scaffold missing: cross bracing, full planking, falling object protection
