## A 53-Year-Old Male Iron Foreman Dies After Fall From Steel Decking Incident Number: 07KY071

# Kentucky FatalityAssessment and Control Evaluation (FACE) ProgramIncident Number:07KY071Release Date:September 5, 2008Subject:A 53-Year-Old Male Iron Foreman Dies After Fall From<br/>Steel Decking

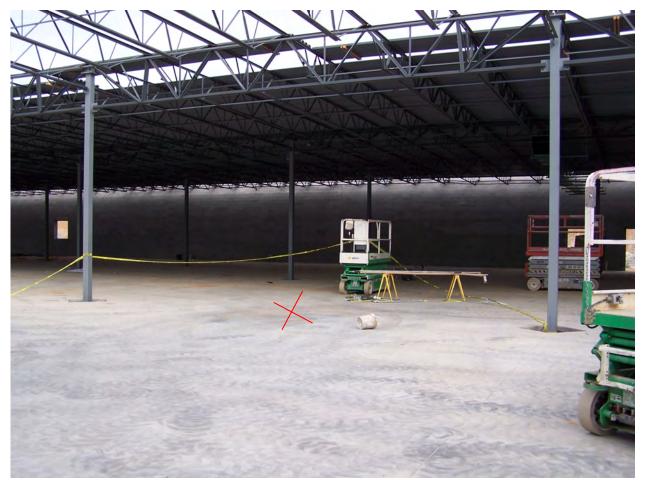
Location where foreman fell.

On the day before the incident, the crew had prepared the site to install corrugated metal decking (3 feet wide by 22 feet long) to steel joists by setting stacks of the metal sheets offset from each other on the steel joists. That same day, the iron workers attached some decking to the steel joists by screwing it to the joists. At approximately 9 AM on the day of the incident, two work crews continued laying the decking. The general foreman, via a 32-foot extension ladder, accessed the work area to check on the progress of the work and consult with the two work crews. All workers, including the general foreman were wearing harnesses with lanyards on the roof; however, none of the men were tied off to the building. It is unknown if temporary anchors had been installed to support the lifelines. The general foreman walked away from one crew to check on another area where work was also being performed. He was approximately 71 feet from the access ladder, walked off the unsecured decking and fell approximately 18 feet to the concrete floor below. The iron workers heard but did not see the general foreman fall. A supervisor for the general contracting company saw the general foreman fall to the concrete floor. Emergency services were contacted immediately at 10:28 AM and dispatched to the scene at 10:31, arriving at 10:34 AM. Upon arrival, emergency management service personnel found the general foreman unconscious. An air ambulance service was contacted. It was cancelled when the general foreman died as he was loaded into the ambulance that was to transport him to the air ambulance location. The ambulance then transported the decedent to the local hospital where they arrived at 10:48 AM. At 10:50 AM the general foreman was pronounced dead by the local coroner.

The workers involved in this incident were wearing personal fall arrest systems which included harnesses with attached lanyards, but were not tied off. Typically iron workers use a cable system to tie off to. According to an employee for the general contractor, all iron workers on the jobsite were trained and certified in OSHA 10 Hour – Subpart R and knew how to use the personal fall arrest systems they were wearing.

Recommendation No. 1: Employers should ensure all employees use personal fall arrest systems appropriately.

## *Recommendation No. 1: Employers should ensure all employees use personal fall arrest systems appropriately.*
