Laborer Falls 55 to 75 Feet to the Ground While Spray Painting Grain Bins

Incident Number: 13KY061

Kentucky Fatality Assessment and Control Evaluation (FACE) Program
Incident Number: 13KY061
Release Date: November 11, 2014
Subject: Laborer Falls 50 to 75 Feet to the Ground While Spray Painting Grain Bins

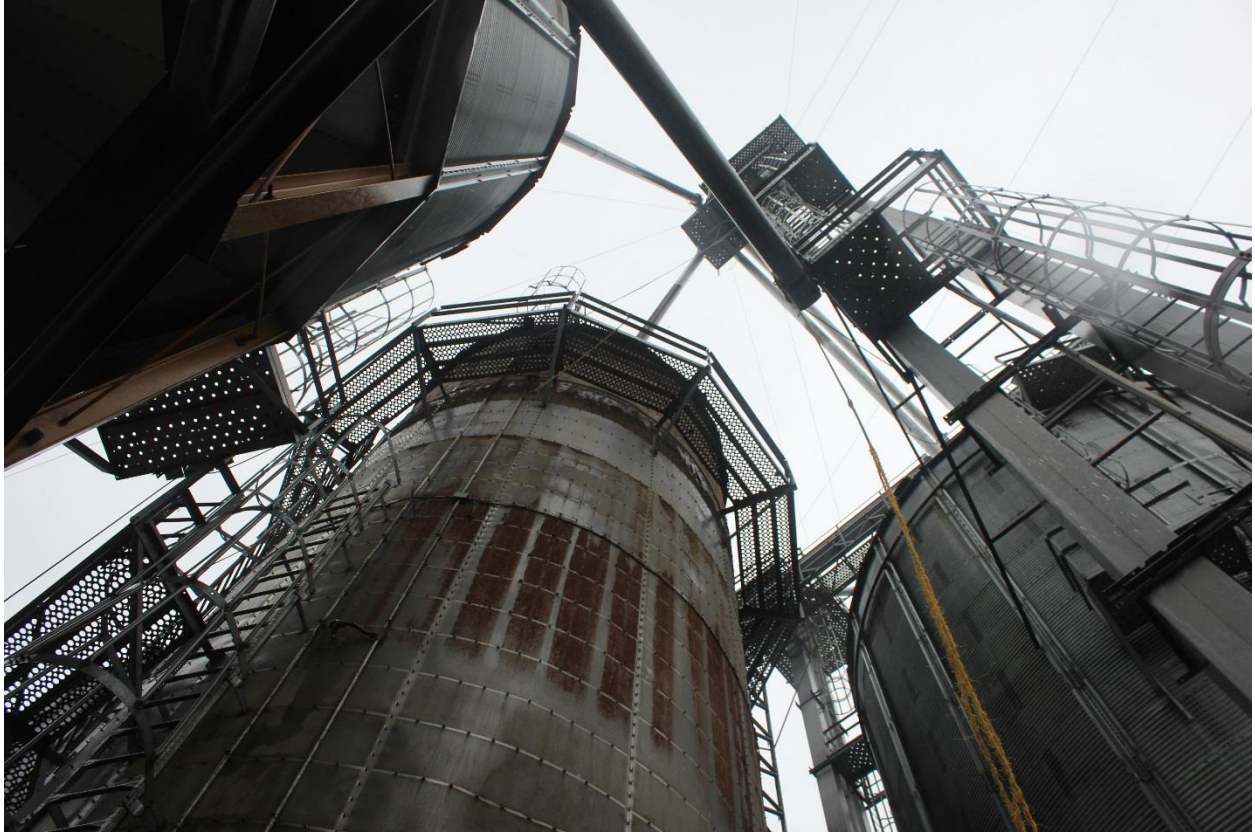
It had been raining the previous day and was overcast the day of the incident; the surfaces of the grain bins were still damp. On November 21, 2013, between 7:00 and 7:30 a.m., the victim started painting the dryer bin, which was equipped with a walking platform with railings. It is unclear why the victim decided to hang from a 10 inch diameter downspout above the dryer bin without any type of fall protection. It was from this downspout that he lost his grip and fell 50-

Photo #2 of the grain bin being painted.

The victim did not wear any type of body harness or fall protection to protect him in the event he fell while painting. Had the victim been wearing full body harness fall protection and been properly tied off, his harness would have prevented him from falling to the ground below when he slipped.
