FACE Report Number 2012-02

January 12, 2015

## Hispanic worker falls from residential roof – North Carolina

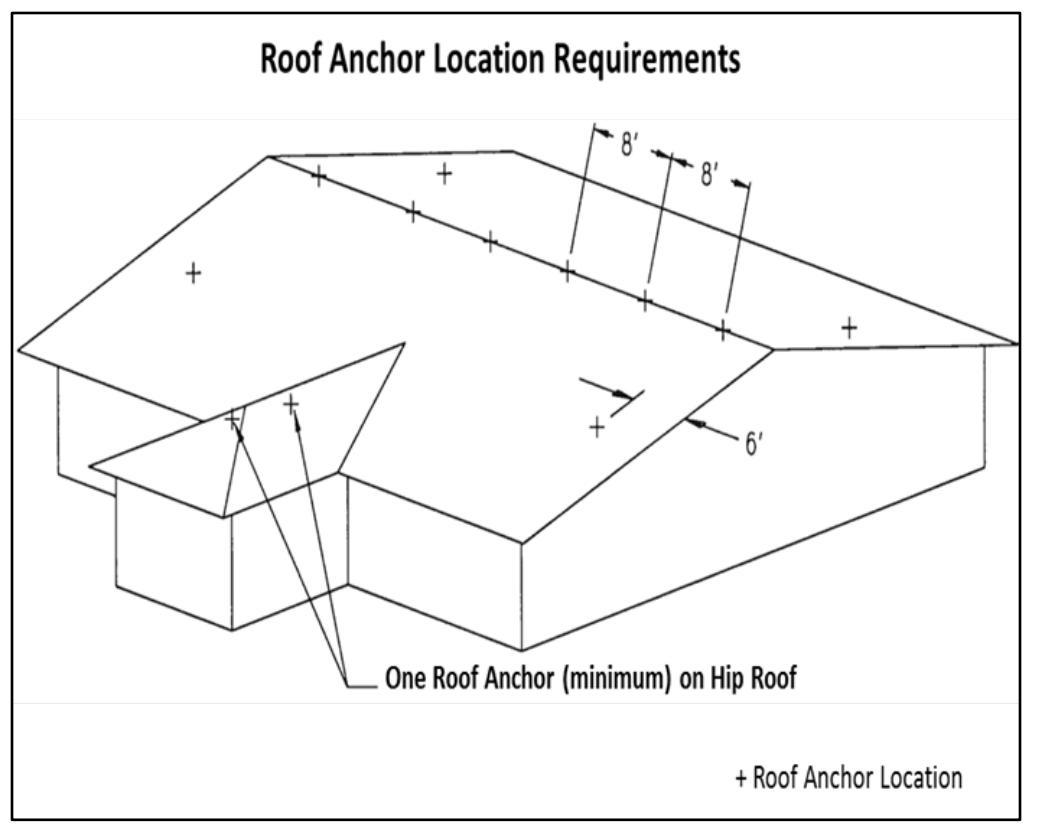
Diagram 1. Example of typical roof bracket installation on residential roof (Diagram courtesy of DBI-SALA/Capital Safety)<sup>Z</sup>

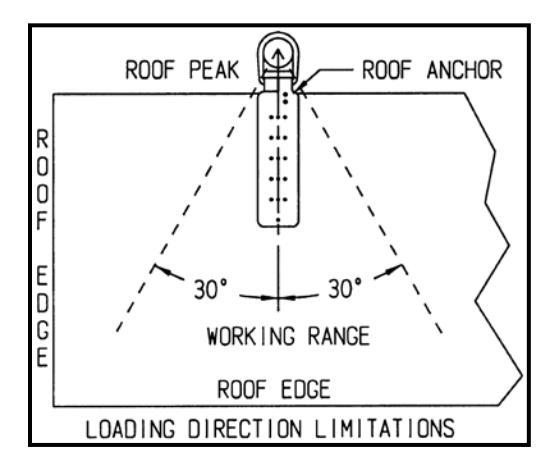
SWING FALL HAZARD

According to 29 CFR 1926.502(d)(16)(iii)<sup>6</sup> the PFAS should be rigged such that an employee can neither free fall more than 6 feet (1.8 m), or contact any lower level. There was only one anchor installed across the ridgeline, the manufacturer recommends anchors be installed a minimum of 5 feet from the ridge ends and a maximum of every 8 feet along the peak (Diagram 1). The laborer's lifeline was rigged at 25 feet with a 6-foot lanyard, which gave him 31 feet of rope and the PFAS system was anchored approximately 29 feet from the ground. He was also working laterally away from the anchor point allowing the swing effect in the event of a fall (Diagram 2 & Diagram 3). In order to minimize the swing effect workers should work directly below the anchor and not extend their work area beyond 30 degrees from the anchor point<sup>7</sup>.

Diagram 2. Working range for PFAS anchor point (*Diagram courtesy of DBI-SALA/Capital Safety*)<sup>Z</sup>
