FATALITY ASSESSMENT AND CONTROL EVALUATION

Tower Technician Killed When Guyed Tower Collapsed Case Report 09NY095

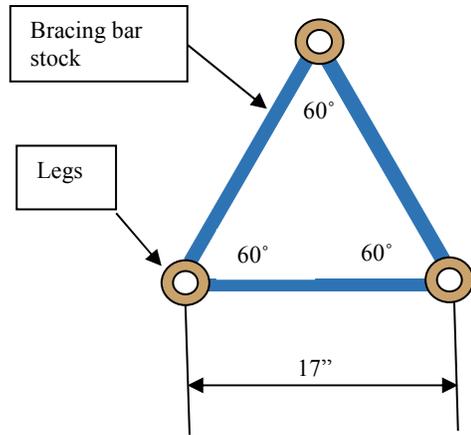
Figure 2*. Top view of the tower

The tower was a 380 foot tall equilateral triangle column with 17 inches on each side (Figures 1 and 2). The tower column was formed by multiple 10-foot-long sections connected by friction fits with two bolts and nuts per connection. Each section was made of three vertical steel pipes or legs that were braced with round steel bars into the triangular column. The steel pipes were 1.5 inch in (outside) diameter and 0.12 inch thick. Round steel bars that were 7/16 inch in diameter braced the three legs in a continuous zigzag pattern.
