A 53-Year-Old Male Iron Foreman Dies After Fall From Steel Decking

Incident Number: 07KY071

Kentucky Fatality Assessment and Control Evaluation (FACE) Program
Incident Number: 07KY071
Release Date: September 5, 2008
Subject: A 53-Year-Old Male Iron Foreman Dies After Fall From Steel Decking

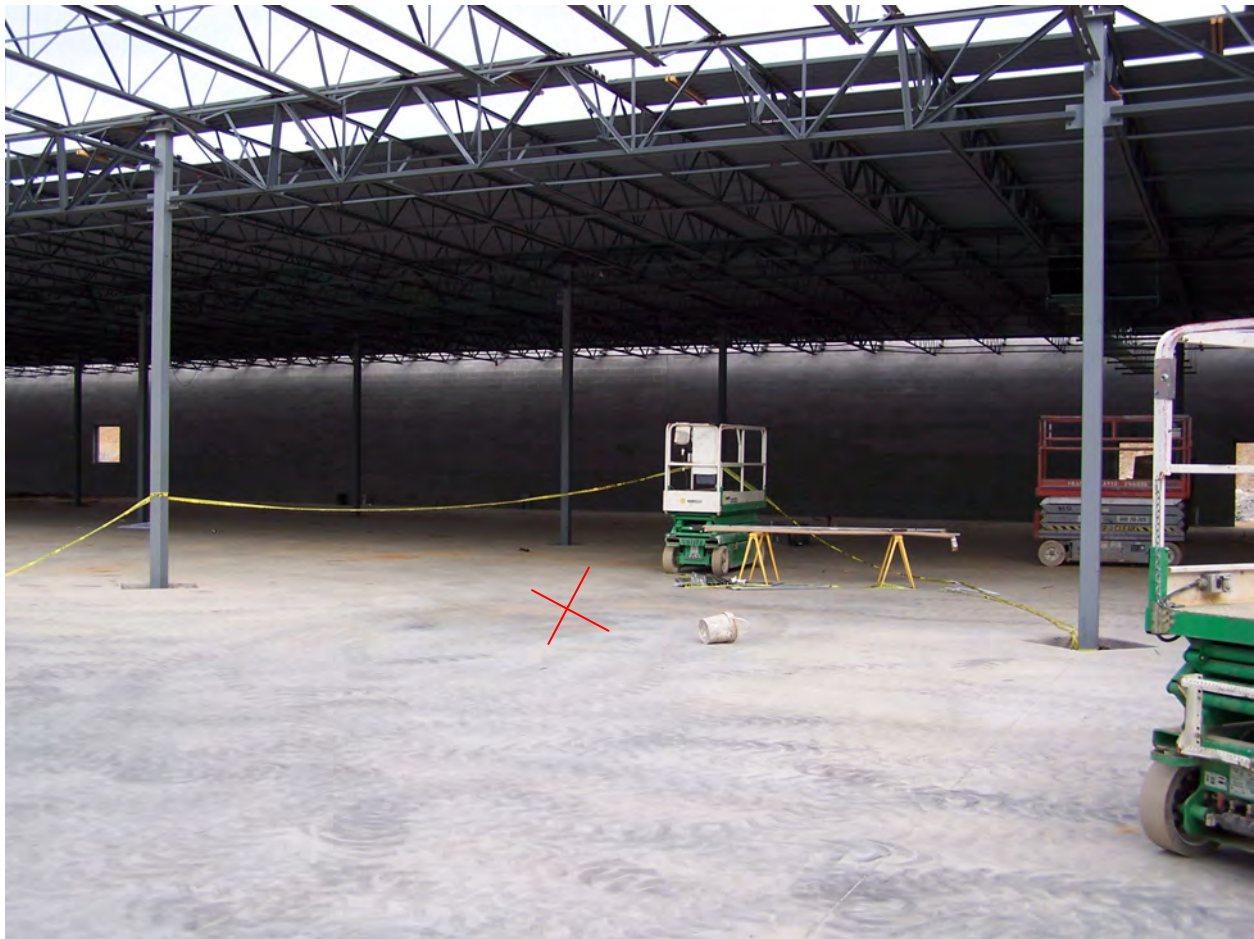
Location where foreman fell.

On the day before the incident, the crew had prepared the site to install corrugated metal decking (3 feet wide by 22 feet long) to steel joists by setting stacks of the metal sheets offset from each other on the steel joists. That same day, the iron workers attached some decking to the steel joists by screwing it to the joists. At approximately 9 AM on the day of the incident, two work crews continued laying the decking. The general foreman, via a 32-foot extension ladder, accessed the work area to check on the progress of the work and consult with the two work crews. All workers, including the general foreman were wearing harnesses with lanyards on the roof; however, none of the men were tied off to the building. It is unknown if temporary anchors had been installed to support the lifelines. The general foreman walked away from one crew to check on another area where work was also being performed. He was approximately 71 feet from the access ladder, walked off the unsecured decking and fell approximately 18 feet to the concrete floor below. The iron workers heard but did not see the general foreman fall. A supervisor for the general contracting company saw the general foreman fall to the concrete floor. Emergency services were contacted immediately at 10:28 AM and dispatched to the scene at 10:31, arriving at 10:34 AM. Upon arrival, emergency management service personnel found the general foreman unconscious. An air ambulance service was contacted. It was cancelled when the general foreman died as he was loaded into the ambulance that was to transport him to the air ambulance location. The ambulance then transported the decedent to the local hospital where they arrived at 10:48 AM. At 10:50 AM the general foreman was pronounced dead by the local coroner.

Recommendation No. 1: Employers should ensure all employees use personal fall arrest systems appropriately.

The workers involved in this incident were wearing personal fall arrest systems which included harnesses with attached lanyards, but were not tied off. Typically iron workers use a cable system to tie off to. According to an employee for the general contractor, all iron workers on the jobsite were trained and certified in OSHA 10 Hour – Subpart R and knew how to use the personal fall arrest systems they were wearing.
