**FATALITY ASSESSMENT AND CONTROL EVALUATION
PROGRAM (CA/FACE)**

A Custodian Dies When He Falls Off a Step Ladder

Case Report: 16CA006

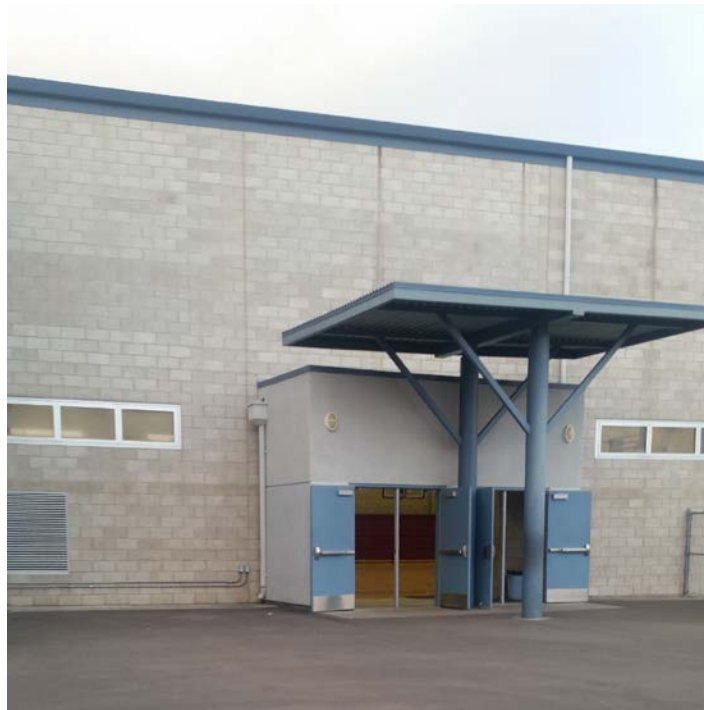
The scene of the incident was the exterior of a gymnasium for a middle school. The ground surface around the perimeter of the building was paved and level. The tops of the windows that were being cleaned in this incident were 15 feet above ground level, and the windows measured approximately 10 feet long by 3 feet high.

EXHIBIT #1. The incident scene.

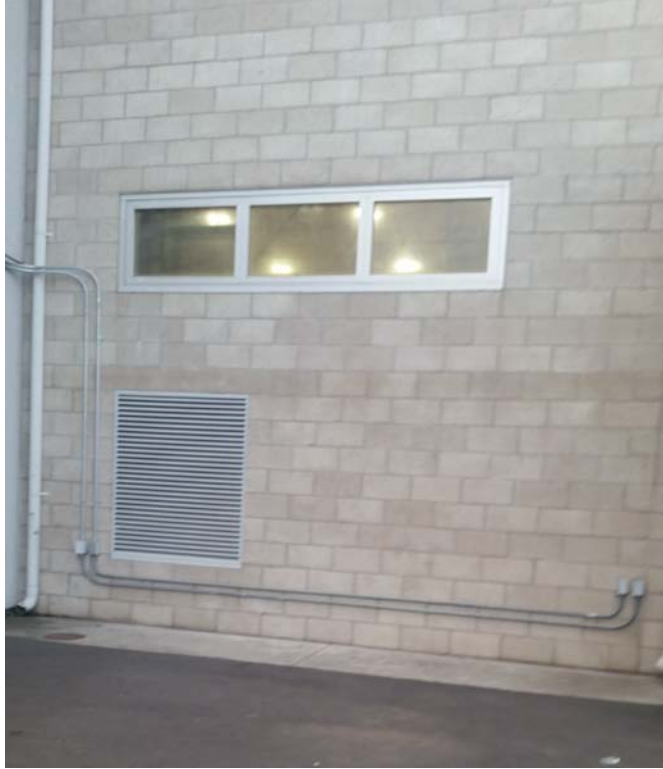
The ladder was placed in an upright position outside of the building directly under the windows that required cleaning. The victim climbed the ladder and began spraying the windows with the cleaning agent and wiping them with the towel. One of the co-workers inside the gymnasium stated he saw the victim's hand as he was wiping the windows from the outside. The other co-worker was positioning trash containers outside the gymnasium approximately 25 yards behind the victim, and saw the victim lying down on the ground directly below the upright ladder. The fall was not witnessed. The co-worker saw the victim bleeding from his head and called 911. The paramedics arrived and transported the victim to a local hospital where he died from his injuries.

EXHIBIT #2. The window the victim was washing when he fell.

Recommendation #1: Ensure that the proper methods and tools are available and used for jobs elevated above ground level.

Discussion: In this incident, the victim was washing windows that were elevated at the top 15 feet above the ground. As he was 5 feet 6 inches tall, the 7-foot ladder that he used would have raised his head height to approximately 10½ feet. With a 7-foot ladder, in order to reach the top of the window for cleaning, the victim likely stepped on the top rung of the ladder. This may have required a greater reach to clean the window, thereby leading to instability and the risk of falling. With a fall from this height, the victim was at high risk of a severe head injury. If the victim had used a 10- or 12-foot ladder, he would have been able to stand on a lower rung and reach the top of the window for cleaning. As an alternative to a taller ladder, there are

extension tools that allow standing on the ground or a lower ladder level to clean windows. If the victim had used either a taller ladder or an extension tool, this incident may have been prevented.

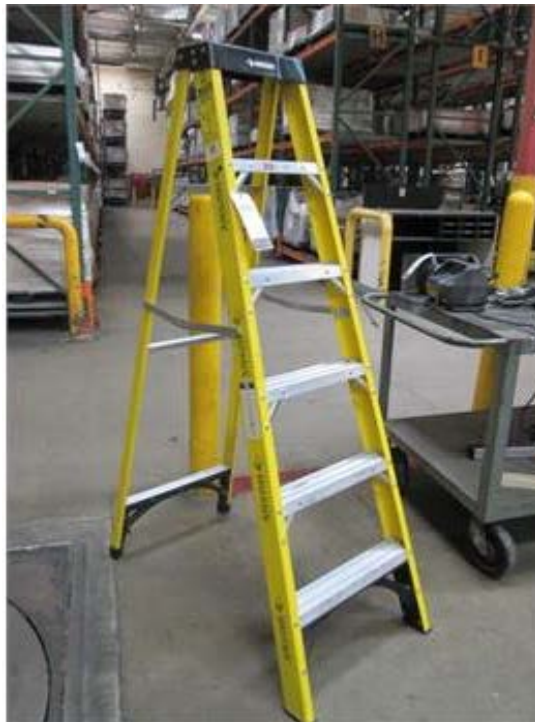
On the day of the incident, the victim, along with two other co-workers, was preparing the school campus for the start of the new school year. After their lunch break, they reviewed the list of custodial tasks and the victim selected to wash and clean the windows in the gymnasium. According to employer representatives, there was a ten-foot ladder available on school grounds. The ladder used by the victim in this incident was a seven-foot step ladder that was in proper working order and met all safety and OSHA requirements (Exhibit 3). After obtaining this

ladder, towel, and a spray bottle with window cleaning liquid from the supply room, the victim went to the outside of the gymnasium while a basketball game was underway.

EXHIBIT #3. A ladder similar to the one involved in the incident.
